**DEPARTMENT OF ENVIRONMENTAL QUALITY
AIR QUALITY DIVISION
ACTIVITY REPORT: Scheduled Inspection**

FACILITY: BREITBURN OPERATING LP - FOSTER 28 CPF		SRN / ID: N1355
LOCATION: HEATH ROAD, ROSE CITY		DISTRICT: Saginaw Bay
CITY: ROSE CITY		COUNTY: OGE MAW
CONTACT: Carolann Knapp ,		ACTIVITY DATE: 06/13/2016
STAFF: Sharon LeBlanc	COMPLIANCE STATUS: Compliance	SOURCE CLASS: SM OPT OUT
SUBJECT: scheduled site inspection for fiscal year 2016.		
RESOLVED COMPLAINTS:

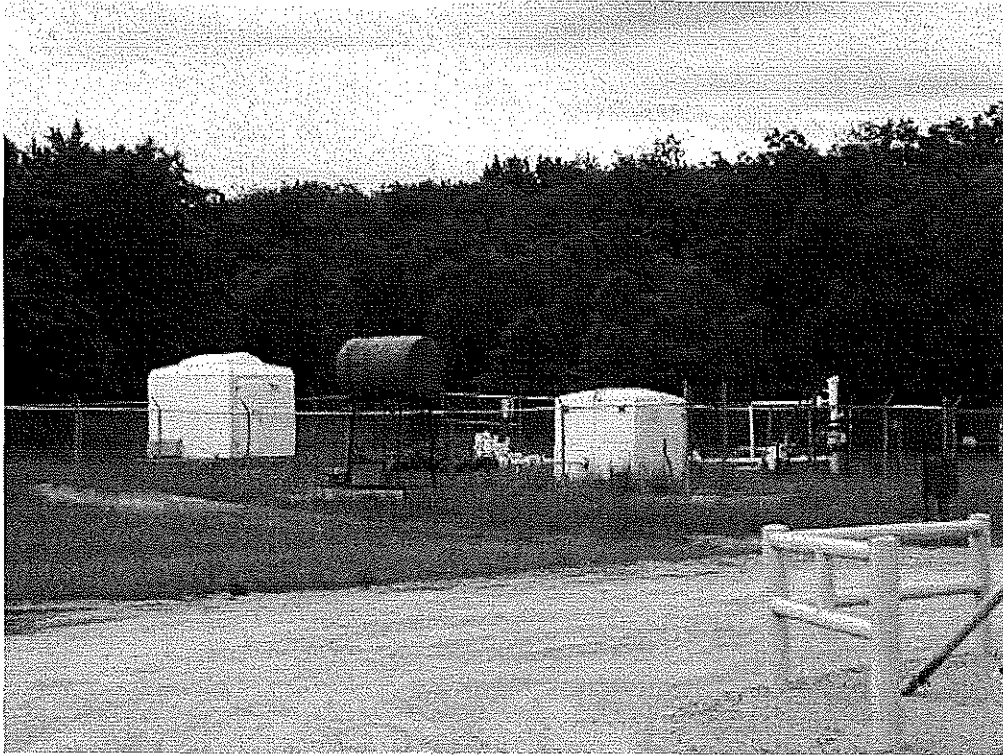
Image 1(DTE Metering) : View of DTE metering station located at the SE end of the facility. Note green tank has been relocated there from the fresh water injection station located immediately west of the metering station.

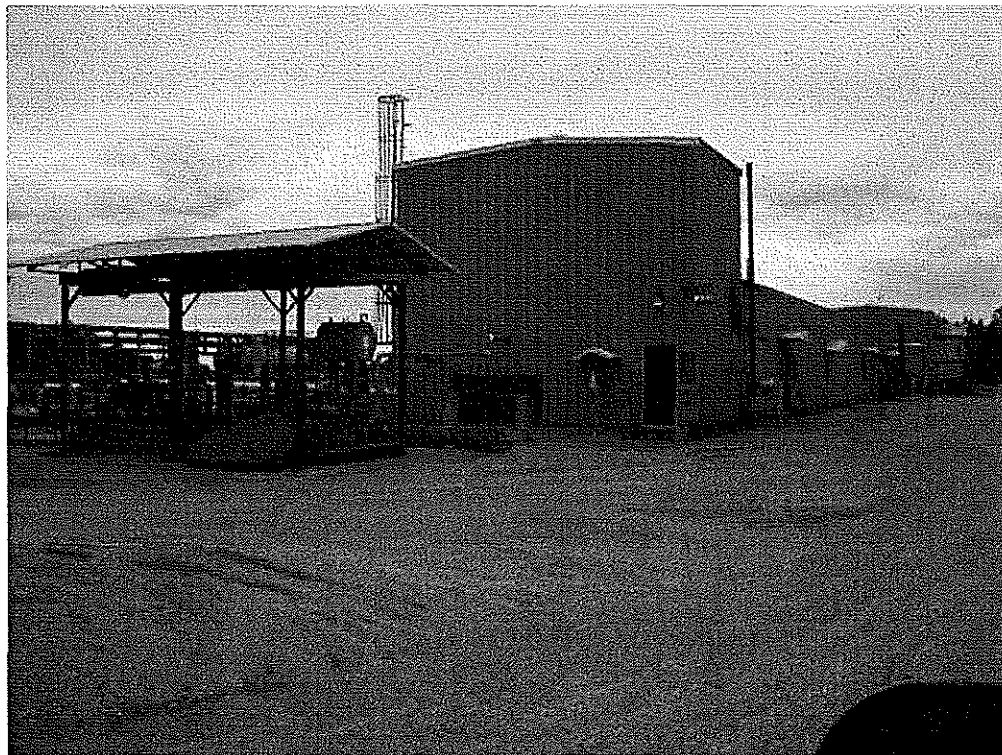
Image 3 (dehy building) : view from left to right of the former fresh water injection station and the eastern entrance of the dehy building. Stack associated with the glycol dehydrator is visible at the NE corner of building (right).

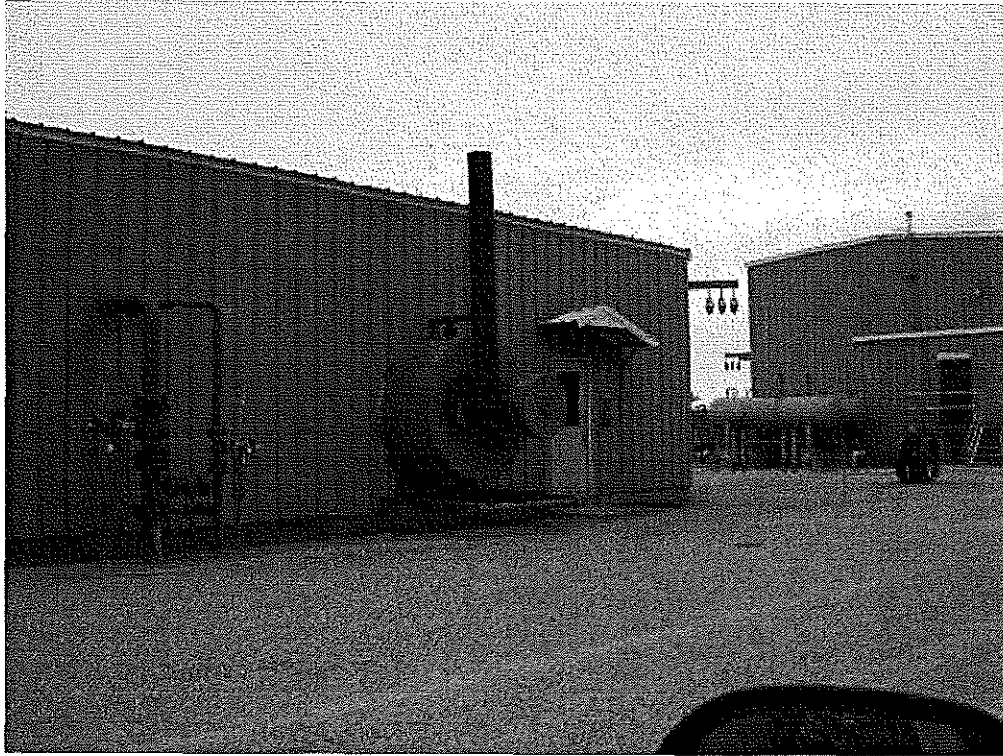
Image 4(in-line heater) : View of inline heater (operating) and associated stack located at the NW end of the dehy building.

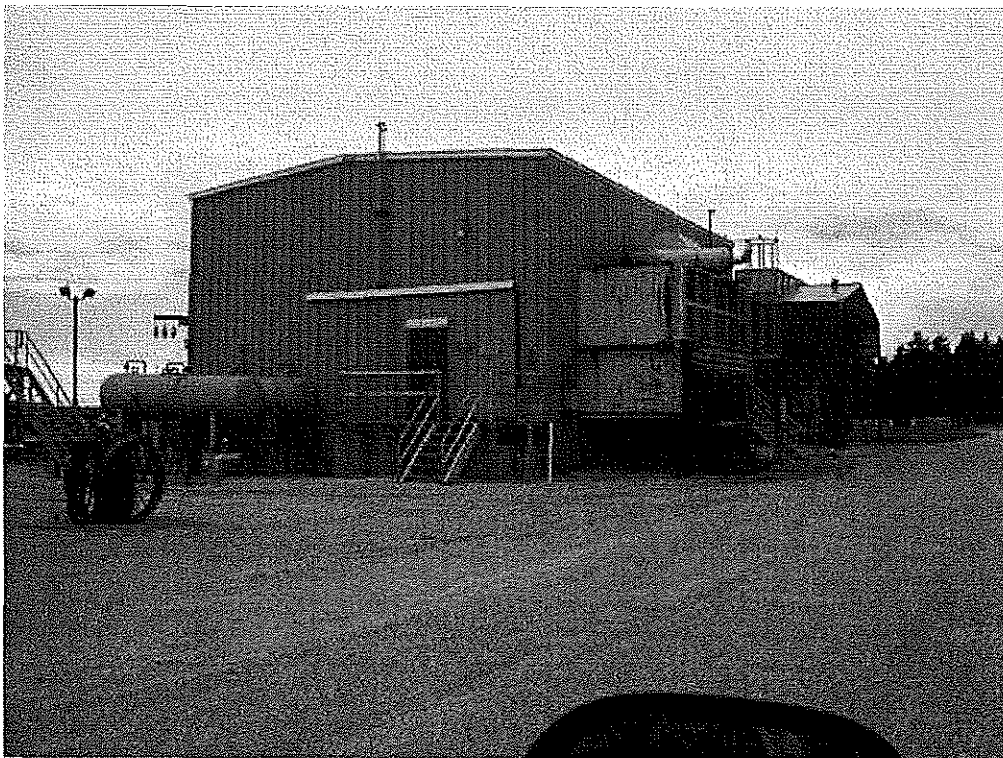
Image 5(inactive compressor) : Inactive compressor building, housing the Waukesha Engine and Cub PF6SU2 Compressor Frame. Active compressor is housed in building immediately in background of the inactive compressor building.

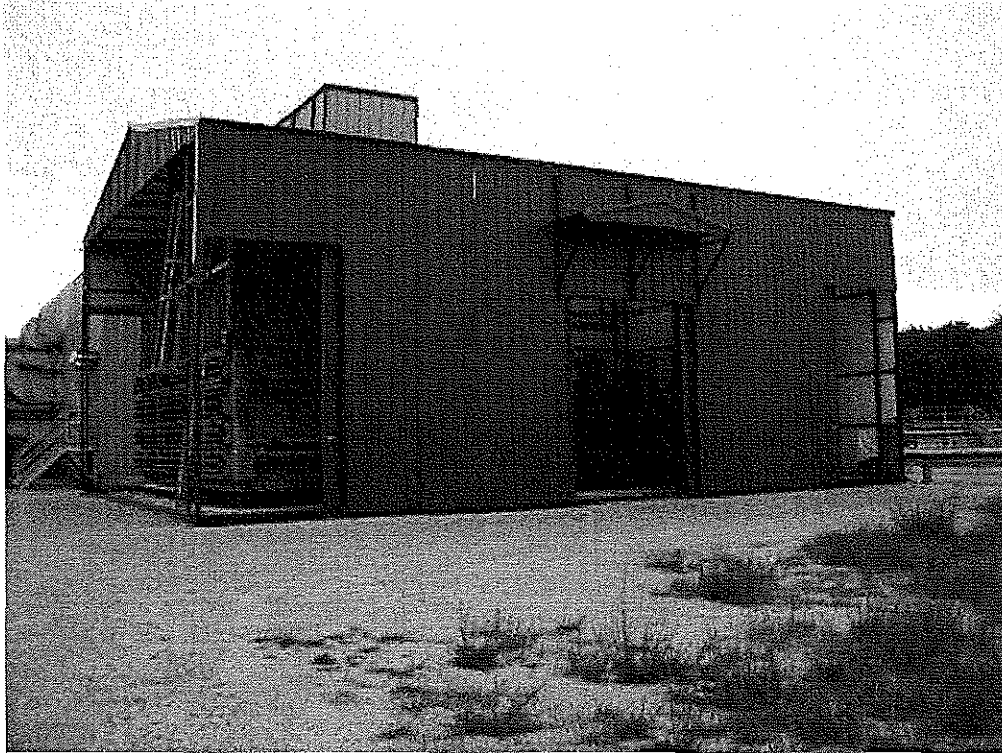
Image 6(active compressor) : building housing the active compressor. This building is located immediately to the west of the inactive compressor building on the north end of the property. This compressor consists of a caterpillar engine and an ariel compressor package.

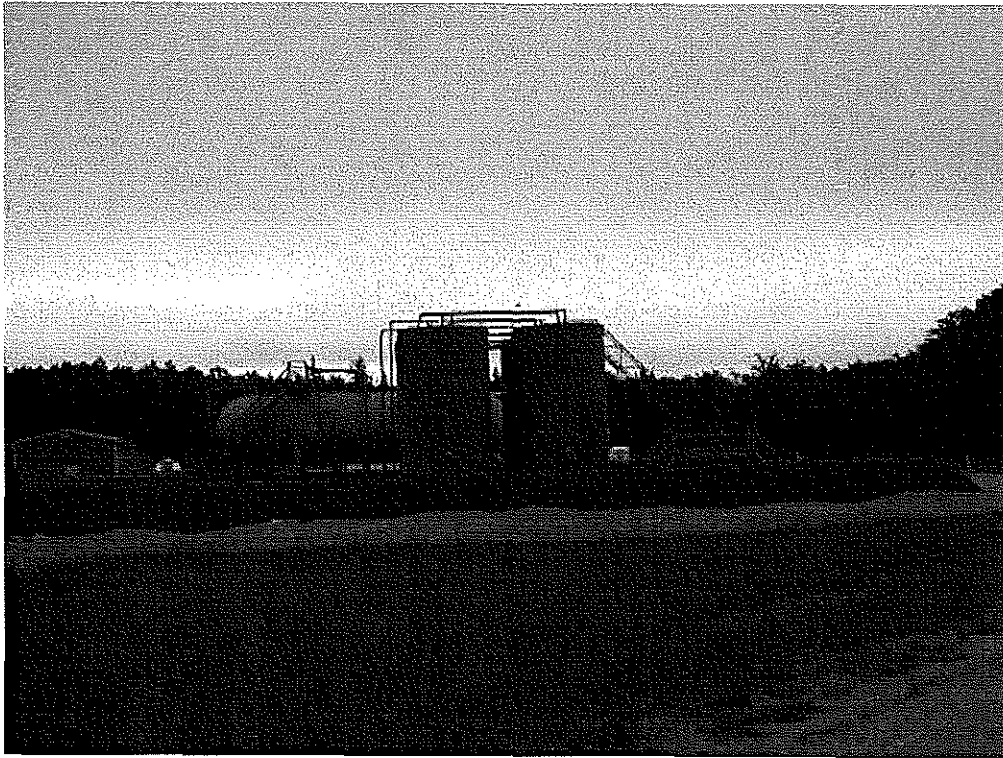
Image 7(Crude ASTS) : view from the NW of the 4 green cylindrical 400 bbl crude oil ASTs. Note the silver bullet shaped tank to the left is a former crude oil tank reported to no longer be in use.

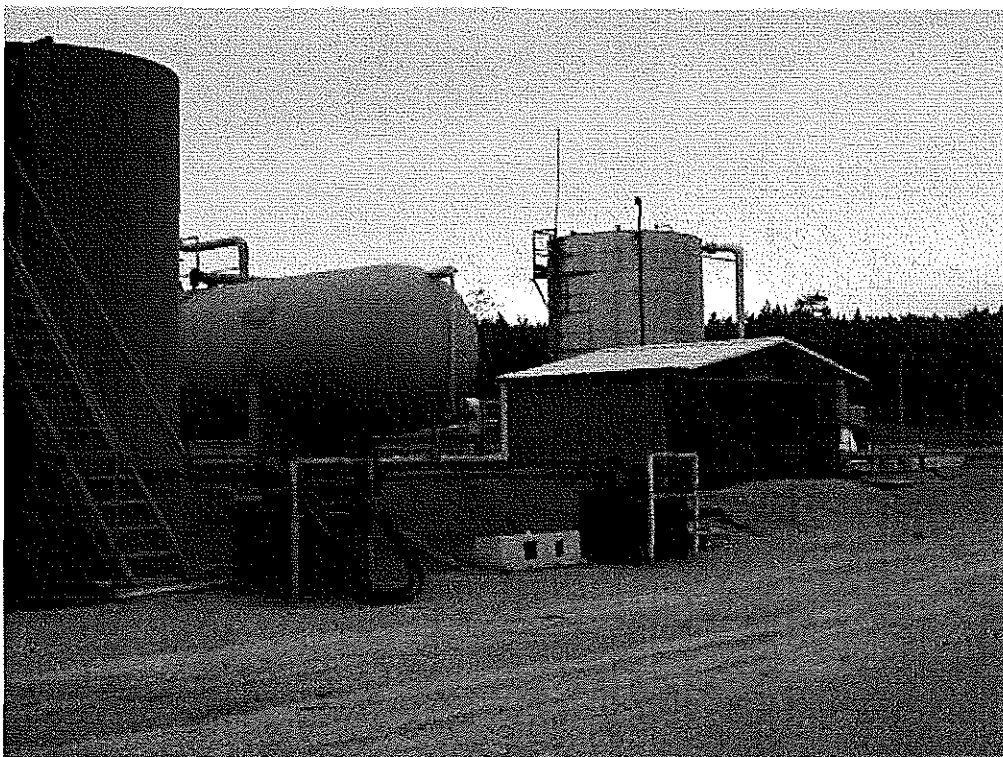
Image 8(crude oil loadout) : view from the SW of the active crude loadout station. One of the 400 bbl crude oil ASTs and the inactive crude AST (silver) are left in the photo. The building to the right is the pump house. The

large white AST is water a water disposal tank.

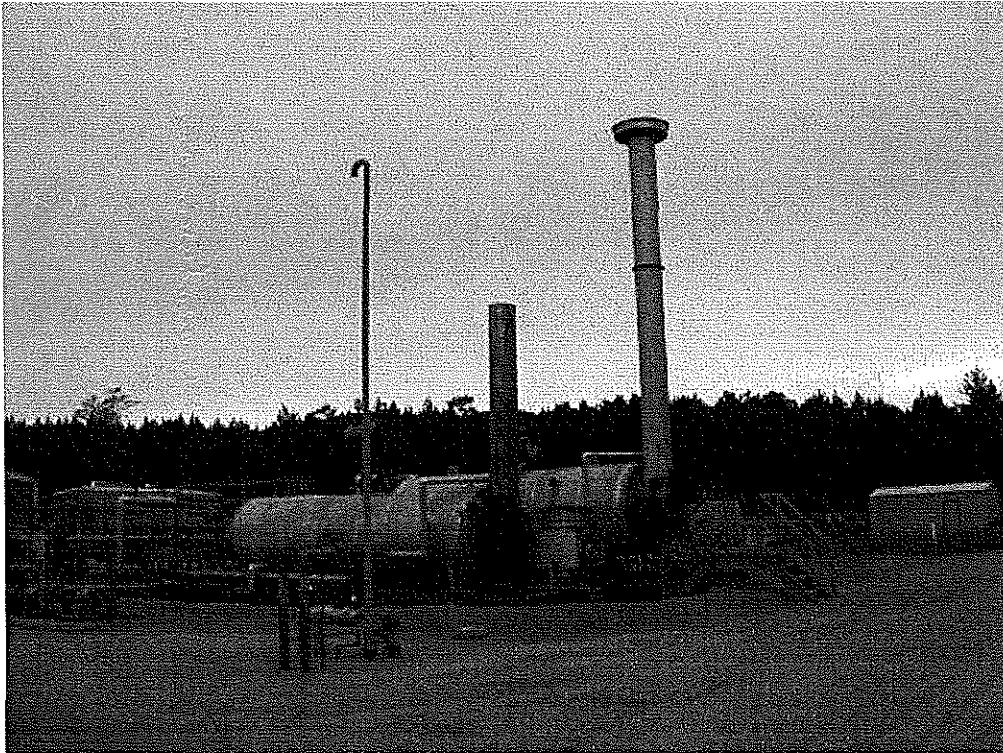
Image 9(inactive heaters) : view of inactive inline heaters located east of the pump house and the crude ASTs and load outs on south side of facility.

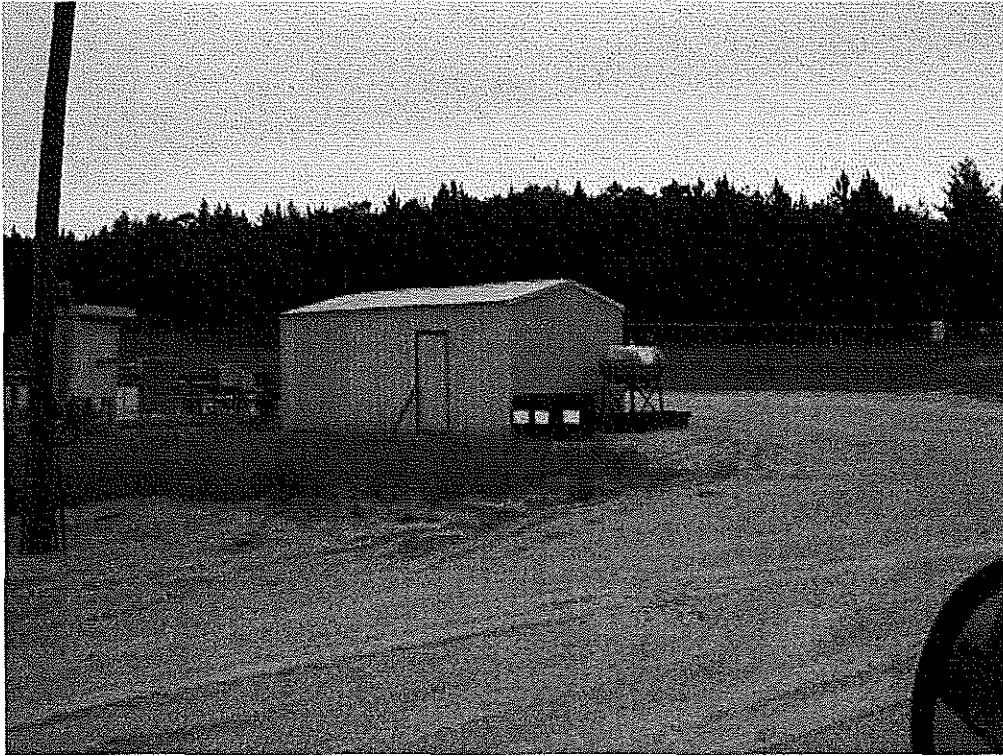
Image 10(water injection) : view from SW of active fresh water injection station. Facility personnel reports that water is not transported offsite, but is reinjected into injection well onsite.
