**DEPARTMENT OF ENVIRONMENTAL QUALITY
AIR QUALITY DIVISION
ACTIVITY REPORT: Scheduled Inspection**

FACILITY: Spartan Motors USA, Inc.		SRN / ID: N2503
LOCATION: 1541 Reynolds Rd, CHARLOTTE		DISTRICT: Lansing
CITY: CHARLOTTE		COUNTY: EATON
CONTACT: Brian Neumann , EHS Manager		ACTIVITY DATE: 07/25/2019
STAFF: Michelle Luplow	COMPLIANCE STATUS: Compliance	SOURCE CLASS: SM OPT OUT
SUBJECT: Scheduled, unannounced inspection to determine compliance with PTI 112-09 for paint booths located in Plant 8 and HAPS/VOC opt-out limits.		
RESOLVED COMPLAINTS:

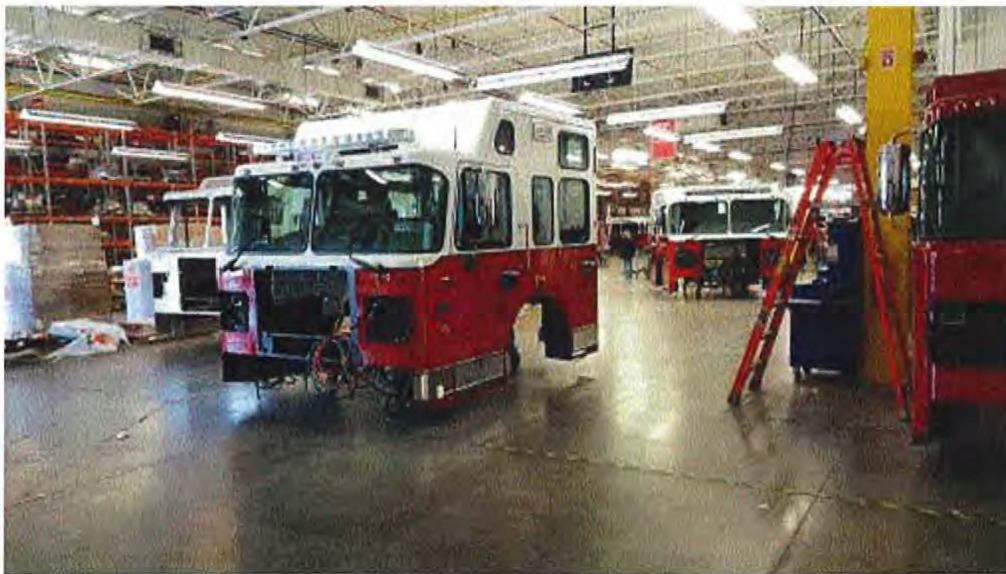
Image 1(Fire Truck Assembly) : Example of Fire truck assembly at Spartan Motors

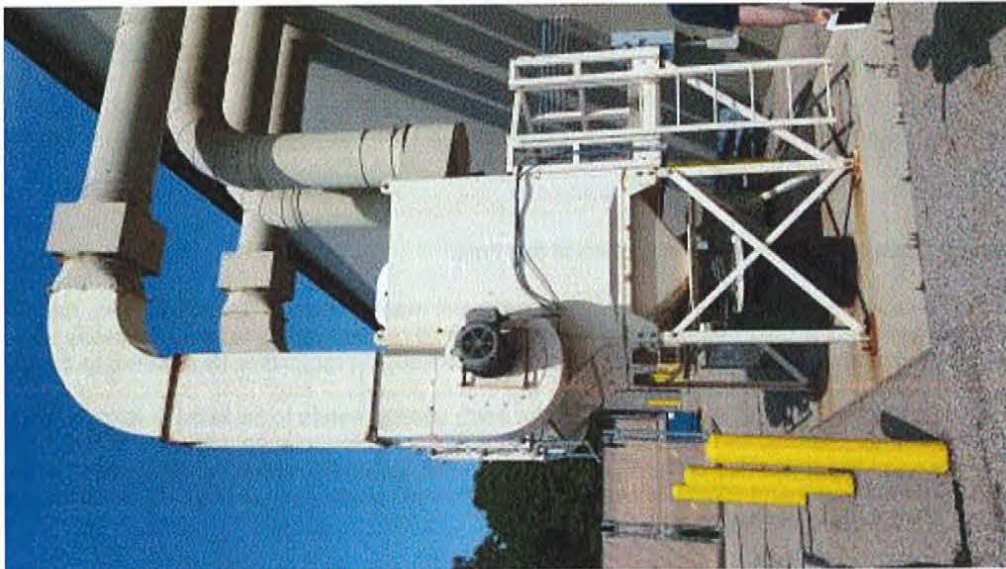
Image 2(Dust Collector) : Dust collector that services the metal grinding, metal cutting, and sanding/buffing stations.

2 metal cutting stations	<p>These are used to customize the metal cab frames by cutting out doors and panels using templates.</p> <p>Emissions are vented to the mechanical pre-cleaner along the walls of the station which collect the particulate in "drawers" before the air flow is directed to a Donaldson Torit baghouse (located outside) where the air flow deposits particulate from the air stream</p>	Rule 285(2)(l)(vi)	Compliance

<p>into the baghouse and eventually is collected into a 55-gallon drum; the air stream is then returned to in the in-plant environment, rather than exhausted to ambient air from the dust collector. This is the same baghouse that is used to control emissions from the grinding stations and sanding/buffing stations.</p> <p>The larger particulate captured in the drawers is shoveled from the drawers into garbage bags that are placed into gondolas. This practice occurs inside the building.</p>		
2 grinding stations (housed in the same booths as the welding stations)	<p>Emissions are vented to the mechanical pre-cleaner along the walls of the station which collect the particulate in "drawers" before the air flow is directed to a Donaldson Torit baghouse (located outside) where the air flow deposits particulate from the air stream into the baghouse and eventually is collected into a 55-gallon drum; the air stream is then returned to in the in-plant environment, rather than exhausted to ambient air from the dust collector. This is the same baghouse that is used to control emissions from the metal cutting stations and the sanding/buffing stations.</p> <p>The larger particulate captured in the drawers is shoveled from the drawers into garbage bags that are placed into gondolas. This practice occurs inside the building.</p>	Rule 285(2)(l)(vi)	Compliance

2 sanding/buffing stations	<p>For all sanding a buffing jobs not conducted with local particulate control (via the hand-held buffers/sanders), ventilation is provided in these 2 stations where aluminum particulate will hit a mechanical pre-cleaner along the walls of the station before being captured outside in a Donaldson Torit dust collector which is connected to a 55 gallon drum. The captured particulate is then sent out as non-hazardous waste. This is the same dust collector that is used to control emissions from the grinding stations and the metal cutting stations.</p> <p>The larger particulate captured in the drawers is shoveled from the drawers into garbage bags that are placed into gondolas. This practice occurs inside the building.</p>	Rule 285(2)(l)(vi)	Compliance
3 Buff & Sand booths	<p>These 3 booths are separate from the other sanding/buffing stations. Each stands alone in its own box, similar in appearance to the 8 permitted paint booths. Each had ceiling and side filters which all appeared to be installed properly. None of these booths were in use during the inspection. Each booth is labeled with a "1," a "2," or a "3." These booths are used to buff finished paint jobs to a shine. The air from these units is filtered through the ceiling and side face filters, and then sent to a cartridge filter housed inside the building before the air is vented outside to the ambient air</p>	Rule 285(2)(l)(vi)(C)	Compliance

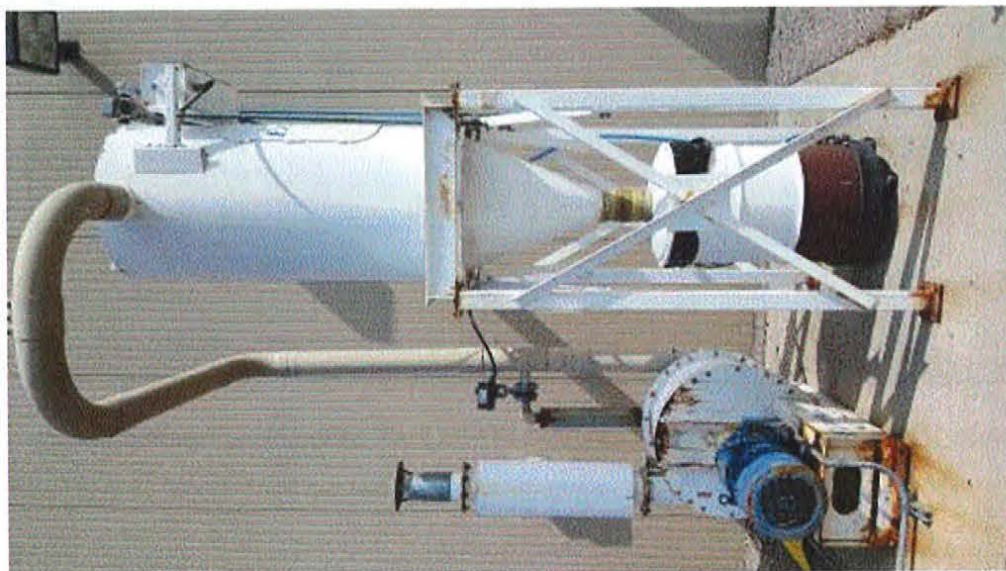
Image 3(Eurovac) : Eurovac Dust collector for clean up of bondo from sanding operations.

EU00052	Paint Repair Booth 12 (Spartan designation repair booth 3). All exhaust filters were properly installed.	PTI 112-09	Compliance
EU00053	Paint Repair Booth 13 (Spartan designation repair booth 4). All exhaust filters were properly installed.	PTI 112-09	Compliance
Eurovac industrial vacuum	<p>This unit is used to clean up bondo dust from sanding operations and may include aluminum shavings from the plant floors. The particulate from this system is captured outside in a Eurovac cyclone dust collector, which collects its particulate in a 55 gallon drum beneath the unit. Exhaust from the cyclone is vented horizontally to ambient air. I saw no signs of particulate being exhausted from this unit during the inspection.</p> <p>Any remaining residual bondo or aluminum shavings are manually swept up and disposed of in the garbage compactor. We viewed the garbage compactor and found that bondo particulate is released from the equipment when it compacts the waste materials; We noted small piles of the bondo surrounding the compactor. This is an unacceptable practice as it allows for the potential of air contaminants to get entrained into the ambient air. B. Neumann said their new practice will be to drop all sweepings into a sealable 55-gal drum to dispose of as non-hazardous waste to ensure that the bondo dust and aluminum shavings particulate is not being released to the ambient air. AQD agrees this is acceptable.</p>	Rule 281(2)(a)	Compliance

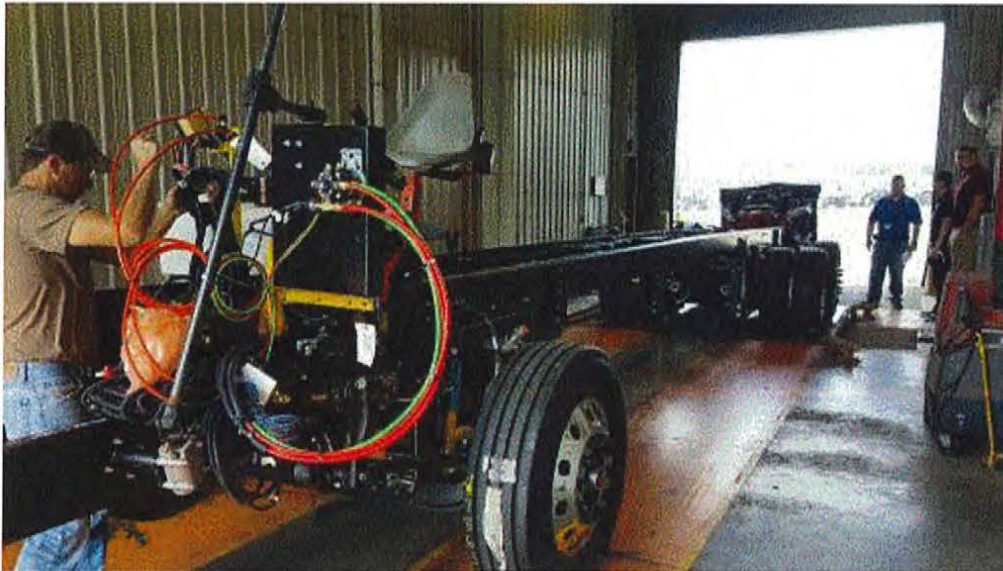
Image 4(Dynamometer) : One of several dynamometer test stands

Equipment	Description/Inspection Notes	Permit Exemption/ PTI Number	Compliance Status
Welding stations	Exhaust is vented to local ventilation units.	Rule 285(2)(i)	Compliance
Plasma cutting stations	Vented to in-plant environment	Rule 285(2)(l)(vi)(B)	Compliance
Chassis Rolling Dynamometer test stand	Bay area where roller dynamometer testing is conducted. Water-driven, water cooled dynamometer. Everything Spartan Motors builds can be tested here, including research and development testing. Used for testing Fire truck engine/transmission	NA	Compliance

<p>packages, the exhaust systems are already equipped with emissions control systems that convert the diesel exhaust to nitrogen compounds.</p> <p>The units tested on these test stands are considered mobile sources, particularly since the emission control systems are already equipped prior to testing.</p> <p>The Air Quality Division does not regulate mobile sources of air pollutants and therefore emissions from this unit should not be incorporated into FGFACILITY emissions.</p>		
--	--	--	--

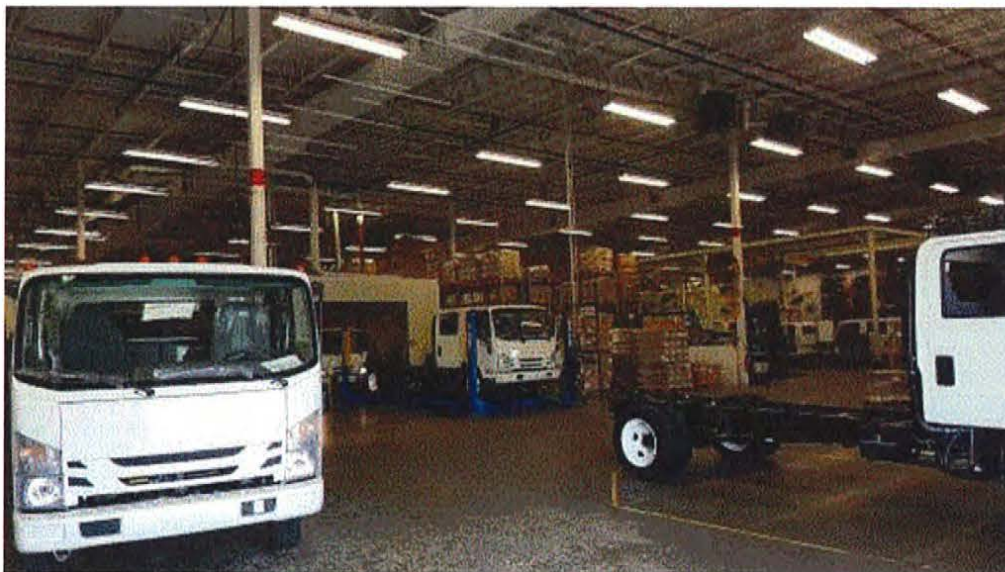
Image 5(Plant 12) : Plant 12 Isuzu truck assembly

Plant 12 is dedicated entirely to the assembly of entire Isuzu trucks by marrying the chassis to the cabs, assembling the exhaust systems, and dynamometer testing on all the finished units. The building is owned by Spartan Motors, but all equipment, product, etc is owned by the Isuzu Japanese corporation. All Plant 12 installations were complete in January 2017, and production began in February 2017.

Equipment	Description/Inspection Notes	Permit Exemption/ PTI Number	Compliance Status
Chassis Rolling Dynamometer test stand	<p>Bay area where roller dynamometer testing is conducted.</p> <p>Used for testing of completed Isuzu diesel trucks; the exhaust systems are already equipped with emissions control systems that convert the diesel exhaust to nitrogen compounds.</p> <p>The units tested on these test stands are considered mobile sources, particularly since the emission control systems are already equipped prior to testing.</p> <p>The Air Quality Division does not regulate mobile sources of air pollutants and therefore emissions from this unit should not be incorporated into FGFACILITY emissions.</p>	NA	Compliance

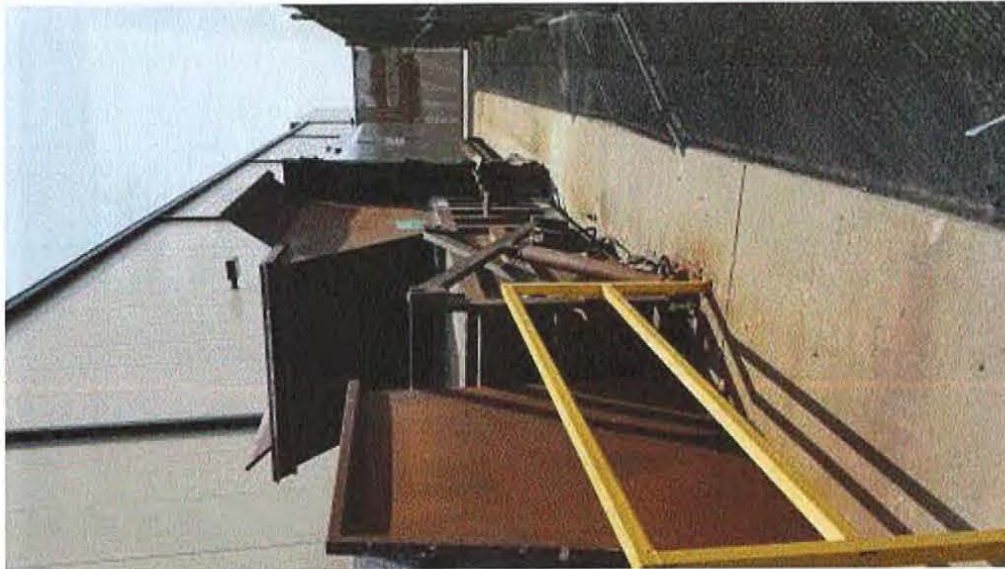
Image 6(Garbage Compactor) : Garbage compactor where bondo dust was seen on the ground. Remedy has been proposed. See inspection report.

B. Neumann showed me that spent filters are disposed of inside Plant 8 in bins prior to being rolled outside to the garbage compactor for disposal. This practice appears to be acceptable for ensuring that particulate from the filters do not get re-entrained into the ambient air. I saw no signs of particulate outside the door of the building where the spent filters are transported. However, in order to ensure that particulate from the spent filters is not being released during transport outside, B. Neumann is going to institute the practice of tarping the rolling bins containing the spent filters to prevent the potential of any release of paint particulate for entering the atmosphere.
