**DEPARTMENT OF ENVIRONMENTAL QUALITY  
AIR QUALITY DIVISION  
ACTIVITY REPORT: Self Initiated Inspection**

FACILITY: Advanced Disposal Services Arbor Hills Landfill Inc		SRN / ID: N2688
LOCATION: 10690 W. SIX MILE RD, NORTHVILLE		DISTRICT: Jackson
CITY: NORTHVILLE		COUNTY: WASHTENAW
CONTACT:		ACTIVITY DATE: 08/15/2019
STAFF: Mike Kovalchick	COMPLIANCE STATUS: Non Compliance	SOURCE CLASS: MAJOR
SUBJECT: Documents EGLE and MaxKrause, US EPA site visit, meeting and tour. Pre-planned with ADS and Fortistar in order to review well data and observe technician conducting well monitoring. In part follow up to ETLF and monthly reports. ADS management present and AQD and MMD District staff.		
RESOLVED COMPLAINTS:

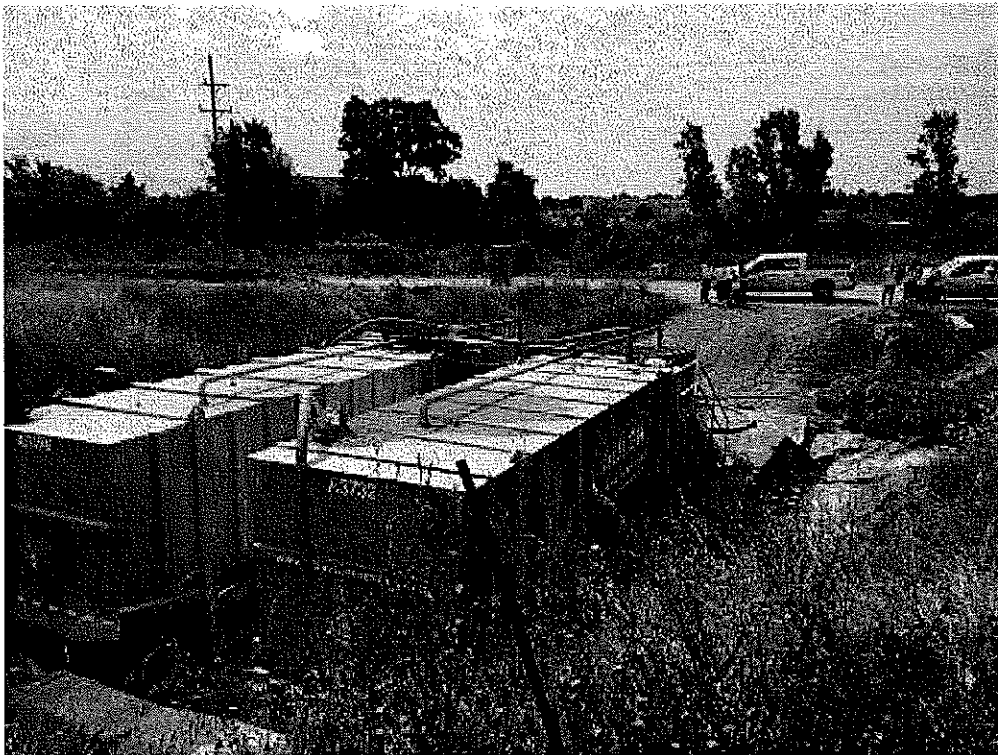
**Image 1(Frac tanks) :** Frac tanks

Next, we proceeded to the 2 frac tanks. Wastewater from the TS-01 sump has been directed to these 2 frac tanks for all of 2019. Aeration is being used in both tanks in order to encourage sulfides to remain in solution. An anti-foaming agent is also being added. More recently, some type of ion-exchange system has been installed as way to remove PFAS compounds (and maybe also phenolics since it is above discharge limits) from the liquid. This was due to recent TS-01 samples that showed high levels of various types of PFAS. (See attached results sheet for TS-01). Lesser but still significant levels were detected in the liquid from AHW, AHE, AHW condensate and also in the outfall. Results from all of these were attached to the August WOI report that we received yesterday for the month of July. PFAS air emissions remain untested/unquantified. It appears that ADS is concerned about PFAS landfill wide and is considering onsite treatment for all the leachate for PFAS. Ultimately, they want a system setup so that all the leachate can be discharged into the sanitary sewer. Observations of the frac tanks showed some foam (PFAS foam?) being emitted out the top of the tanks. There was also significant build-up of material around the frac tank vents. (See attached photos.) The frac tanks remain highly odorous. I recorded elevated H<sub>2</sub>S readings in the 0.02 ppm to 0.04 range standing about 100 feet downwind. (Mark still insists that there is no H<sub>2</sub>S being emitted from the frac tanks despite the Jerome readings to the contrary. He felt the H<sub>2</sub>S must be coming from somewhere else.)

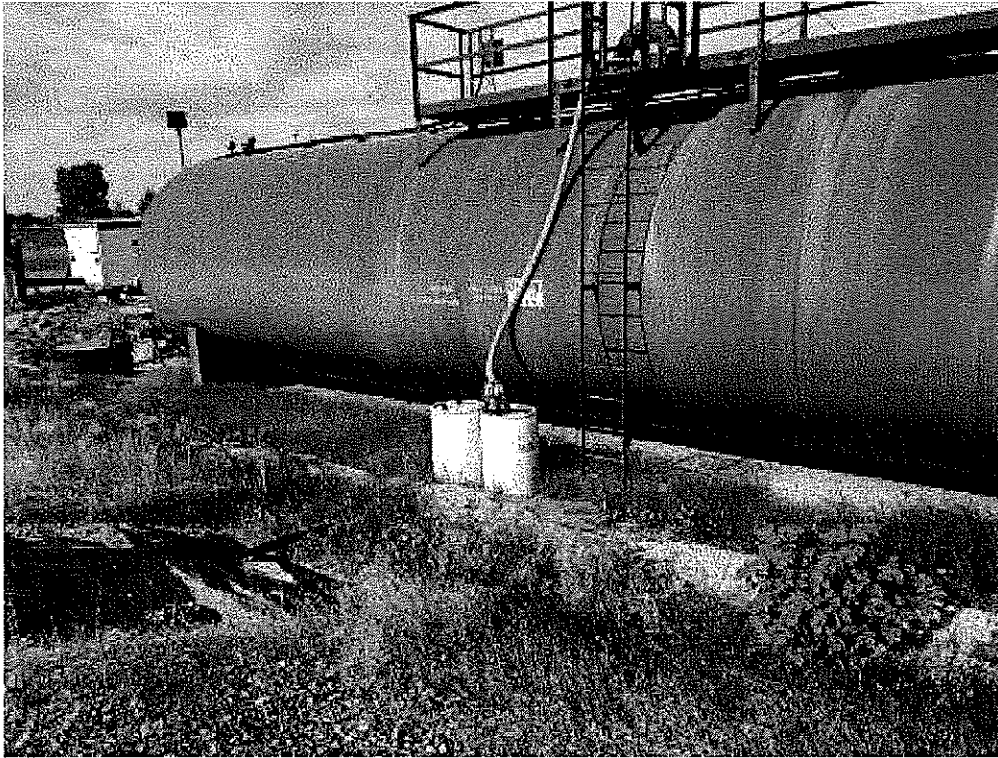
**Image 2(Bullet tank carbon) :** Bullet tank carbon units.

We first stopped at the Leachate tank farm area. Mark gave an explanation of how the system worked to the group. Some odors were noted downwind of the tanks. Jerome H2S readings of only .003 ppm were noted. Based on the intensity of the odors, it appears the odors consisted of more than just H2S. Some evidence of past spills of leachate were observed around the tanks and associated aeration/control equipment/loading docks. This included dead vegetation. (See attached photos.) Individual carbon cannisters appeared to be being used to control emissions from the 2 smaller green bullet tanks that are currently empty. The carbon systems and aeration are also being used on the larger Green Tank (West LF) and Blue Tank ( East LF) however these were not clearly observed. Todd and Brain informed us that these carbon systems are to be upgraded in the near future.

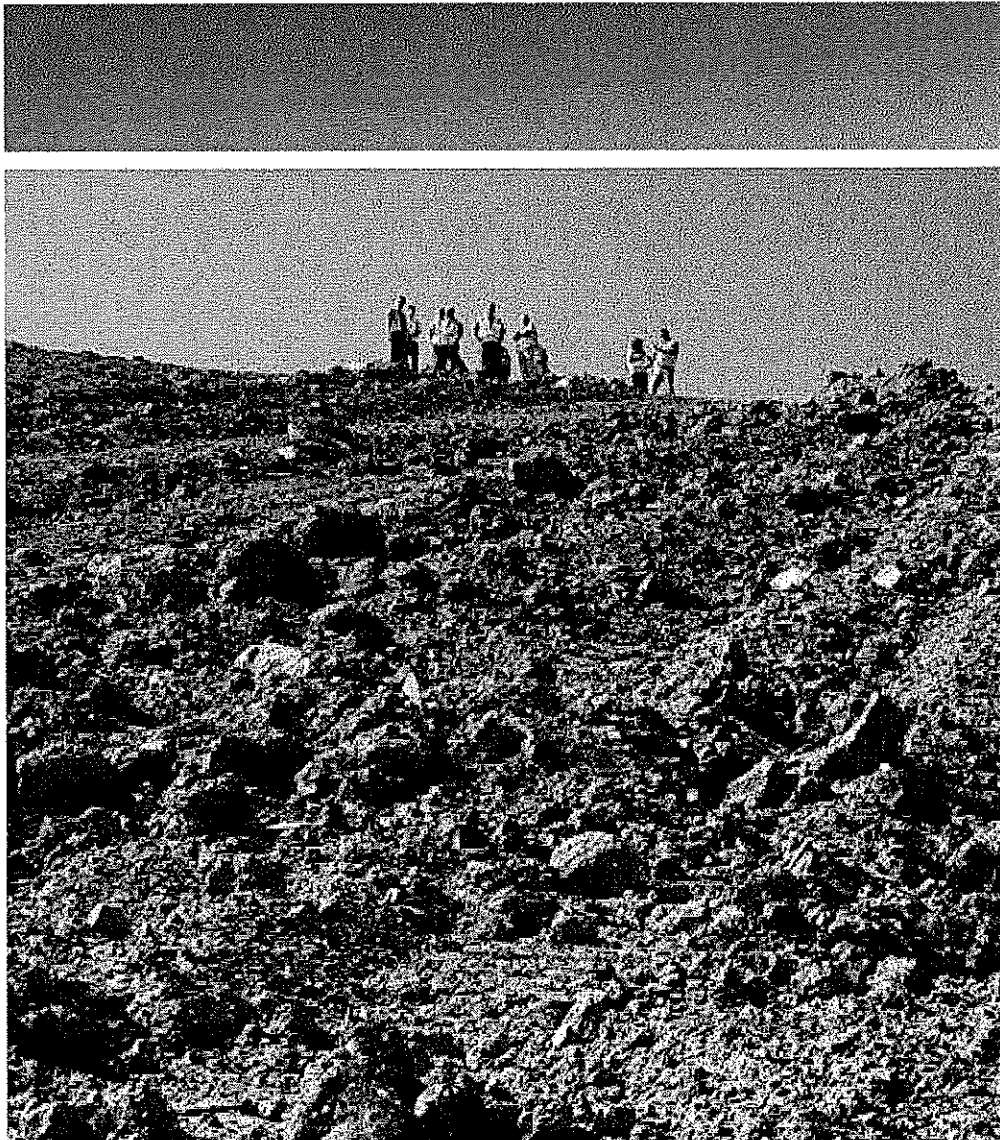
Image 4(North slope) : North slope

Next, we proceeded to the subsidence area on the north side of the hill top plateau. From the top, I was able to see that fresh dirt had been placed on the seam area just below the geomembrane liner where I had detected high levels of methane the previous day. I also could see that the odorous pile of uncomposted material that was present the previous day had been removed. See attached photo that shows the new areas of dirt and the distant compost area. With everyone else remaining up top, I descended to the base of the subsidence area which is bowl shaped to take H<sub>2</sub>S and methane readings. As from the previous day, very high levels of odors were encountered and significant levels of both H<sub>2</sub>S and methane were detected. As before, the highest levels of methane (saturated meter so above 10,000 ppm) were detected in a dry stream bed/ditch that drained the subsidence area. It was at least 4 ft deep in places with some trash visible on the sides of the ditch. H<sub>2</sub>S reading as high as 5 ppm were detected in the ditch. (I think I heard that there was some suggestion that more dirt was going to be placed below the subsidence area within the next few days but not sure. )

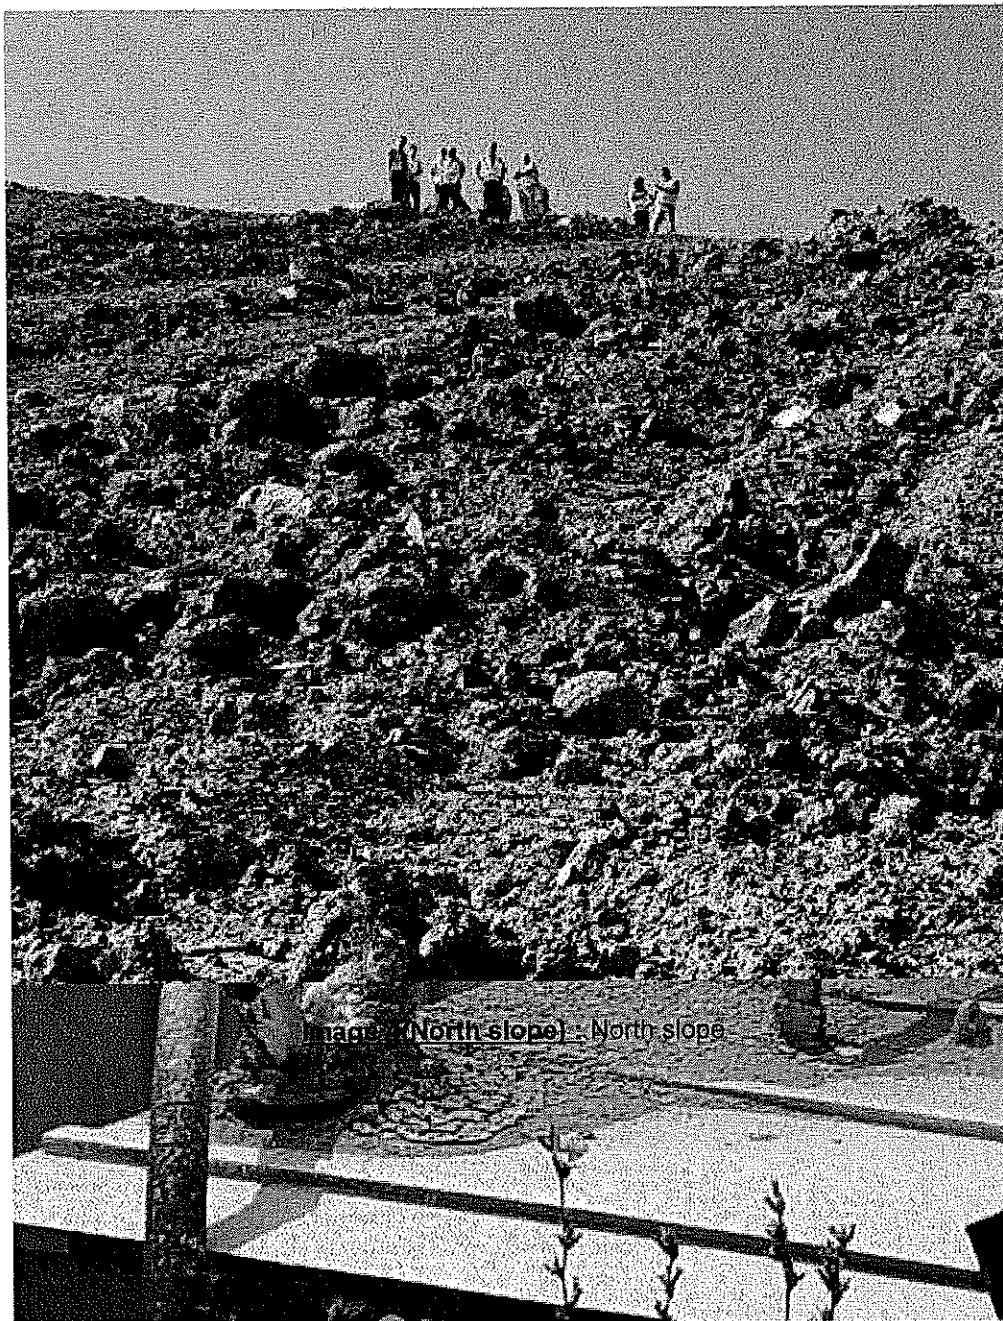
Image 5(North slope) : North slope

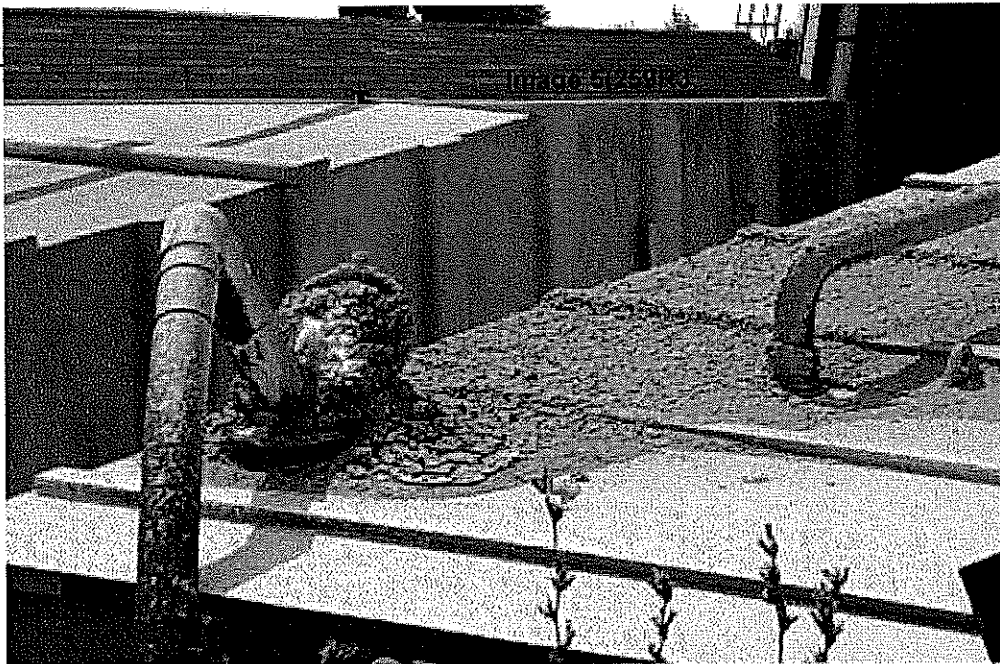
Image 5(Well 290)

Well 290 was just above 259R3 and located on plateau on top of the hill. The well head itself also had been pushed over at an angle. For this well, methane was at 31.7%, Oxygen 0.12%, balance gas at 55.3% and a

temperature of 126.1 degrees F. July well data showed flow at 8 scfm. This is much lower than previously reported as the orifice plate data inputted in the ENV200 had been .4" instead of 1" actual. Mark also asked Anthony to do a down camera evaluation of this well also. The data from this well is quite different than nearby well 259R3. This well had an odd combination of low oxygen but high balance gas that is assumed to be nitrogen or otherwise air. It appears that oxygen is getting used up underground with the nitrogen unreacted. It is possible that the air intrusion in this well is occurring at a greater depth than hole 259R3. There was also some discussion that perhaps the balance gas doesn't really contain nitrogen but something else. (Note: Balance gas % is determined by mass balance, not directly.) Max suggested one gas to test for is ammonia but seems like a long shot that the gas will have significant levels of that. See attached photo of well.

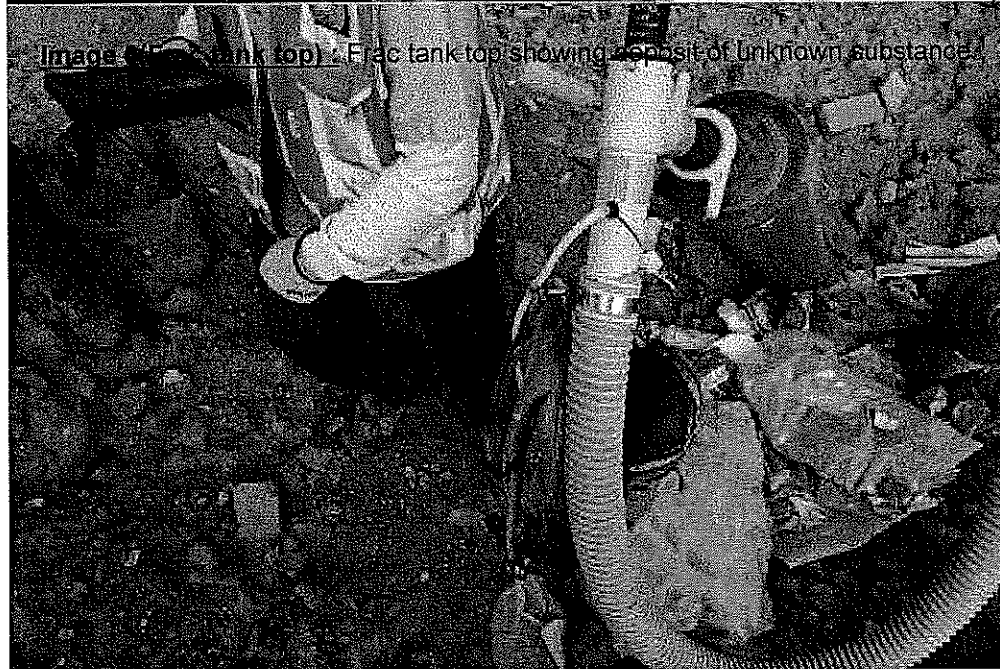
Image 6(Well tank top) : Flac tank top showing deposit of unknown substance

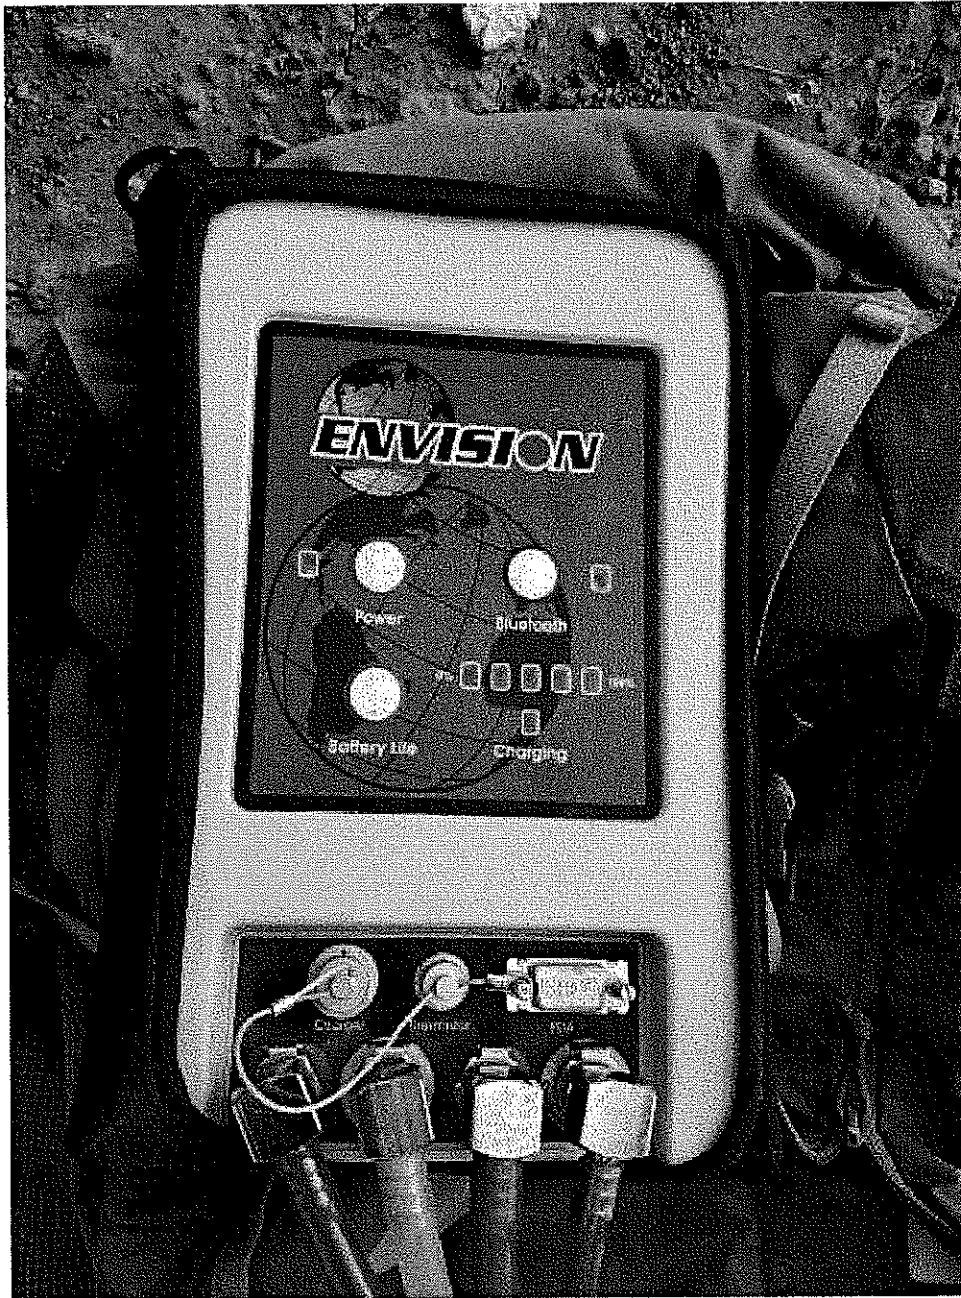
We proceeded to the south edge of the top of the hill. There we were meet by the representatives of Fortistar who were there to demonstrate taking gas well head readings. I had previously indicated to ADS that we would like to have them do this for well 259R3 and adjacent well 290. Of the WO1 wells, these 2 showed the most evidence of the gas samples being contaminated with air. A gas technician took readings from both wells using an Envision ENV200 Gas Analyzer. (Refer to <http://www.raeco.com/products/gasmonitoring/Elkins-earthworks-Envision-landfill-gas-monitor.html> ) See attached photos which include screen shots of readings for both wells. The gas analyzer itself was carried in a backpack with 4 plastic tubes that are used to connect to the well head. Separately, a tablet is used to display the gas readings which connects wirelessly to the backpack. Gas is drawn through the analyzer for 300 seconds before a final reading is recorded although values appear to stabilize long before that time.

**Image 11(Well head device)** : Well head gas meter.
