DEPARTMENT OF ENVIRONMENTAL QUALITY
AIR QUALITY DIVISION
ACTIVITY REPORT: Self Initiated Inspection

FACILITY: Advanced Disposal Services Arbor Hills Landfill Inc		SRN / ID: N2688
LOCATION: 10690 W. SIX MILE RD, NORTHVILLE		DISTRICT: Jackson
CITY: NORTHVILLE		COUNTY: WASHTENAW
CONTACT: Anthony Testa , Site Manager		ACTIVITY DATE: 10/28/2020
STAFF: Mike Kovalchick	COMPLIANCE STATUS: Non Compliance	SOURCE CLASS: MAJOR
SUBJECT: SEM Survey conducted with 33 exceedances found.		
RESOLVED COMPLAINTS:

Major / ROP Source. Full Compliance Evaluation (FCE) and Partial Compliance Inspection (PCE) Which Consisted of an Abbreviated Methane SEM Survey

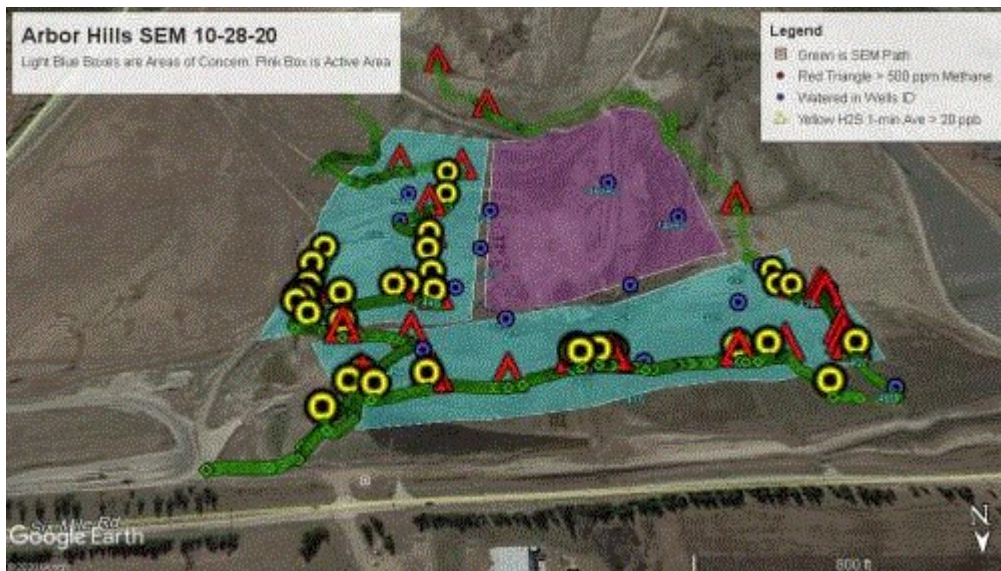
As provided in a previous table, **33** locations were found to have exceeded the 500 ppm above background threshold during the inspection. The attached aerial image of the AHL shows the path followed during the survey and the locations of methane concentrations above 500 ppm. It also shows the locations of where H2S was measured to be above 20 ppb. Finally, it outlines the locations of the areas of concern and the current location of the active face.

Image 1(SEM Path) : SEM Path along with SEM methane hits and areas where H2S was above 20 ppb.(Yellow circles.)

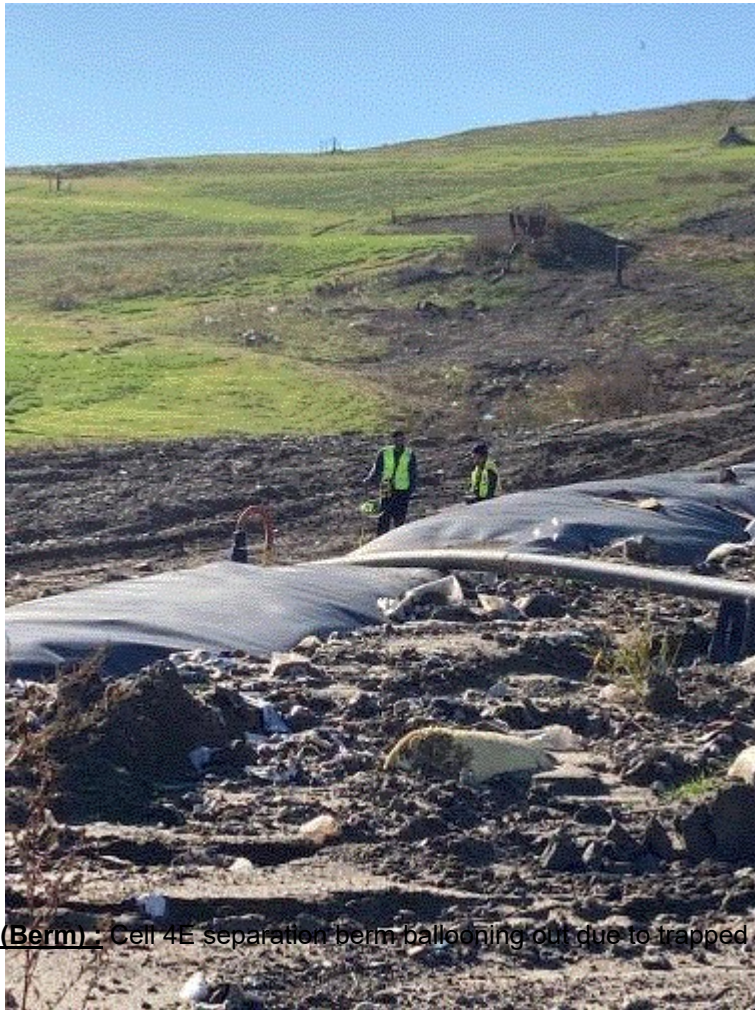
AQD 26	Access Riser in line with the above Well 5-01, further north.	42.40481383	-83.55695583	35,254
AQD 27	Well 439R	42.40479667	-83.55651167	4257
AQD 28	Cell4E Temporary separation Berm. Visible length of Synthetic liner bubbling up with gas. Installed a Vacuum with Jumper line to well on slope.	42.40502217	-83.55550667	1010
AQD 29	At Cell 4E Temporary separation Berm, farther south. [See attached photo.]	42.404903	-83.55552783	717
AQD 30	Well 437, (2) penetrations	42.40535283	-83.555958	7254
AQD 31	Next to Well 437, in the same construction area of the well.	42.405314	-83.55599333	858
AQD 32	Well ??, (2) penetrations, located at the top of the hill, active face. (Note, this is one w/flag 33)	42.4053595	-83.55670283	2040
AQD 33	Well 433, located farther north of the above. (Note, this is one w/flag 32)	42.4058555	-83.55620283	715

Image 2(Berm): Cell 4E separation berm ballooning out due to trapped methane.
