DEPARTMENT OF ENVIRONMENTAL QUALITY
AIR QUALITY DIVISION
ACTIVITY REPORT: Scheduled Inspection

| FACILITY: ELM PLATING CO | | SRN / ID: N3209 |
| SUBJECT: Unannounced, scheduled inspection. | | |

Minor Source Inspection of Elm Plating Company (N3209)Facility Contacts

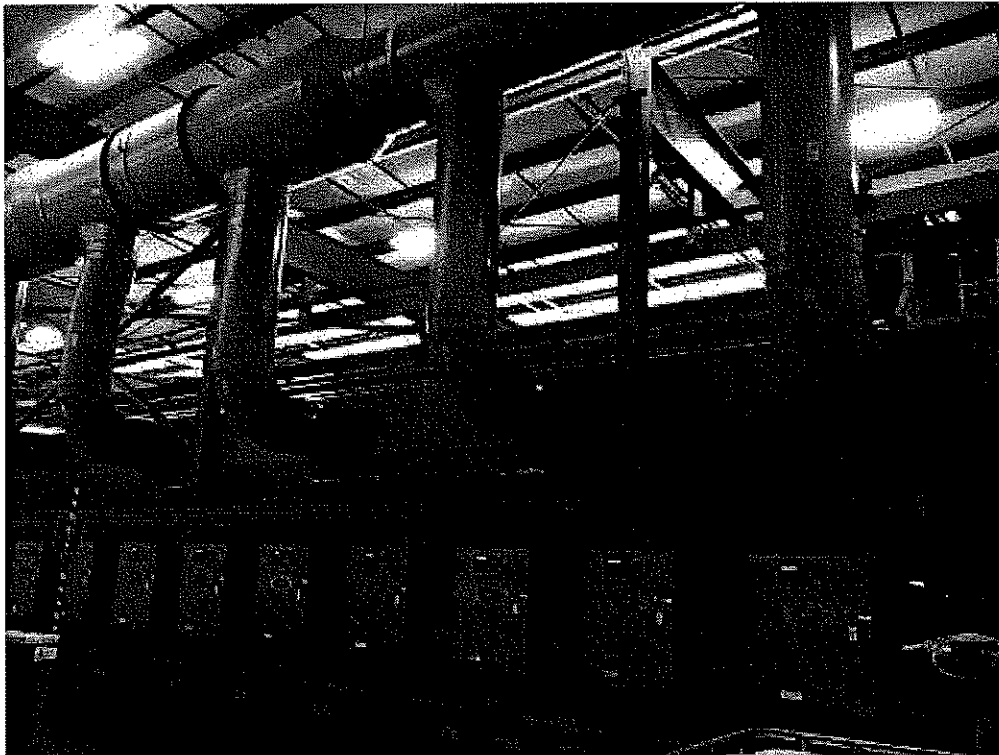
Image 2(2) : Tanks and exhaust for the B5 line.

Next, we observed the newer B5 line. Brian explained that each tank in this line can be monitored independently, allowing for better conservation of electricity (See Image 2). He also pointed out the exhaust system associated with the line, and how it runs to the scrubber control device. The control device appeared to be well-maintained. Overall, the B5 line appeared to be in good condition and well ventilated. Tanks producing emissions were collected via side collection hoods adjacent to each tank. On the opposite side of the tank from the hood was a blower to direct tank emissions to the hoods.

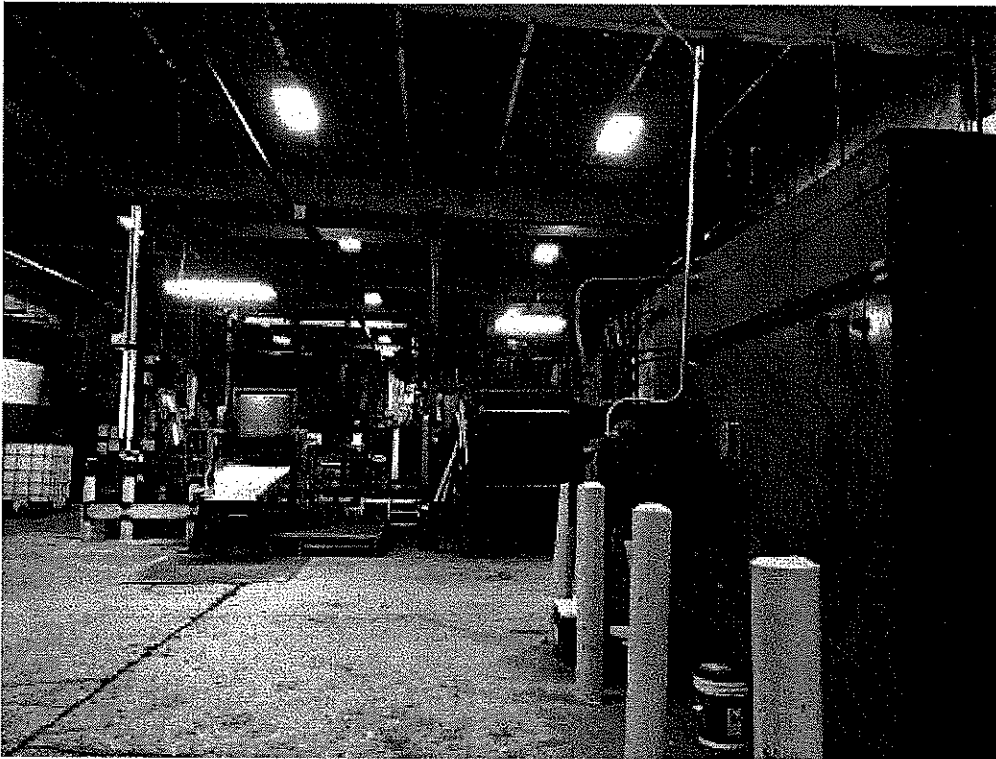
Image 3(3) : View of the B3 line. (Not in operation at the time of the inspection)

Brian then escorted me as I conducted the onsite tour portion of the inspection. We first observed the B3 Line, which was not operating during the inspection (See Image 3). Brian explained that the B3 line does not have as much work as some of the other lines, so they typically don't operate it on Fridays.

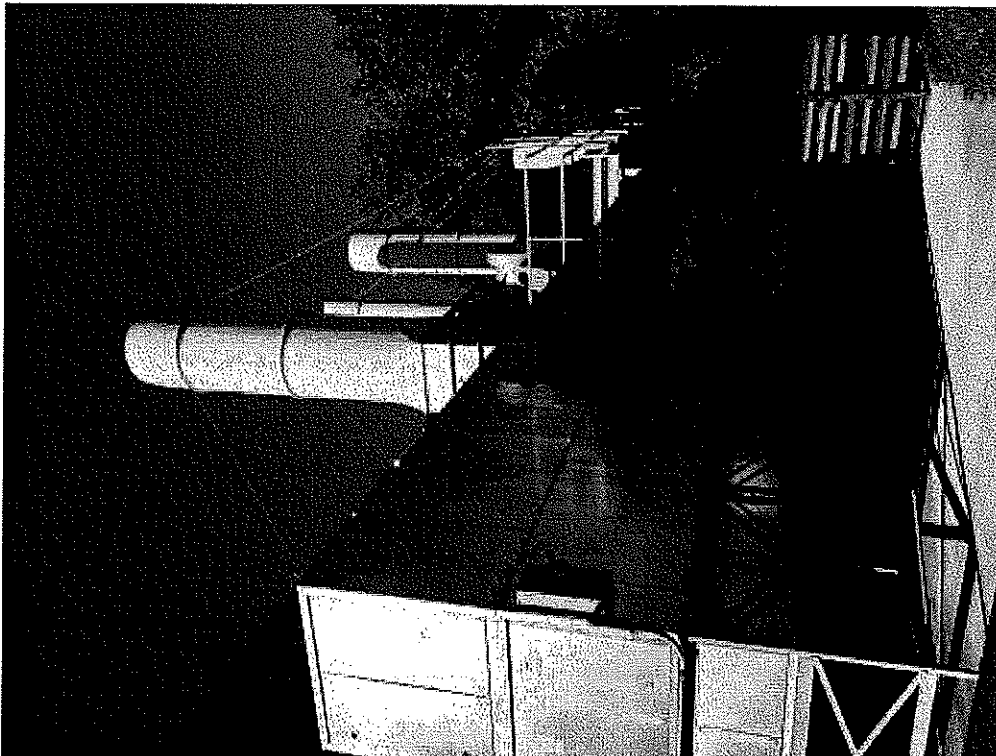
Image 4(4) : Stacks associated with the B5 line.

We then walked outside to observe the stacks associated with the B5 line (See Image 4). No odors or visible emissions were noted. Brian explained that the very top section, from the top set of bolts up, was the part that was recently added to the stacks.

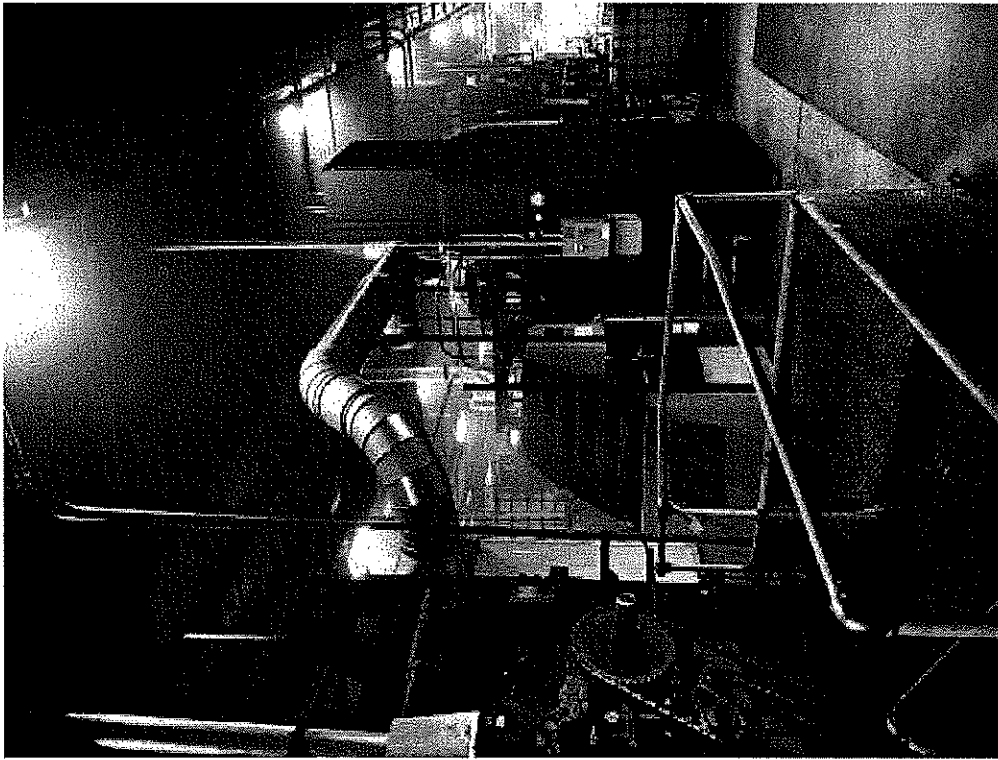
Additionally, the facility installed three Torit baghouses, one for each heat treat line. These baghouses were installed to help resolve the opacity issues noted during the last inspection. These units are equipped with fire dampers and magnehelic pressure gauges.

After this discussion, we toured the three heat treat lines and observed the baghouses (See images 6 and 7). Brian pointed out hoods that were installed on the furnaces to help direct emissions to the baghouses. See Image 5.

Image 7(7) : View of heat treat line

Image 6(6) : View of heat treat line

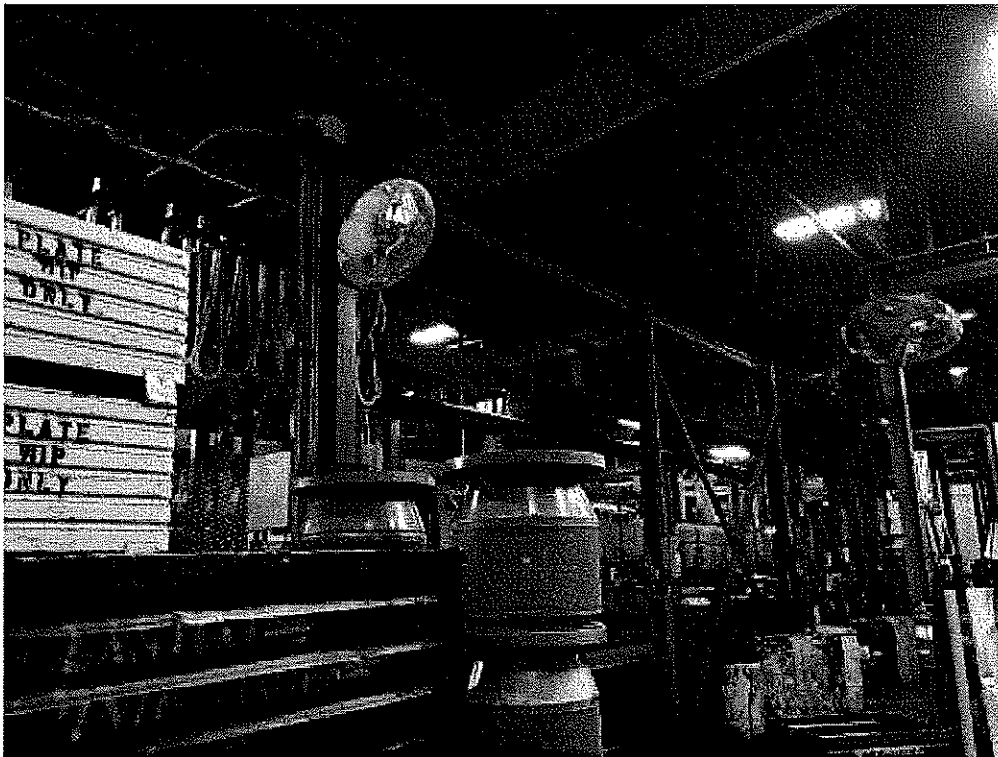
Image 8(8) : View of B4 line

Next, we observed the B4 (see Image 8) and C3 lines. These lines are located within the same vicinity. No issues were noted.
