DEPARTMENT OF ENVIRONMENTAL QUALITY  
AIR QUALITY DIVISION  
ACTIVITY REPORT: Self Initiated Inspection

FACILITY: MICHIGAN PAVING & MATERIALS CO		SRN / ID: N5460
LOCATION: 1600 N ELM ST, JACKSON		DISTRICT: Jackson
CITY: JACKSON		COUNTY: JACKSON
CONTACT: Michael Jackson , Division Manager		ACTIVITY DATE: 08/28/2015
STAFF: Michael Gabor	COMPLIANCE STATUS: Compliance	SOURCE CLASS: SM OPT OUT
SUBJECT: Synthetic Minor / Opt-Out Source. Full Compliance Evaluation (FCE) and Inspection (PCE).		
RESOLVED COMPLAINTS:

**Synthetic Minor / Opt-Out Source. Full Compliance Evaluation (FCE) and Inspection (PCE).**

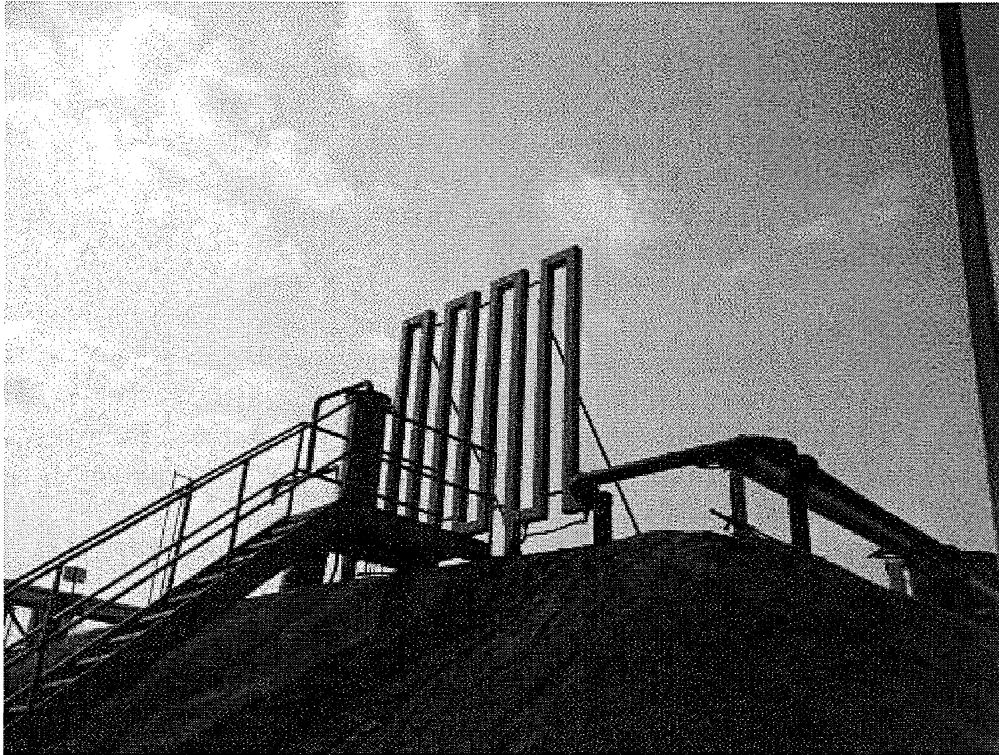
Image 1(Figure 1) : Condenser component of the vapor condensation and recovery system, 8/28/15, 10:44 am.

I then observed the stack (Figure 12) associated with EUHMAPLANT. Stack emissions appeared to be steam and no fugitive emissions were observed from the baghouse. I also observed the LAC storage tanks (EUACTANKS, Figure 13) and the associated vapor condensation and recovery system, as required by SC 3.1. As indicated above, I noticed a strong, pungent asphalt odor earlier during the inspection that MJ attributed to the LAC delivery. I noted the strong odor again as I observed the LAC tanker truck delivery and shared my concern with MJ.

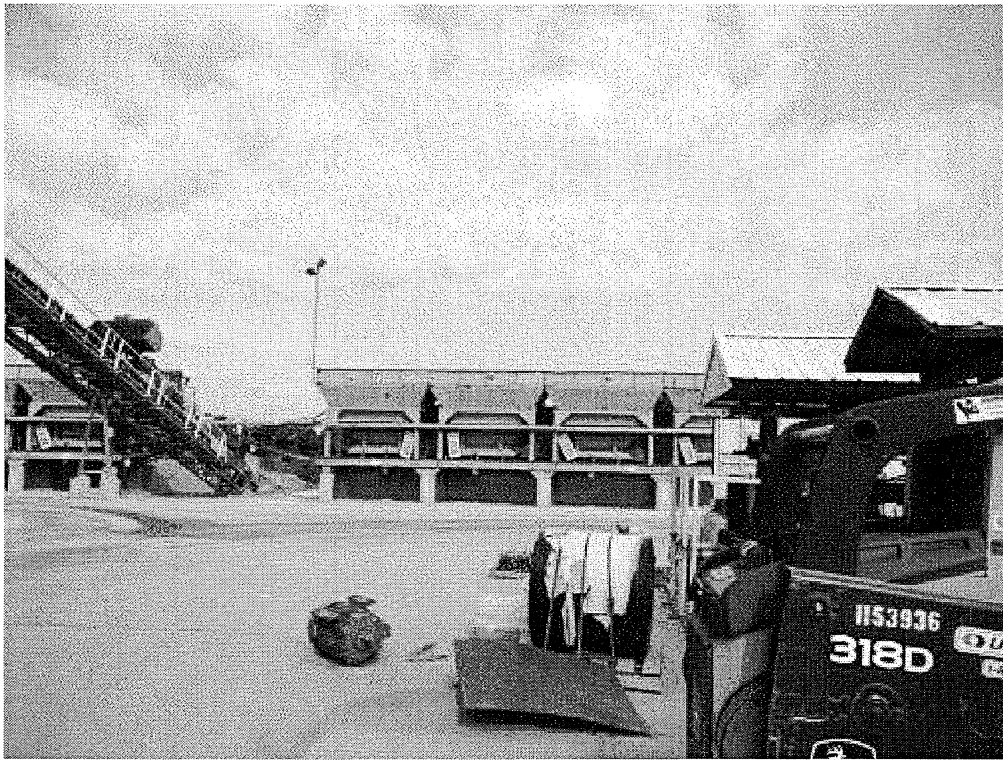
MJ then pointed out the cold feed aggregate bins (Figure 2), the aggregate conveyers (Figure 3), the dual drum dryer and mixer (Figures 4 and 5), and the baghouse (Figure 6) that make up EUHMAPLANT. I did not notice any visible fugitive emissions from these components during the inspection.

**Image 2(Figure 2)** : The cold feed aggregate bins, 8/28/15, 10:15 am.

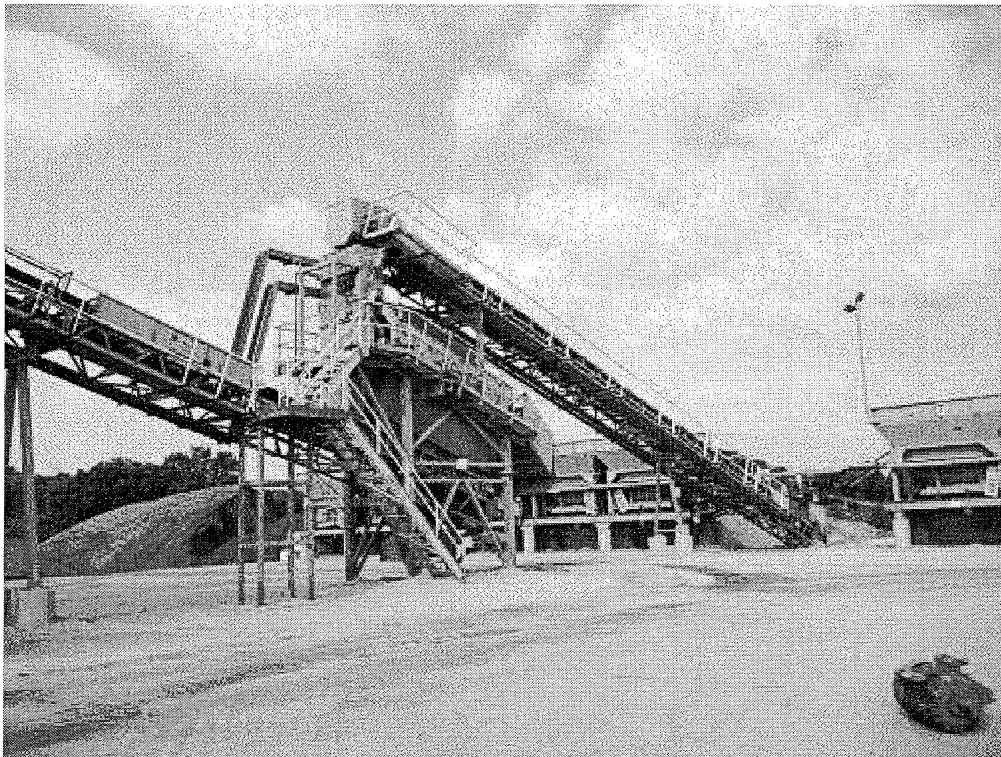
**Image 3(Figure 3)** : The aggregate conveyers, 8/28/15, 10:15 am.

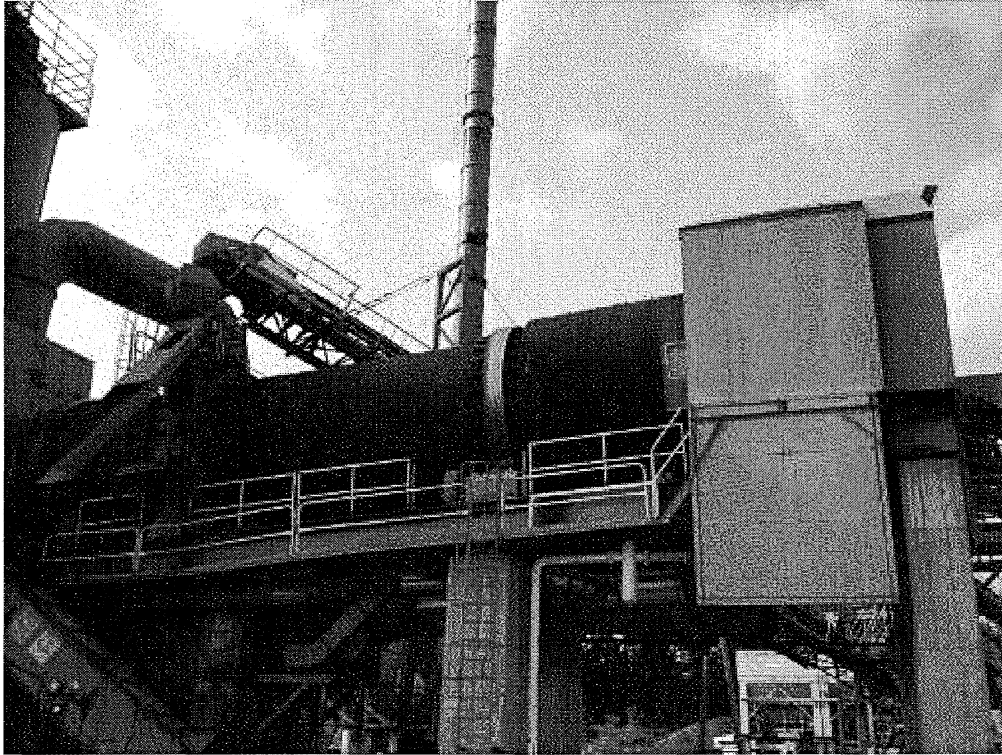
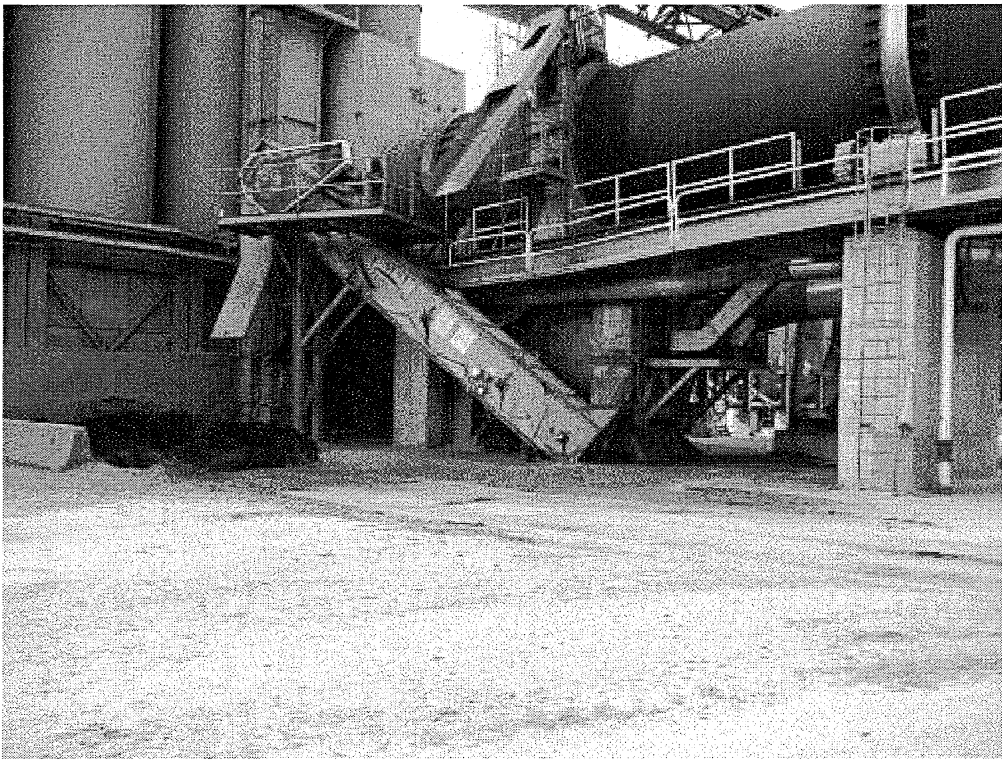
**Image 4(Figure 4)** : The dual drum dryer and mixer, 8/22/15, 10:15 am.

**Image 5(Figure 5)** : The dual drum dryer and mixer, 8/22/15, 10:15 am.

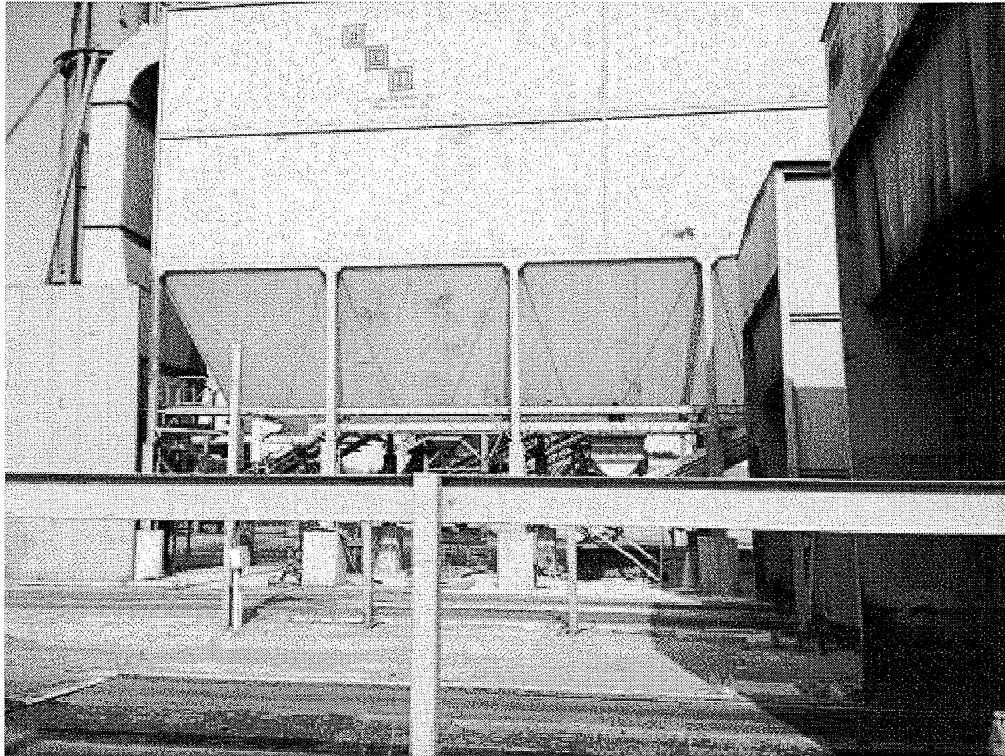
**Image 6(Figure 6)** : The baghouse, 8/22/15, 10:43 am.

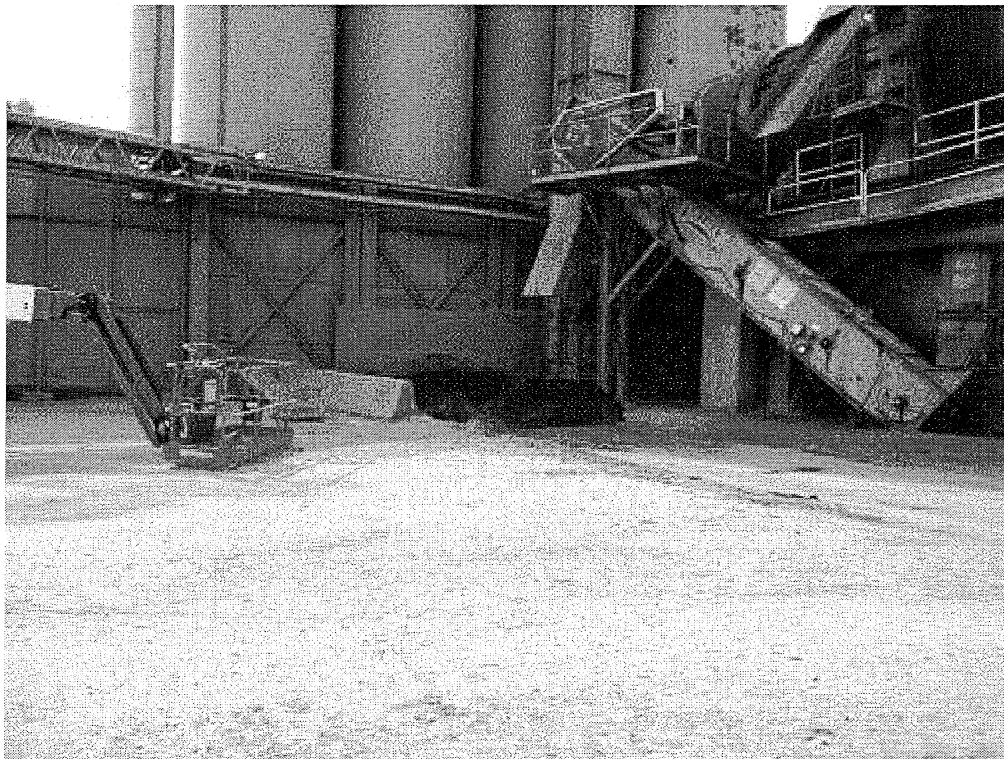
MJ did point out an area where HMA material is discarded from the process during the drum dryer startup phase (Figure 7) as a potential source of limited, fugitive emissions. This first-produced HMA may have not been fully heated to specification, so it is later reused as RAP. During the inspection I did not notice this activity.

**Image 7(Figure 7)** : Area where HMA material is discarded from the process during the drum dryer startup

phase, 8/22/15, 10:15 am.

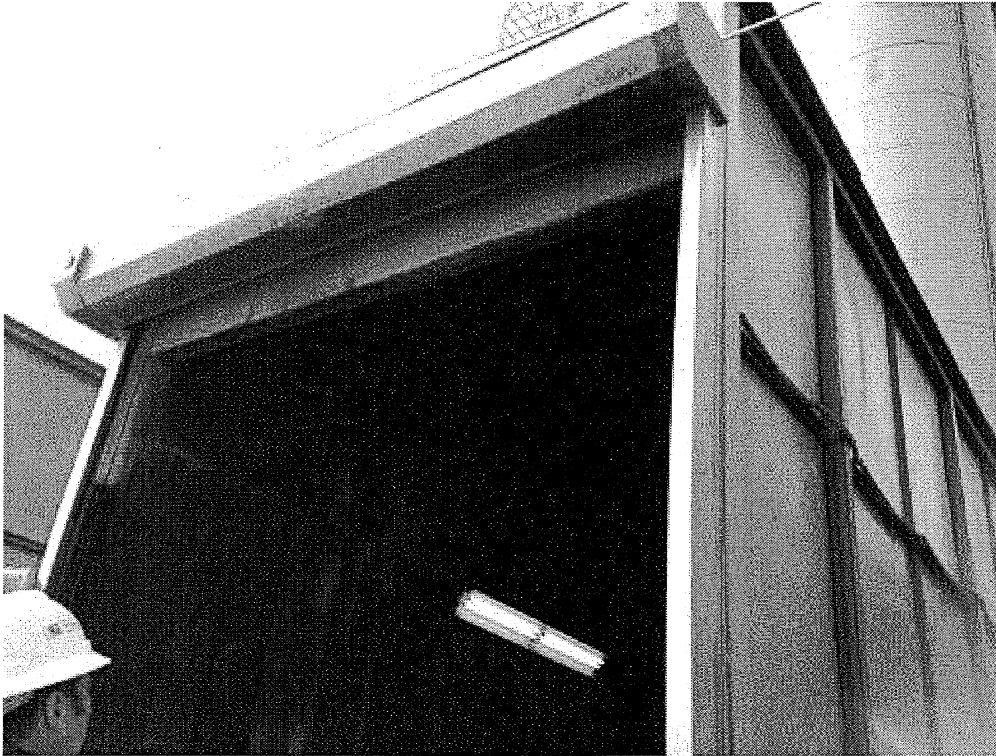
I also observed the HMA truck load out area associated with EUSILOS and its emissions control system, as required by SC 4.2. The load out area consists of 2 enclosed booths (Scale 1 and Scale 2) that have openings on both ends to allow for the entry and exit of transport trucks and they also house truck scales. The silo loadout enclosure openings have a plastic / rubber curtain assembly that extend two to three feet downward to assist with the capture of fugitive emissions associated with load out activities. During the inspection, I noticed that the curtain was missing on scale 1 (Figure 8). I requested that it be replaced as soon as possible. MJ documented replacement with an emailed photograph on September 2, 2015 (Figure 9).

**Image 8(Figure 8)** : Missing curtain on the silo loadout enclosure entrance, 8/22/15, 10:36 am.

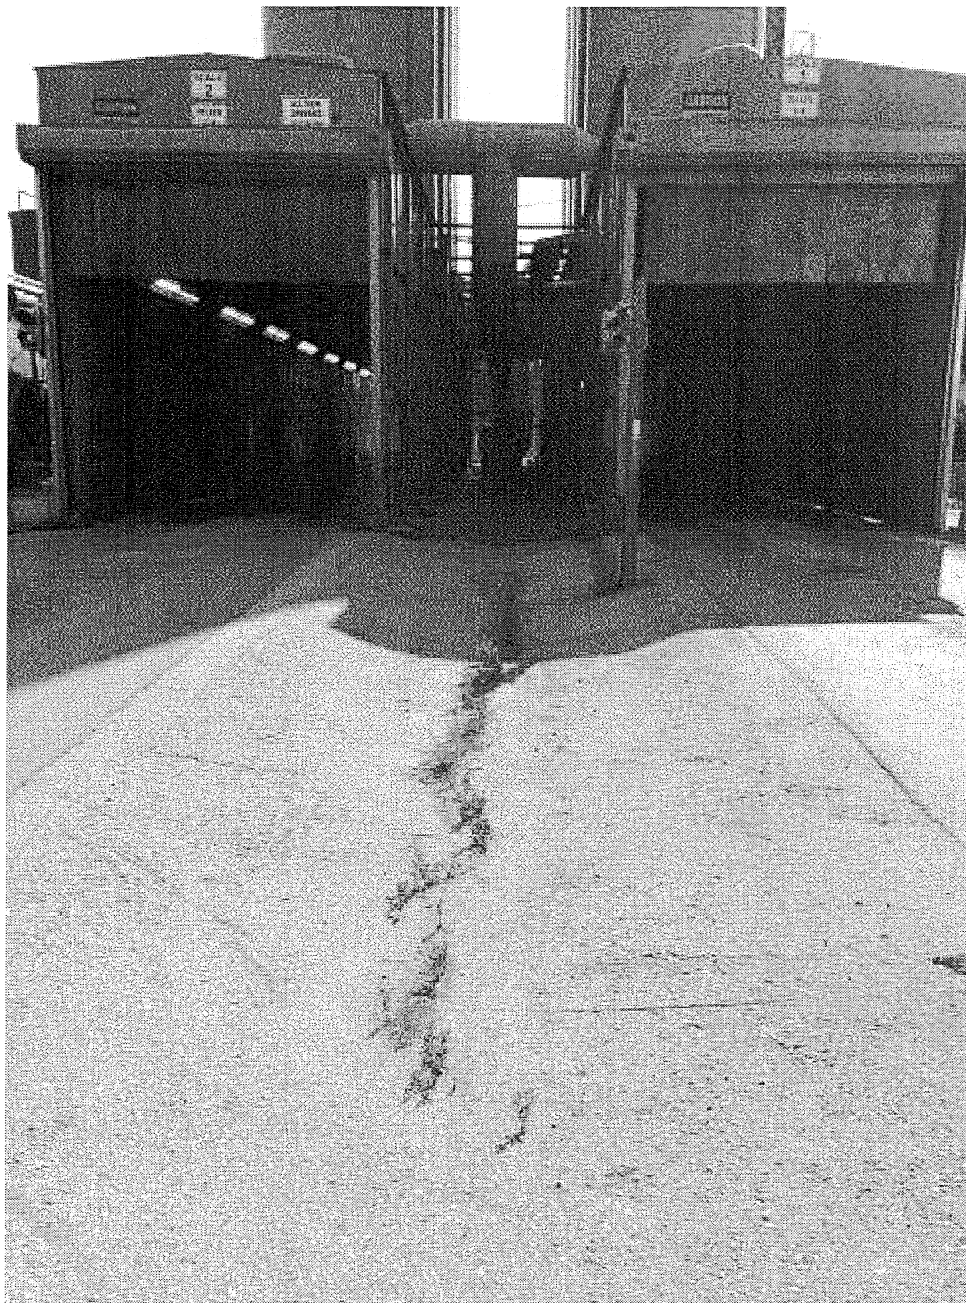
**Image 9(Figure 9)** : The facility documented replacement of the silo loadout enclosure curtain with an emailed photograph on September 2, 2015.

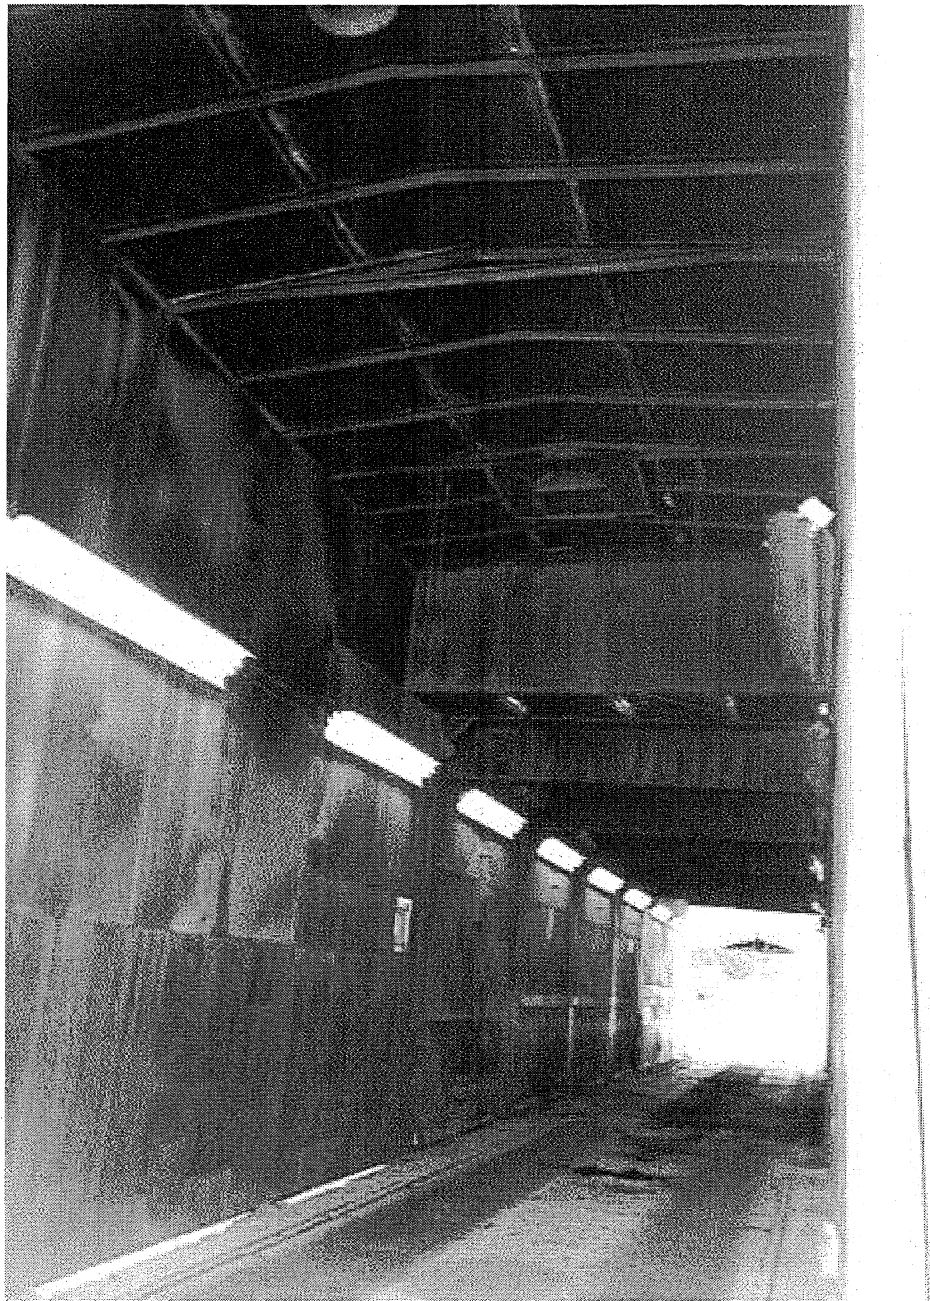
Emissions generated during a load out are drawn by a variable speed fan (an upgraded component installed in 2014) through duct openings located in the booth ceiling (Figure 10) and are ducted back to the drum dryer burner. I inquired whether the fan speed is displayed and / or monitored, and MJ showed me the fan's digital display that indicated a 30% draw speed. MJ explained that the draw speed can be increased, but at about 65%, it begins to reduce the dryer drum burner's performance.

**Image 10(Figure 10)** : Interior of the loadout enclosure, 8/22/15, 10:20 am.

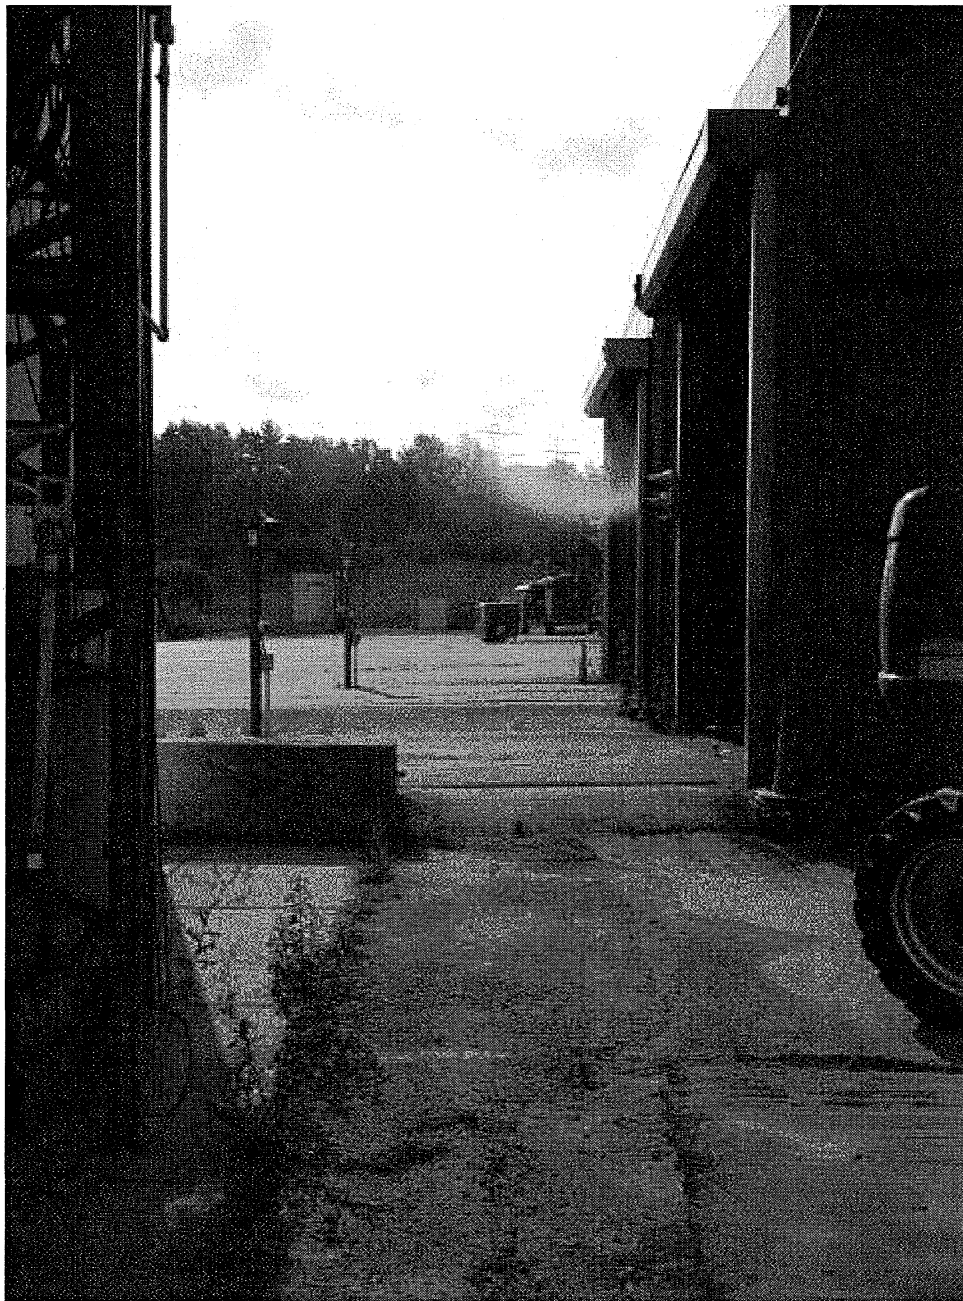
During the inspection, I observed a truck load out and noted fugitive emissions escaping below the flap (Figure 11). I suggested to MJ that the flaps may need to be

**Image 11(Figure 11)** : Fugitive emissions escaping below the enclosure curtain during a truck loadout, 8/22/15, 10:18 am.

expanded and / or the fan draw speed may need to be increased to improve the overall capture efficiency. He acknowledged that more may be done to improve the capture efficiency, such as increasing the fan draw speed to about 40%. MJ also stated that a few years ago, high speed roller doors were installed on both booths, but quickly failed due to jamming issues, etc. I indicated that the load out emissions control system could be improved and MJ expressed a commitment to review and address any identified deficiencies.

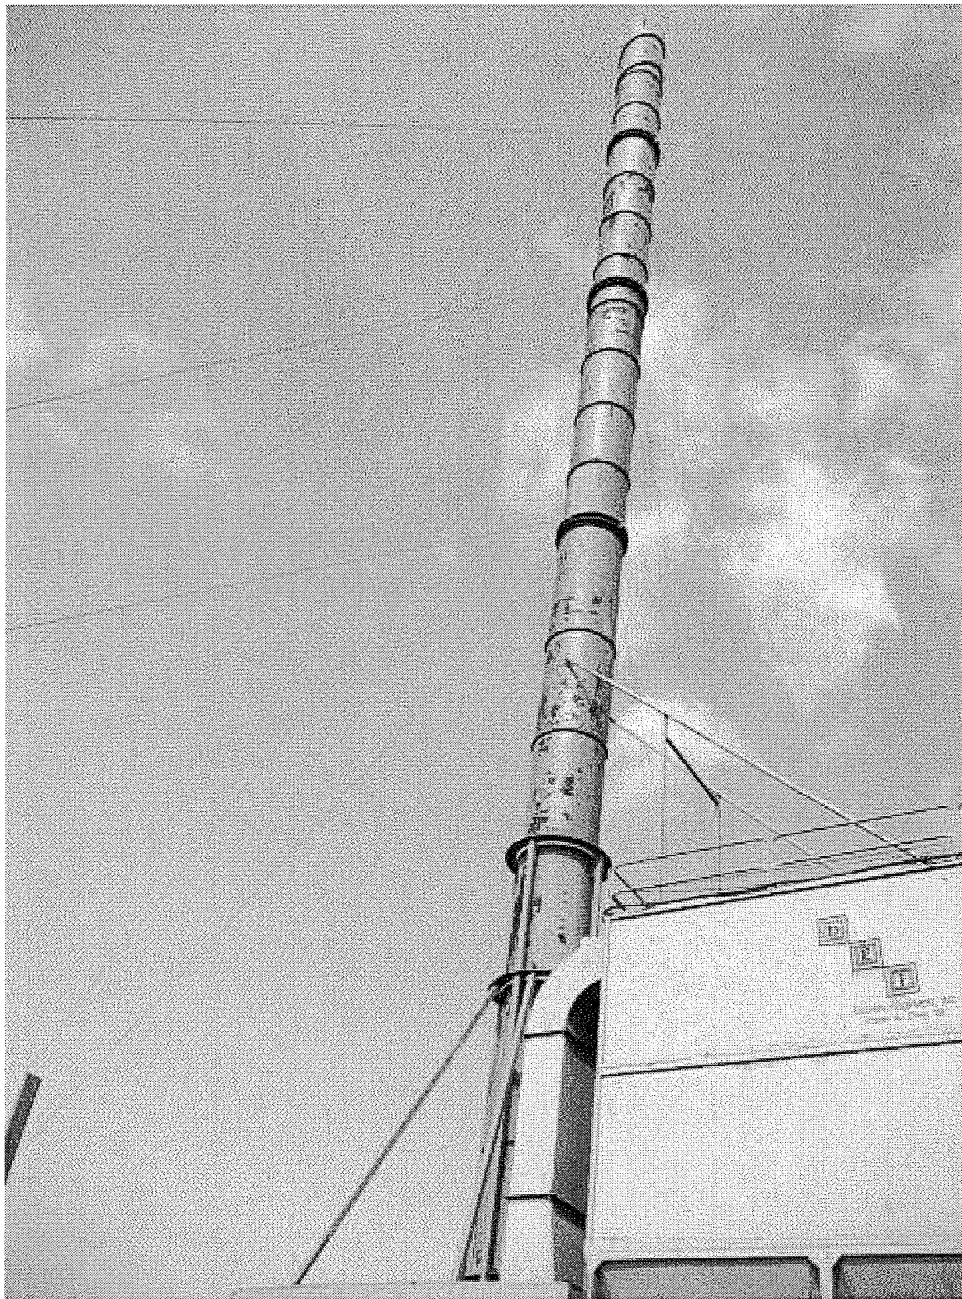
**Image 12(Figure 12) :** The stack associated with EUHMAPLANT, 8/22/15, 10:43 am.

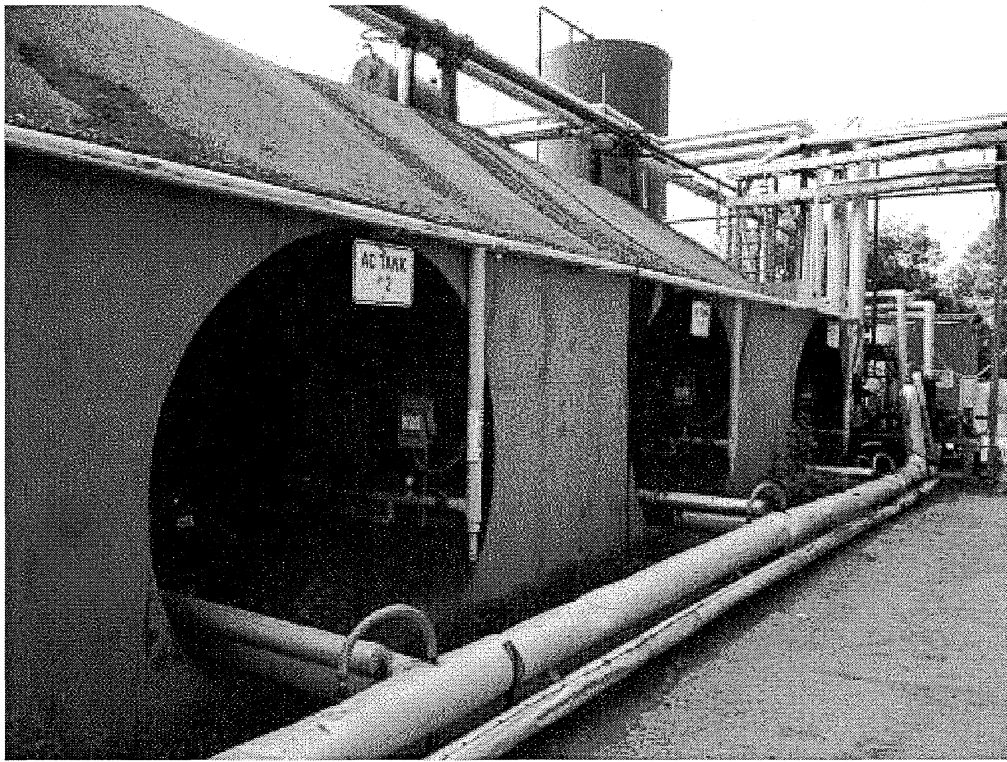
**Image 13(Figure 13) :** The liquid asphalt cement (LAC) storage tanks, 8/22/15, 10:42 am.
