# DEPARTMENT OF ENVIRONMENTAL QUALITY AIR QUALITY DIVISION ACTIVITY REPORT: On-site Inspection

FACILITY: Pitsch Sanitary Landfill		SRN / ID: N5619
LOCATION: 7905 Johnson Rd, BELDING		DISTRICT: Grand Rapids
CITY: BELDING		COUNTY: IONIA
CONTACT: Ross Young , Site Manager		<b>ACTIVITY DATE:</b> 08/04/2022
STAFF: David Morgan	COMPLIANCE STATUS: Non Compliance	SOURCE CLASS: MAJOR
SUBJECT:		
RESOLVED COMPLAINTS:

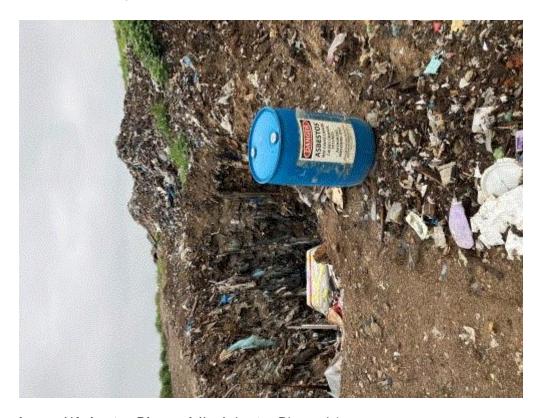
Image 1(Asbestos Disposal 1): Asbestos Disposal 1

In response to an AQD Violation Notice sent on February 4, 2022, asbestos containing waste is currently being placed into a designated pit on the edge of Cell 5 and Cell 6. The pit is approximately 50 ft deep and was marked with barrels that had asbestos warning labels. Upon inspection of the pit, bags and other forms of asbestos waste were observed without daily cover. It is noted that the material was wet as it had rained the night before the inspection. Upon review of asbestos manifest records it was determined that bags of asbestos waste were received on August 1st which was 3 days prior to the inspection. Since the waste in the pit was not covered with compacted non-asbestos-containing cover material at the end of the operating day a violation of ROP No. MI-ROP-N5619-2020b, Table EUASBESTOS, Condition III.1.c will be cited. PSL is maintaining a map of deposited asbestos waste.
