### DEPARTMENT OF ENVIRONMENTAL QUALITY AIR QUALITY DIVISION ACTIVITY REPORT: Scheduled Inspection

FACILITY: Citizens Disposal, Inc.		SRN / ID: N5991
LOCATION: 2361 W. Grand Blanc	Rd., GRAND BLANC	DISTRICT: Lansing
CITY: GRAND BLANC	· · · · · · · · · · · · · · · · · · ·	COUNTY: GENESEE
CONTACT: Robb Moore, Environr	nental Manager	ACTIVITY DATE: 11/28/2017
STAFF: Julie Brunner	COMPLIANCE STATUS: Compliance	SOURCE CLASS: MAJOR
SUBJECT: Performed a scheduled	inspection to determine compliance with ROP No	D. MI-ROP-N5991-2016.
RESOLVED COMPLAINTS:

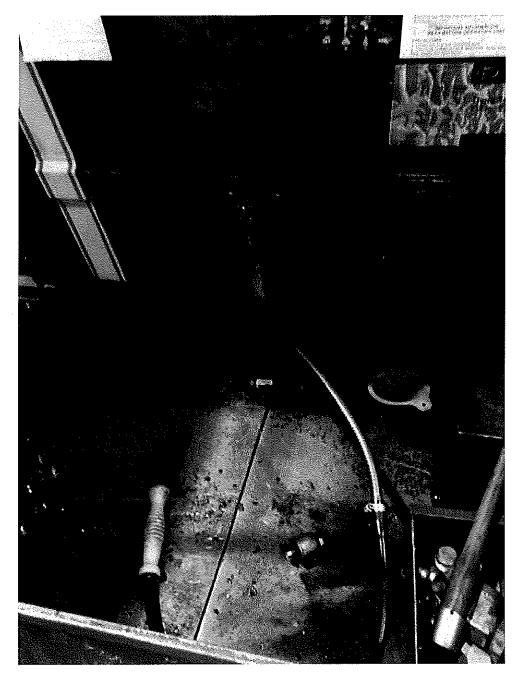
There is a parts washer located in the shop. It is included as FGCOLDCLEANER in the ROP. The parts washer was closed when viewed. The Safety Date Sheet (SDS) for the solvent used shows the material is a petroleum distillate. There are some exempt Rule 282 heaters at the facility including one propane heater for the office and a Salamander portable heater in the shop. There are 2 - 1000 gallon, and 1 - 500 gallon diesel fuel tanks for equipment refueling on site. These are occasionally moved around the landfill operations for refueling of off-road vehicles. There are also 2 - 335 gallon hydraulic oil tanks in the shop that were identified. The oil tanks at the facility are exempt under Rule 284(2)(i).

Image 1(2) : Parts washer

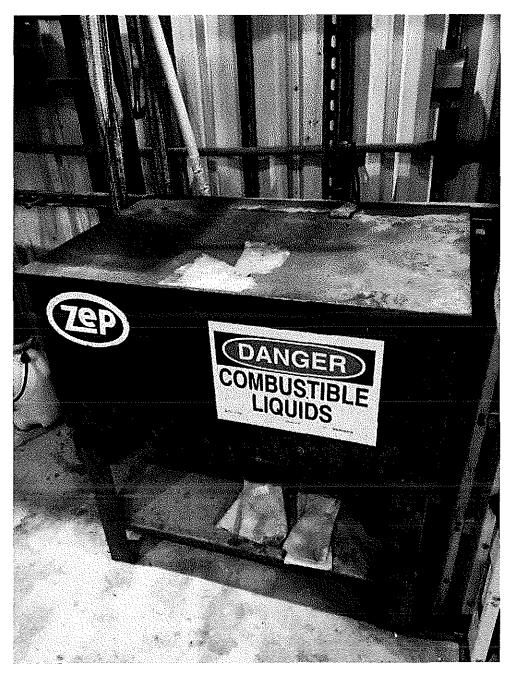
Image 2(1) : Parts washer

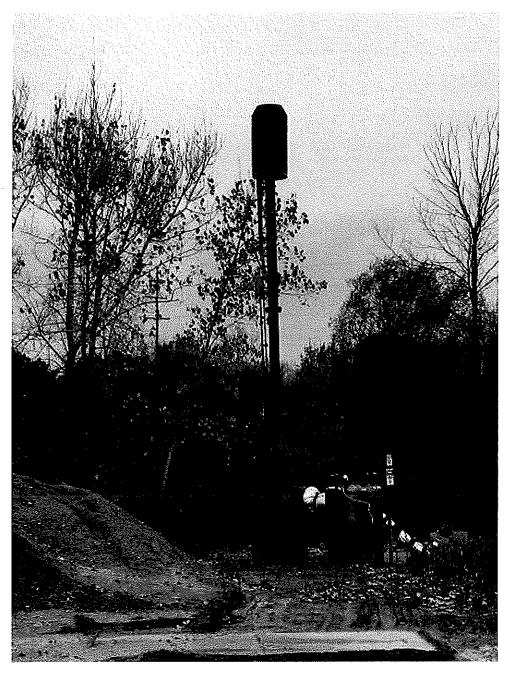
EUGROFFLARE handles excess gas that the engine plant cannot take. The landfill is producing gas in excess of the capacity of the plant and a couple hundred scfm of gas goes to the flare. The Glof flare had nitrogen tanks beside it which is the gas used to ignite the pilot light on the flare. No VEs were observed from the flare. EUZINKFLARE is for backup. If two (2) engines are down in the engine plant, then the flare is operated. It is run once a month to check operation at a minimum.

Image 3(3) : Grof flare

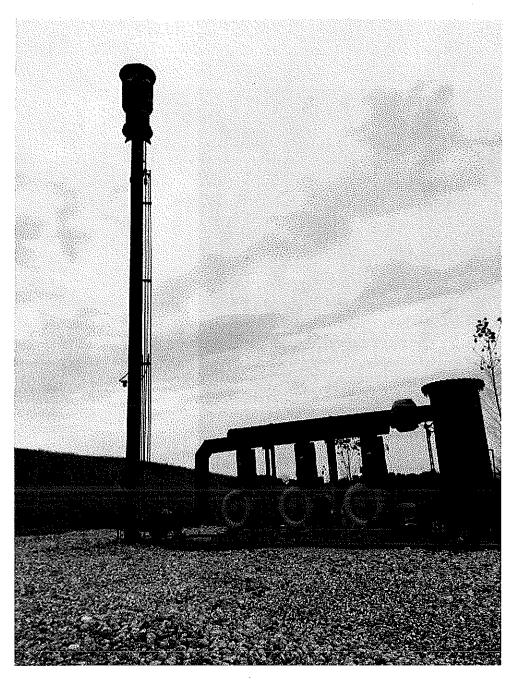
The drive around the operations of the landfill including the working face was done with Robb Moore. We drove first by the inactive (closed) landfill owned by Waste Management, the Groff Flare, and the Zink Flare which was not operating. While driving around the circumference of the landfill, risers for the leachate collection system and the electric powered leachate pumps were noted. Trash pickers were observed around the landfill operations. Little odor was noted around the base of the working face. At the working face of the landfill, the odor was not too bad. Wind speed was light and offsite potential for odors was observed to be low. At night, the working face is covered with tarps. Approximately 100 to 200 trash trucks per day make their way to the working face of the landfill and the scales close at 4:00 PM.

Image 4(8) : Zinc flare

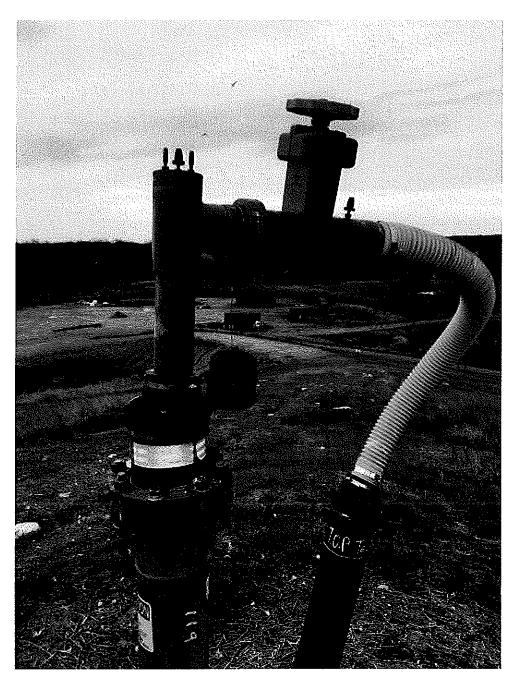
Image 5(9) : Landfill gas well riser
