**DEPARTMENT OF ENVIRONMENTAL QUALITY
AIR QUALITY DIVISION
ACTIVITY REPORT: Off-site Inspection**

FACILITY: Granger Grand River Avenue Landfill		SRN / ID: N5996
LOCATION: 8550 West Grand River Avenue, GRAND LEDGE		DISTRICT: Lansing
CITY: GRAND LEDGE		COUNTY: CLINTON
CONTACT: Kimberly Smelker , Operations Manager		ACTIVITY DATE: 11/10/2020
STAFF: Michelle Luplow	COMPLIANCE STATUS: Compliance	SOURCE CLASS: MAJOR
SUBJECT: Virtual, scheduled compliance inspection of the landfill and EDL generating station to determine compliance with MI-ROP-N5996-2018		
RESOLVED COMPLAINTS:

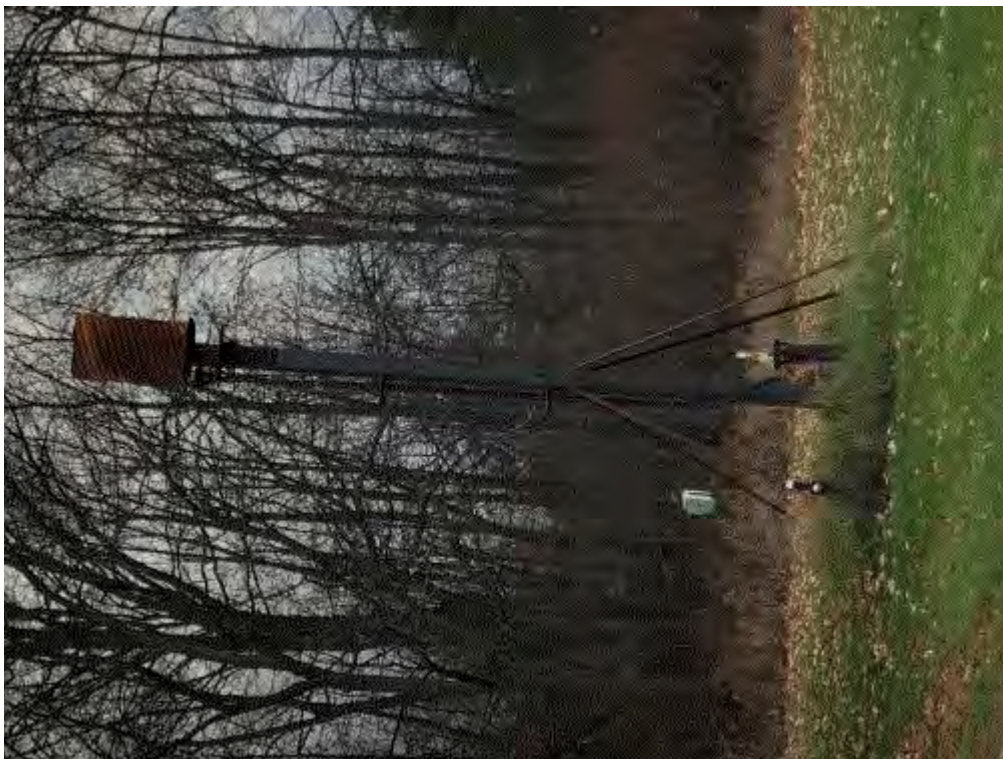
Image 1(Landfill flare) : Note not operating. Photo Credit: Dan Zimmerman, EDL

The candlestick flare is used to burn off any excess landfill gas that isn't combusted in the landfill gas engines owned by EDL. K. Smelker said the flare ran for 3.5 hours in 2019 and does not believe that the flare has operated at all during calendar year 2020. During the virtual inspection with Dan Zimmerman, he showed me the candlestick flare and it was not operating while onsite (no opacity, no heat signature waves, no flame).

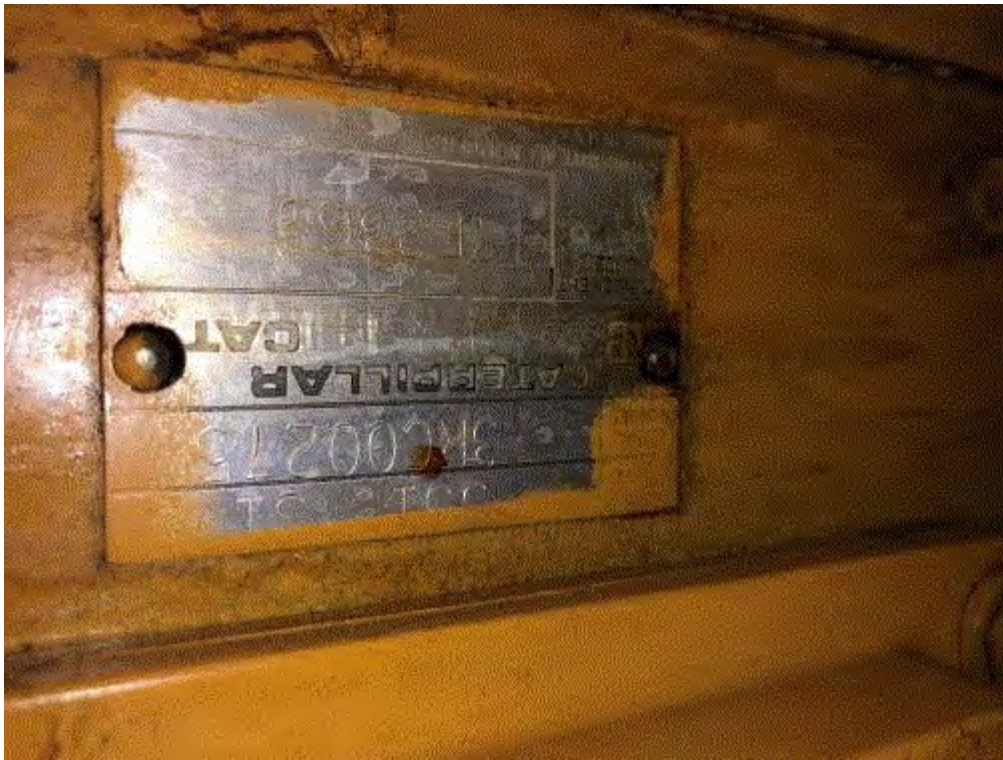
Image 2(EUICE1 Serial #) : Serial # for Engine 1. Photo Credit: Dan Zimmerman, EDL

1	3RC00275	10/15/1990	8/2/2013	The engine with serial no. 3RC00274 that was online 4/10/1991 and manufactured 11/15/1990 was swapped out for engine serial no. 3RC00275 on 6/1/2013.
3	4EK00132	12/16/1993	3/01/1994	Not operating during inspection
5	4EK00479	4/18/1995	9/23/1997	NA
