DEPARTMENT OF ENVIRONMENTAL QUALITY  
AIR QUALITY DIVISION  
ACTIVITY REPORT: Scheduled Inspection

FACILITY: MCGILL ROAD LANDFILL		SRN / ID: N6032
LOCATION: 3895 MCGILL RD, JACKSON		DISTRICT: Jackson
CITY: JACKSON		COUNTY: JACKSON
CONTACT: Steve Walters , District Engineer		ACTIVITY DATE: 08/12/2020
STAFF: Stephanie Weems	COMPLIANCE STATUS: Compliance	SOURCE CLASS: MINOR
SUBJECT: Scheduled, announced inspection.		
RESOLVED COMPLAINTS:

Inspection of McGill Road Landfill SRN N6032

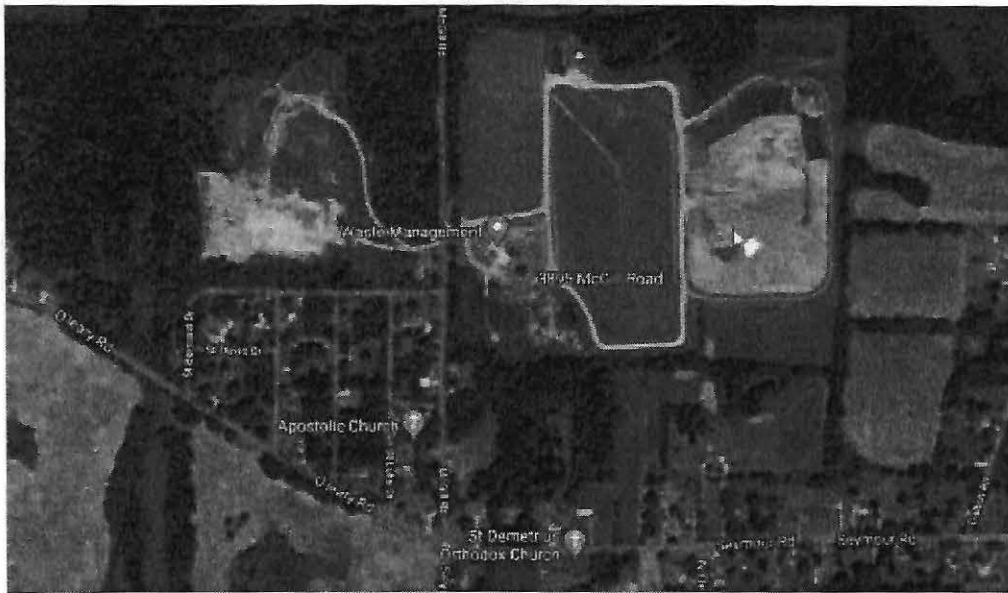
**Image 1(1)** : Aerial photo

The facility is located in Jackson County. It is immediately surrounded by agricultural and residential sources. See attached aerial photo.

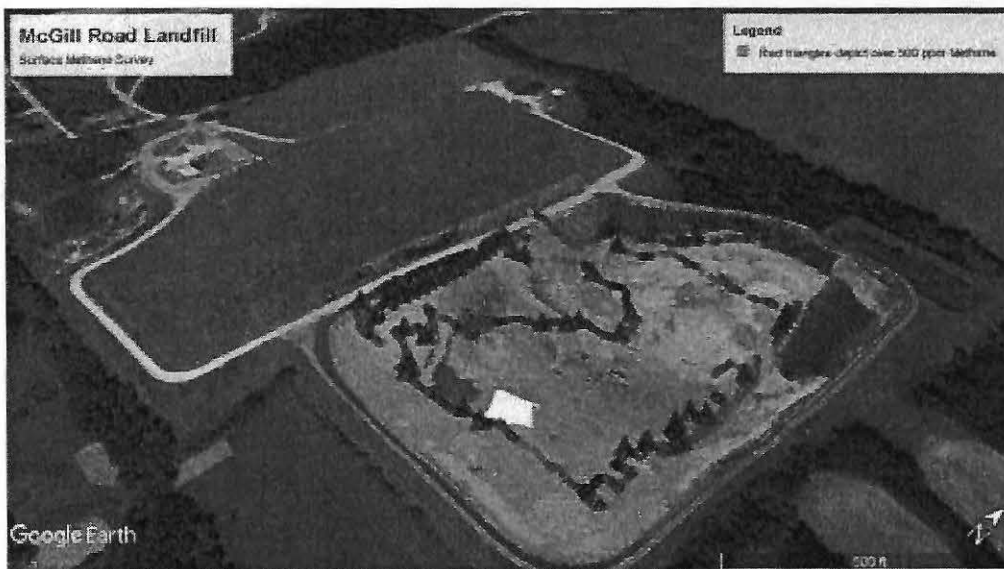
**Image 2(2)** : SEM survey path and hits detected.

We then walked over to the active cell. We traversed this cell thoroughly. (See attached map outlining path taken) In this area we were able to find 49 hits where methane levels were above 500ppm. Mike has documented these findings in a separate report, but the SEM results section below outlines the findings.

During the inspection, AQD performed an abbreviated SEM survey and found 49 areas with methane concentrations greater than 500 ppm. Detailed spreadsheets/reports of the data collected have already been provided electronically to the facility contacts via email.

This landfill is not subject Federal New Source Performance Standard (NSPS) for Municipal Solid Waste Landfills 40 CFR Part 60, Subpart WWW (or the newer Subpart XXX regulation) as the current size of the landfill is 2.194 million megagrams which is below the 2.5 million megagrams NSPS threshold. Therefore, compliance with the 500-ppm methane standard is not required. Cover integrity observed during the AQD SEM survey appeared to be excellent in the inactive western 2/3 of the landfill. This area had very little methane emissions coming from the surface and undetectable levels of methane coming from passive vents that were present. The active eastern portion of the landfill had little vegetation with small cracks in the soil and numerous small erosion features and a few surface geomembrane liners that were installed to limit the amount of leachate being generated. All landfill gas collected is directed to a single gas flare. SEM hits detected were mostly found in active areas that currently lack a gas collection and control system (GCCS) and near the edge of a couple geo-membrane liners. Surface penetrations such as wellheads that were surveyed were found to be in good shape. One significant widespread area of elevated methane concentrations was found on the western slopes of the active cell area. This area lacks gas collection.

At this time, no action is required by the facility to address the surface methane emissions. It is noted that if proposed changes to Michigan's Part 115 Waste Management rules are enacted, it would require that surface methane emissions more than 500 ppm be addressed.

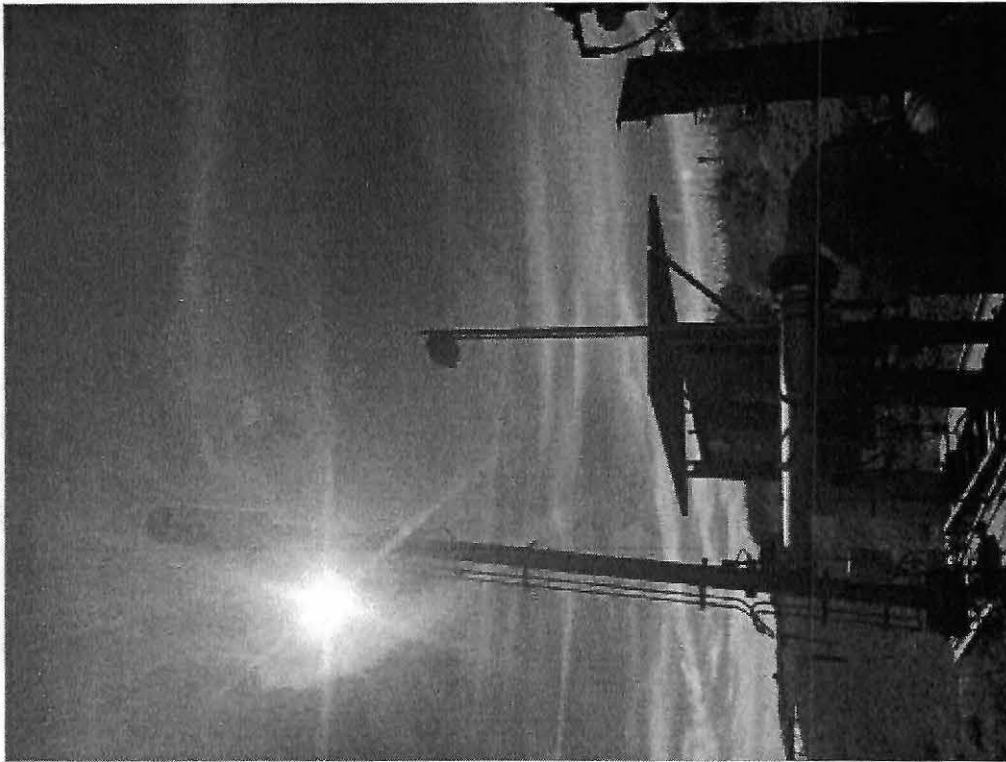
**Image 3(3) :** Flare

McGill has 19 operating Gas Wells (GW) currently. They are the standard monitoring GW with control valve, flow meter, sample ports (pressure, vacuum and gas composition required by NSPS WWW). Steve and Ron said that a technician has been reading the GWs monthly, although they are not currently required to do so. Wells are connected to the standing single open flare, 25 feet in height (so relatively small).

I asked Ron about the flare and how often maintenance is conducted on it. He explained that the flare has a 650 scfm max flow rate, but right now they are running at approximately 380 scfm. He said that preventative maintenance is conducted on the unit once a month to make sure that everything is running correctly.

The flare has a pilot flame with propane and is located on the cell phase on the north end and up on the first vertical/horizontal plateau. Yokagawa is the manufacturer. According to previous inspection reports, it has an automatic shut off valve if there is no flame. It will attempt to self-start 5 times and then calls for help. Computer disks record the data; however, because they are not yet subject to the standard, they are not required to do this.

We then crossed over to the next section of closed landfill. We traversed this area, and no methane hits were detected. This is the portion of the landfill where the flare is located. I was able to observe the flare operating. No visible emissions were observed. I was also able to see the operating panel. (See attached photos). The flare appeared to be operating according to manufacturer's specifications.
