DEPARTMENT OF ENVIRONMENTAL QUALITY AIR QUALITY DIVISION ACTIVITY REPORT: On-site Inspection

FACILITY: DAFTER SANITARY LANDFILL INC		SRN / ID: N6033	
LOCATION: 3962 W 12 MILE ROAD, DAFTER		DISTRICT: Marquette	
CITY: DAFTER		COUNTY: CHIPPEWA	
CONTACT: TIM HARROW , SITE MANAGER		ACTIVITY DATE: 10/16/2023	
STAFF: Drew Yesmunt	COMPLIANCE STATUS: Compliance	SOURCE CLASS: MAJOR	
SUBJECT: Targeted Inspection FY24			
RESOLVED COMPLAINTS:

Facility: Dafter Sanitary Landfill Inc (SRN: N6033)

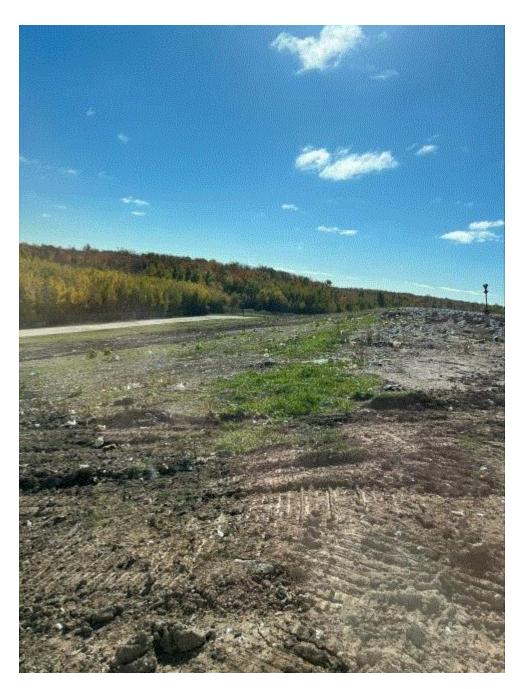
At the time of the inspection, no fugitive dust emissions were observed. There are six cells (A,B,C,D,E,F) at DSL. Cell A is currently partially closed. Cells B, C, D, E, and F are currently operating. A cap of 5 acres has been budgeted for 2025 and is planned for bidding in 2024.

Image 1(DSL Grounds): Dafter Sanitary Landfill

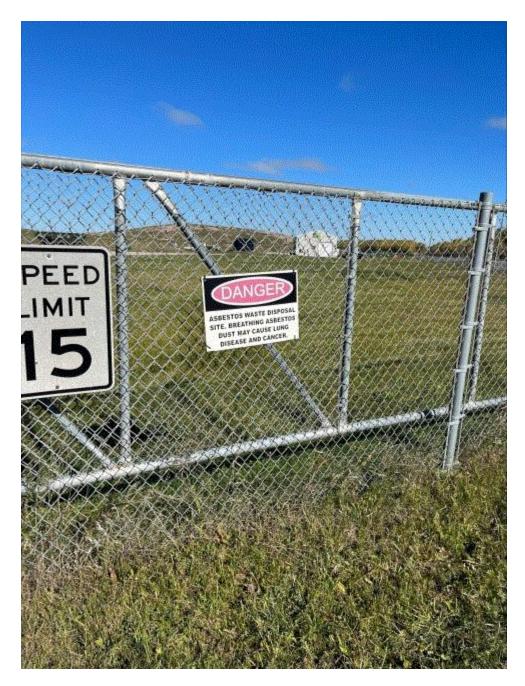
Upon entering the facility and during the tour, it was observed the perimeter of the landfill was completely fenced. Signs at the entrance state that the facility actively accepts asbestos material. During the tour of the landfill, asbestos warning signs were observed along the perimeter. Tim Harrow provided an updated Asbestos Disposal Locations map that provides information on each asbestos shipment received with the point number, date, and elevation of where that shipment is deposited in the landfill. Before a shipment is received, a minimum 24-hour notice is provided that asbestos material will be incoming. Upon notice, a location is determined and prepared for the asbestos material to be disposed of. After disposal, the asbestos waste is covered with at least two feet of non-asbestos-containing material and compacted before end of day.

Image 2(Asbestos Warning): Warning sign posted at front of facility gates
