DEPARTMENT OF ENVIRONMENTAL QUALITY  
AIR QUALITY DIVISION  
ACTIVITY REPORT: On-site Inspection

<b>FACILITY:</b> DELTA SOLID WASTE MANAGEMENT AUTHORITY		<b>SRN / ID:</b> N6035
<b>LOCATION:</b> 5701 19TH AVENUE N, ESCANABA		<b>DISTRICT:</b> Marquette
<b>CITY:</b> ESCANABA		<b>COUNTY:</b> DELTA
<b>CONTACT:</b> David Lundquist , Operations Manager		<b>ACTIVITY DATE:</b> 12/13/2022
<b>STAFF:</b> Lauren Luce	<b>COMPLIANCE STATUS:</b> Non Compliance	<b>SOURCE CLASS:</b> MAJOR
<b>SUBJECT:</b> Targeted Inspection FY23		
<b>RESOLVED COMPLAINTS:</b>

**Facility:** Delta Solid Waste Management Authority (SRN: N6035)

**Location:** 5701 19<sup>th</sup> Avenue North, Escanaba, MI 49829

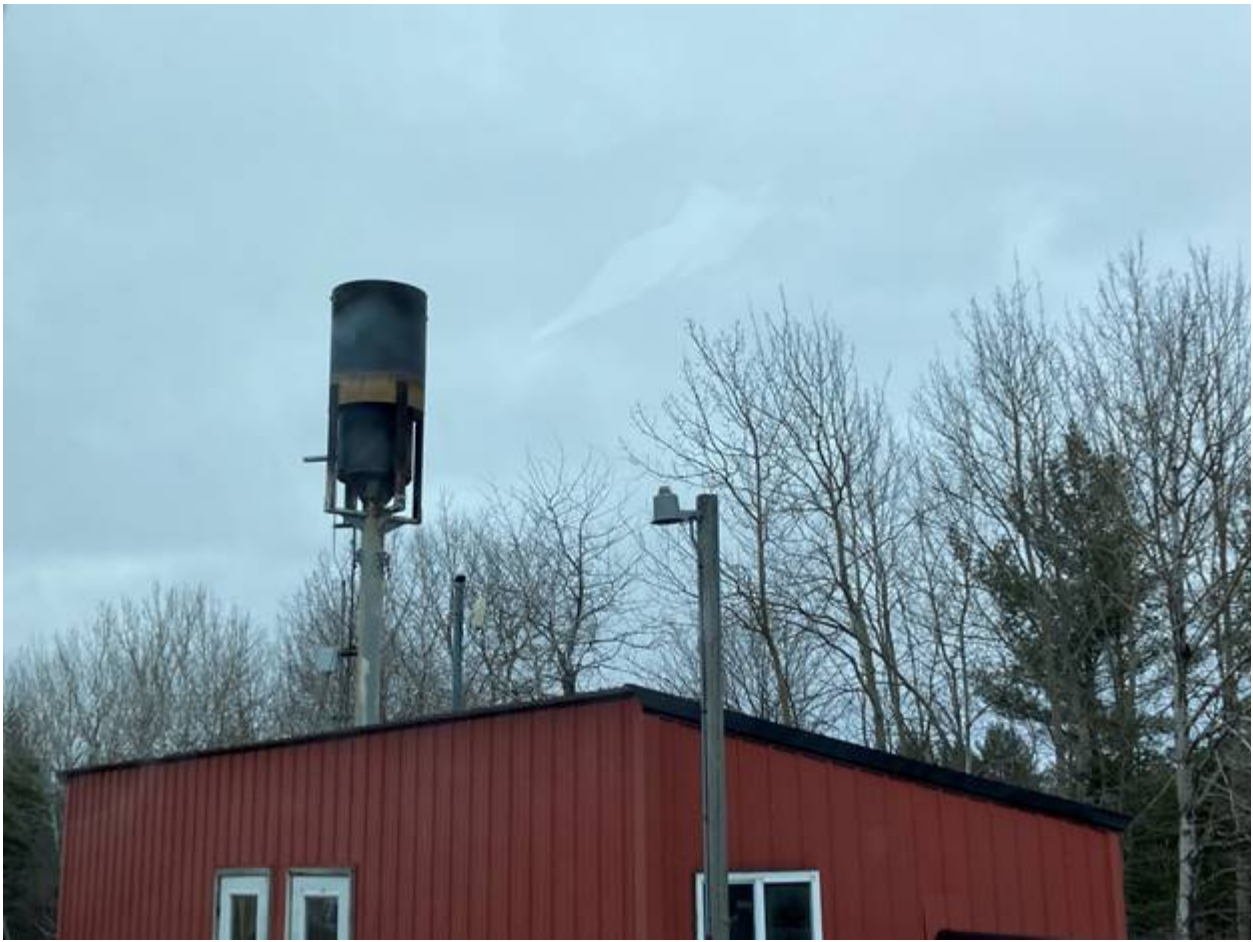
The landfill has an open flare at both the North and South Landfills. There were no visible emissions during the inspection (SC I.1). A flame was present at both flares during the inspection (SC III.2). The flares were tested in accordance with the regulation on 9/19/2022. No visible emissions were observed from either flare during the testing (SC V.3). The net heating value of gas being combusted was determined to be 476.6 BTU/ft<sup>3</sup> for the North Landfill and 291.1BTU/ft<sup>3</sup> for the South Landfill. The exit velocity for the North Landfill flare was determined to be 1.84 feet per second and the South Landfill flare was 6.93 feet per second (SC V.2)

The landfill has an open flare at both the North and South Landfills. There were no visible emissions during the inspection (SC I.1). A flame was present at both flares during the inspection (SC III.2). Both flares are equipped with a heat sensing device and a device that records gas flow (SC IV.2, 3). At the time of the inspection (1:19PM) the South Flare had a temperature of 1259 degrees Fahrenheit and a flow of 157 CFM. As stated above, both flares were tested in accordance with the regulation on 9/19/2022 (SC V.1-4). Both flares are maintained regularly, malfunctions are recorded, and temperature and flow are recorded. Records on flare temp, flow, and hour meter were provided for 2020-2022 (SC VI.2).

*Image 1: South Landfill flare*

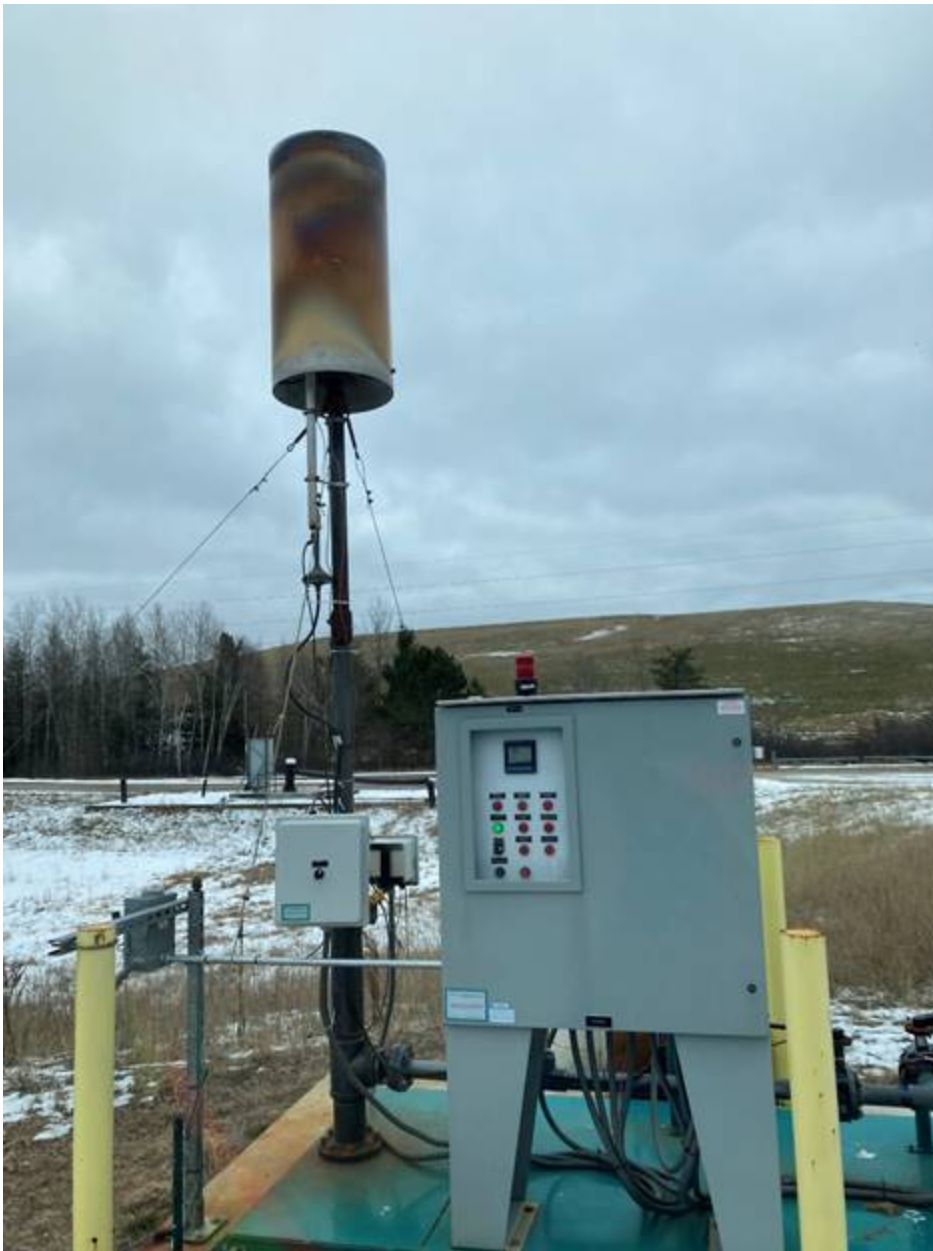
*Image 2: North Landfill flare*

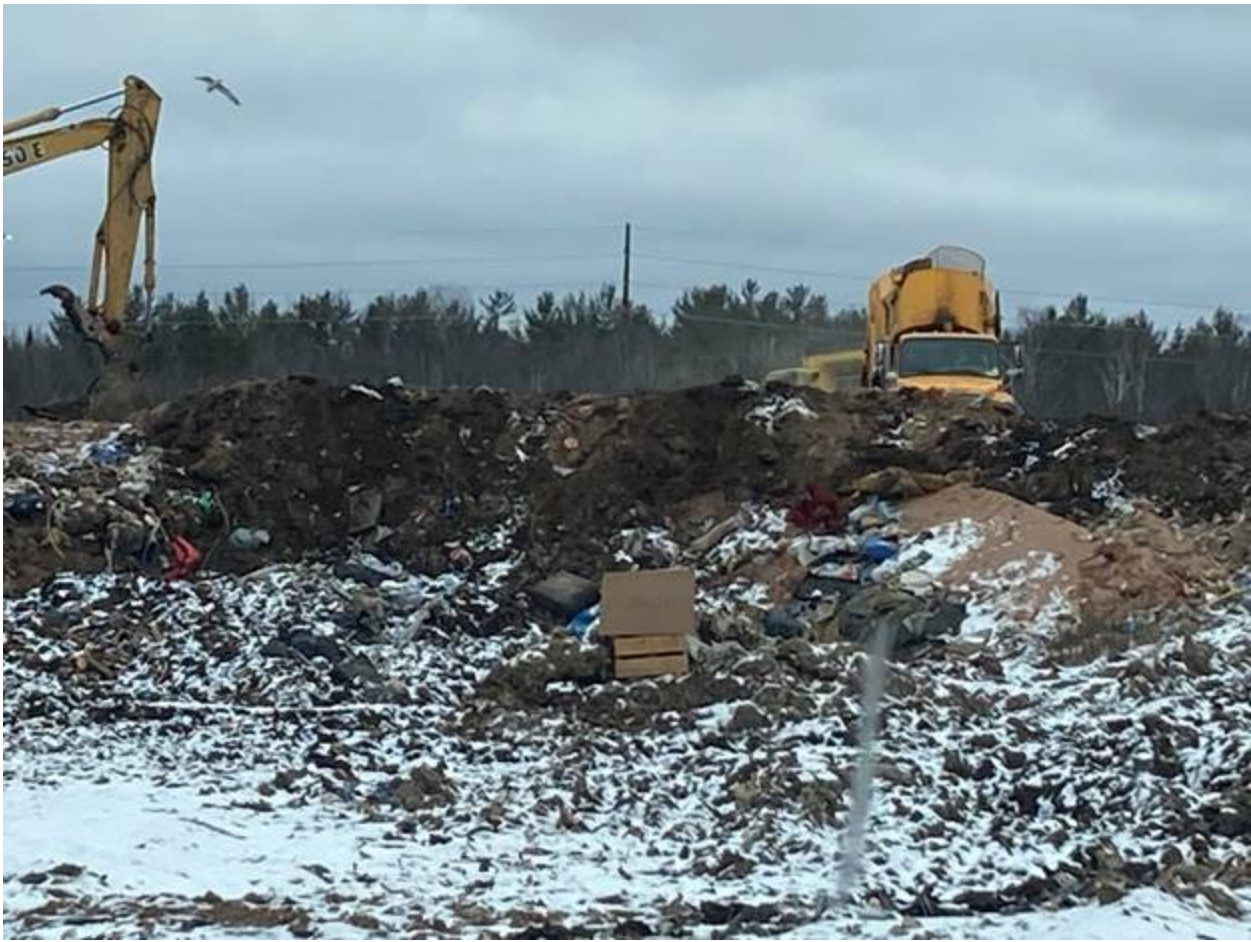
During the tour, one warning sign was present at the entrance of the South Landfill. There were no warning signs at the entrance of the North Landfill or along the perimeter of either landfill. It was relayed to Landfill Staff that additional signage would be needed to comply with the regulation. The regulation also requires that, unless meeting the no visible emissions requirement, a cover of at least 6 inches shall be applied at the end of each operating day or at least once every 24-hour period while the site is in continuous operation (SC III.1). Delta Landfill

staff were unaware of this requirement and were not covering the asbestos on a regular basis or completing visible emissions checks. Asbestos was observed uncovered during the on-site tour. Records on the amount and type of material used to cover the asbestos were not available (SC VI.4).

*Image 3: Asbestos in cell 6 (uncovered)*

Based on the inspection performed and records reviewed, Delta County Landfill does not appear to be in compliance with MI-ROP-N6035-2022. There appears to be the following violations: inadequate warning signs for asbestos (EUASBESTOS, SC III.1), asbestos was not being covered at the frequency required in SC III.1.c or daily Method 22 readings for 15 minutes were not being performed and recorded (EUASBESTOS, SC III.1), a map of the location of asbestos in cell 6 was initially not available (EUASBESTOS SC VI.2), the facility was not keeping records on all fuels combusted in the furnace on an hourly basis or observing and recording daily visible emissions (EUFURNACE1, SC VI.2, 3), SEMS data was not being properly reviewed with exceedances documented and exceedance procedures followed (FGLANDFILL-AAAA, SC V.3, VI. 1, VII.4). These violations have been conveyed to the facility at the inspection and through email correspondence. A violation notice will be issued.

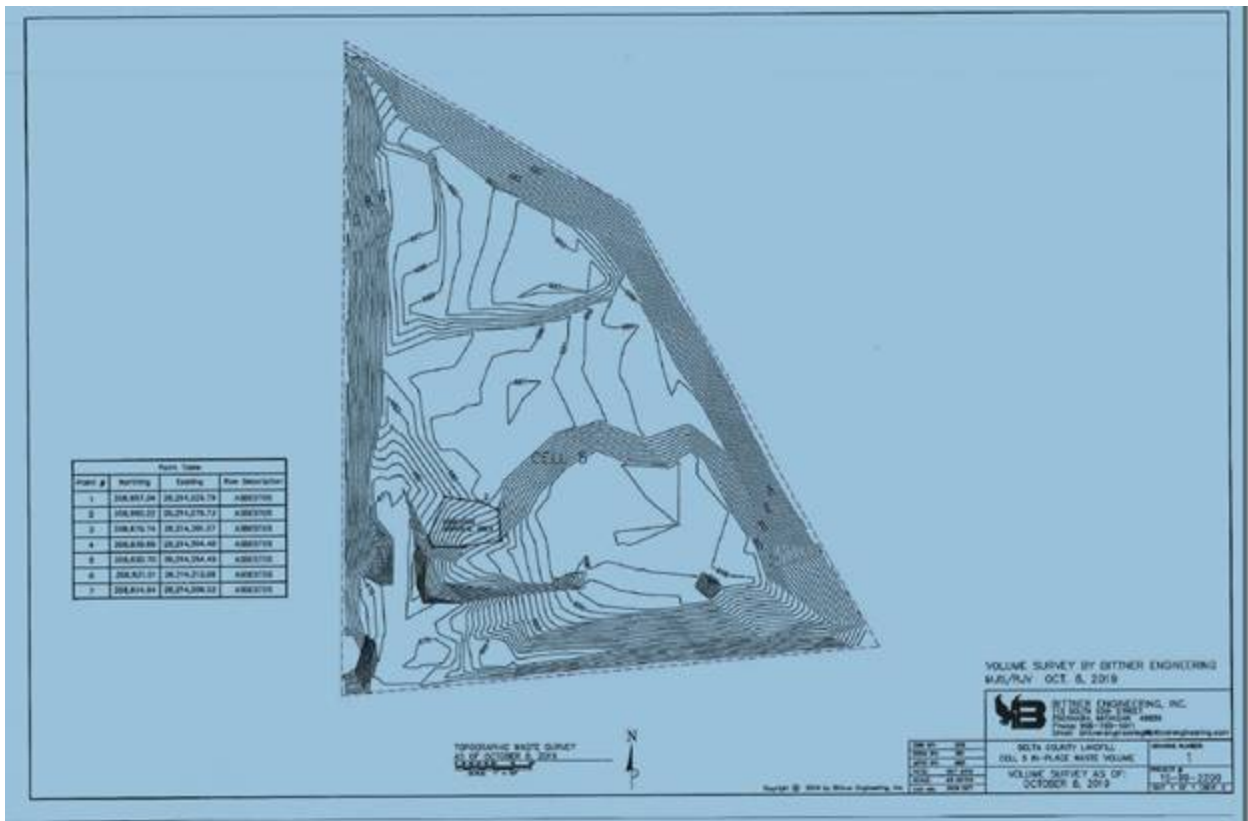
Delta County Landfill keeps records of the name, address, and phone number of the waste generator and transporter for each shipment received on the *Waste Shipment Record* form. The quantity of the asbestos-containing waste material is also recorded (SC VI.1). Copies of the Waste Shipment Records and receipts were provided. Asbestos is currently disposed of at one location in cell 6, it was previously disposed of at one location in cell 5. The facility was able to provide some maps of the asbestos disposal locations (SC.IV.2). However, initially an asbestos map of cell 6 was not available. The facility had a consultant create a map of the cell 6 disposal area after the inspection. The maps indicate the location of the asbestos disposal area and provide initial elevation data. Asbestos location maps were also provided for the South Landfill after an email request.

Image 4: Asbestos map (cell 5)
