DEPARTMENT OF ENVIRONMENTAL QUALITY
AIR QUALITY DIVISION
ACTIVITY REPORT: On-site Inspection

FACILITY: D.C. Byers Co.		SRN / ID: N6637
LOCATION: 5946 Clay Ave SW, GRAND RAPIDS		DISTRICT: Grand Rapids
CITY: GRAND RAPIDS		COUNTY: KENT
CONTACT: Doug Lectka , President/Owner		ACTIVITY DATE: 01/12/2022
STAFF: April Lazzaro	COMPLIANCE STATUS: Non Compliance	SOURCE CLASS: Minor
SUBJECT: Unannounced, self-initiated inspection.		
RESOLVED COMPLAINTS:

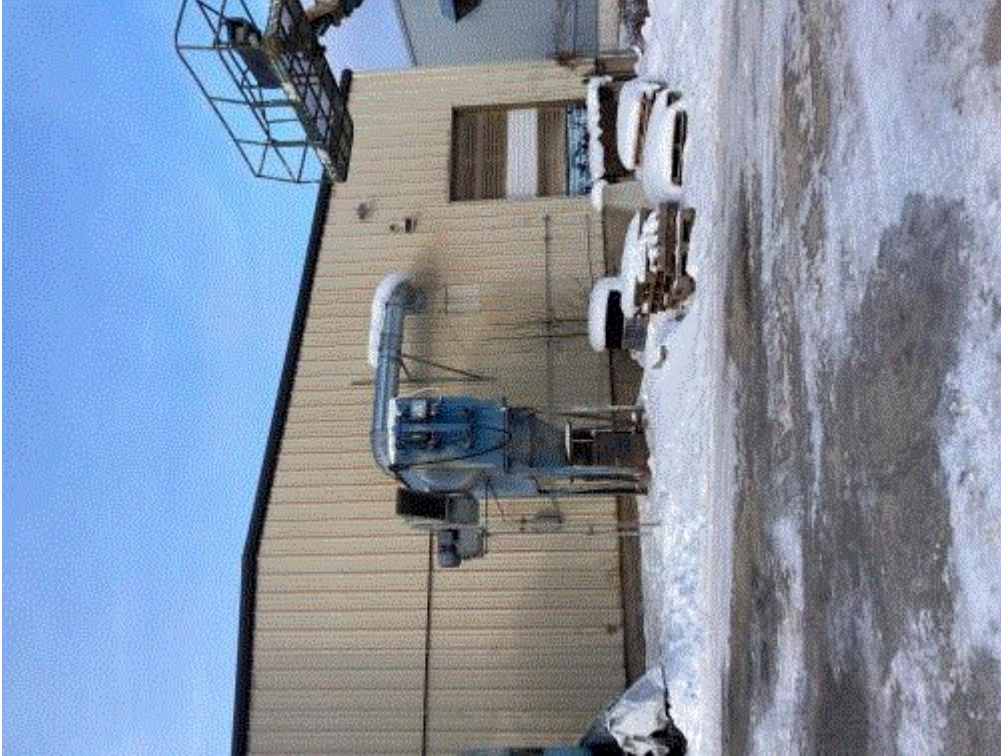
Based on the amount of sand on the floor within the sandblast room, it is unlikely that the cartridge filter is collecting much sand. A visual observation did not find obvious defects to the unit, but the operating condition and filter status is unknown.

Image 1(EUSANDBLAST) : Cartridge filter collector for sandblasting operation.

PTI No. 280-99 requires maintenance of the cartridge filter system, and as indicated above the internal status of the unit is unknown. A request for an internal inspection, and report of findings will be made.

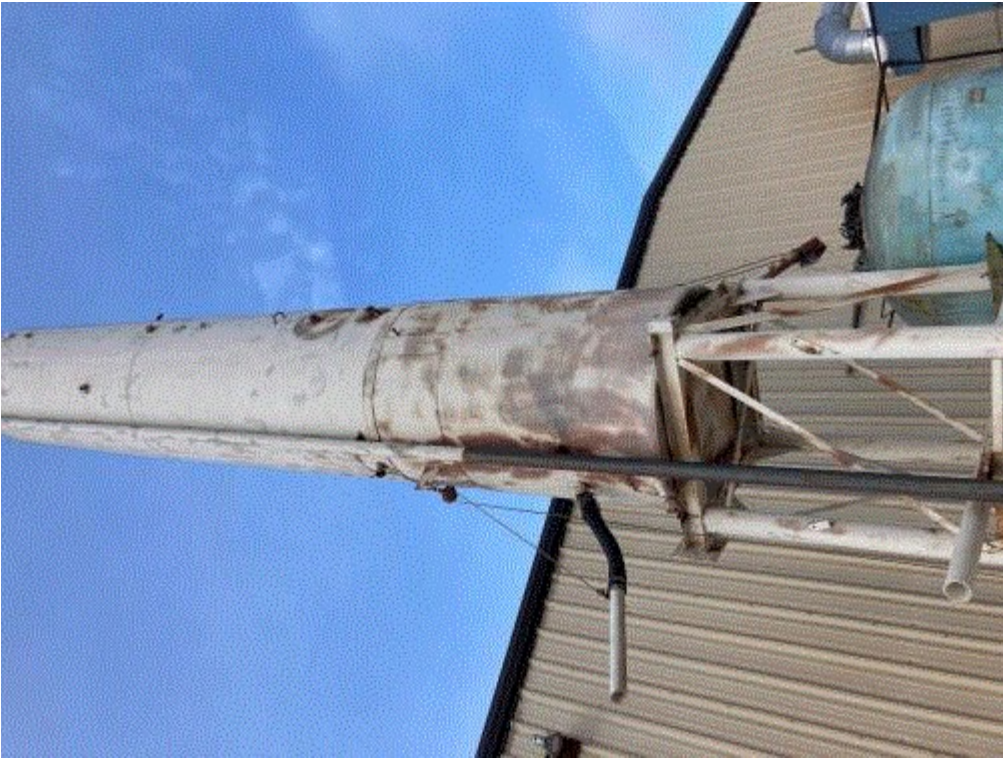
Image 2(EUSANDBLAST) : Sand storage tower.

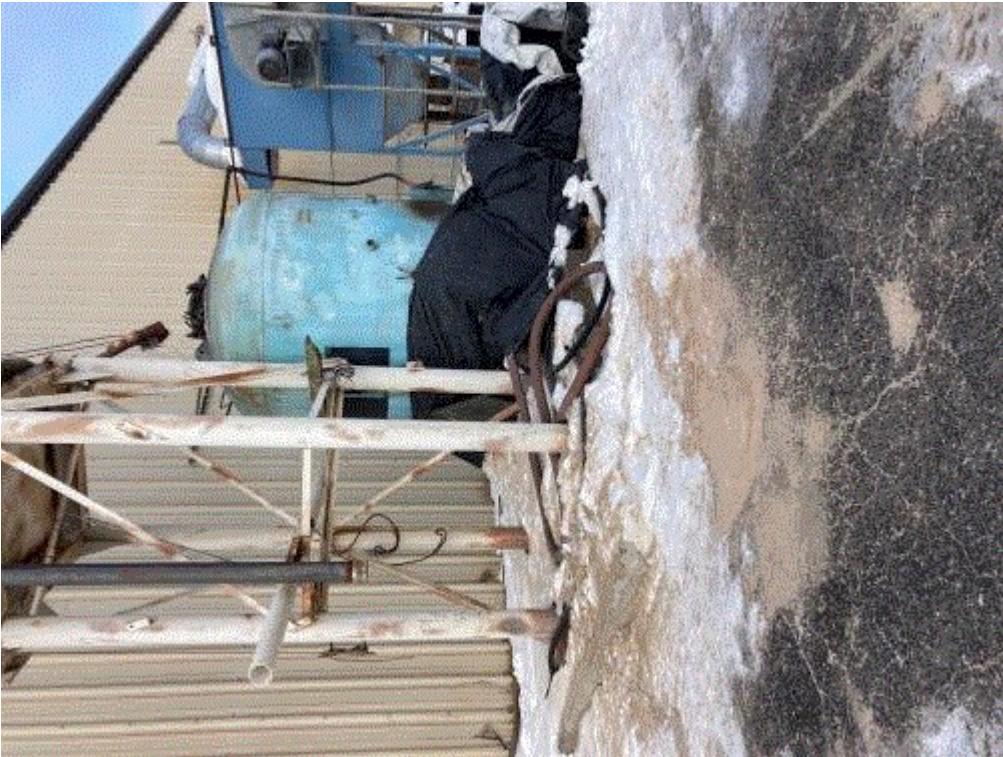
Image 3(EUSANDBLAST) : Base of sand storage tower and cartridge filter collector.

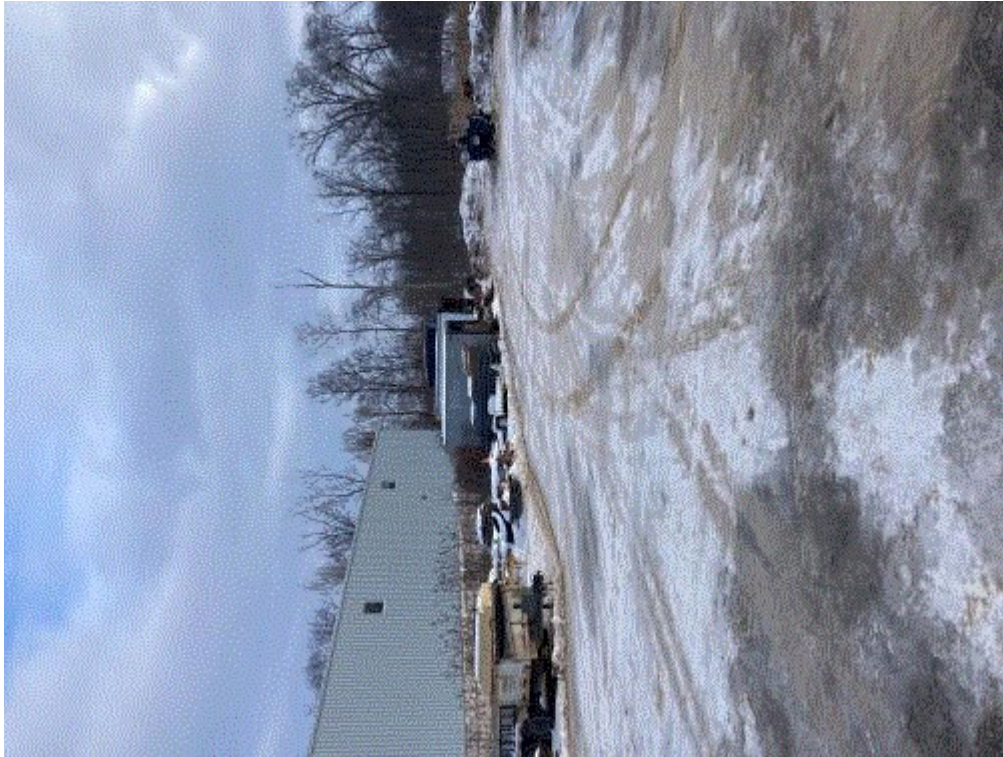
When we exited out the man door of the sandblast room, I observed large quantities of sand covering the exposed portions of the parking lot, as well as sand on top of the snow downwind of the cartridge filter exhaust duct.

Mr. Lectka and I discussed the sand, and he informed me that he has been applying the dirty/used sandblast sand on the parking lot for traction on snow and ice. I informed him that this practice is not considered proper disposal of a waste and must be discontinued. He asked for additional information related to this practice, and I stated that it would be provided.

I discussed with Mr. Lectka that the use of the sand on the parking lot, and the fact that it was blowing around, as evidenced by the sand on undisturbed snow, is a violation of Air Quality Division Rules. Specifically, Rule 336.1370(1) states, "Collected air contaminants shall be removed as necessary to maintain the equipment at the required operating efficiency. The collection and disposal of air contaminants shall be performed in a manner so as to minimize the introduction of contaminants to the outer air."

Image 4(EUSANDBLASTING) : One area of parking lot where sand has been applied and becoming air contaminant.
