**DEPARTMENT OF ENVIRONMENTAL QUALITY
AIR QUALITY DIVISION
ACTIVITY REPORT: Scheduled Inspection**

FACILITY: MetoKote Corp.		SRN / ID: N7241
LOCATION: 3001 Hollow Ridge Dr., EATON RAPIDS		DISTRICT: Lansing
CITY: EATON RAPIDS		COUNTY: EATON
CONTACT: Joe Limon , Plant Manager		ACTIVITY DATE: 02/22/2017
STAFF: Michelle Luplow	COMPLIANCE STATUS: Compliance	SOURCE CLASS: MINOR
SUBJECT: Scheduled, unannounced inspection to determine compliance with general PTI 269-09 and PTI 74-03.		
RESOLVED COMPLAINTS:

Conduct an unannounced scheduled compliance inspection of MetoKote by determining compliance with PTI 74-03 for an acetic acid tank (pretreatment of substrate) and PTI 269-09 a general permit for a natural gas-fired burnoff oven.

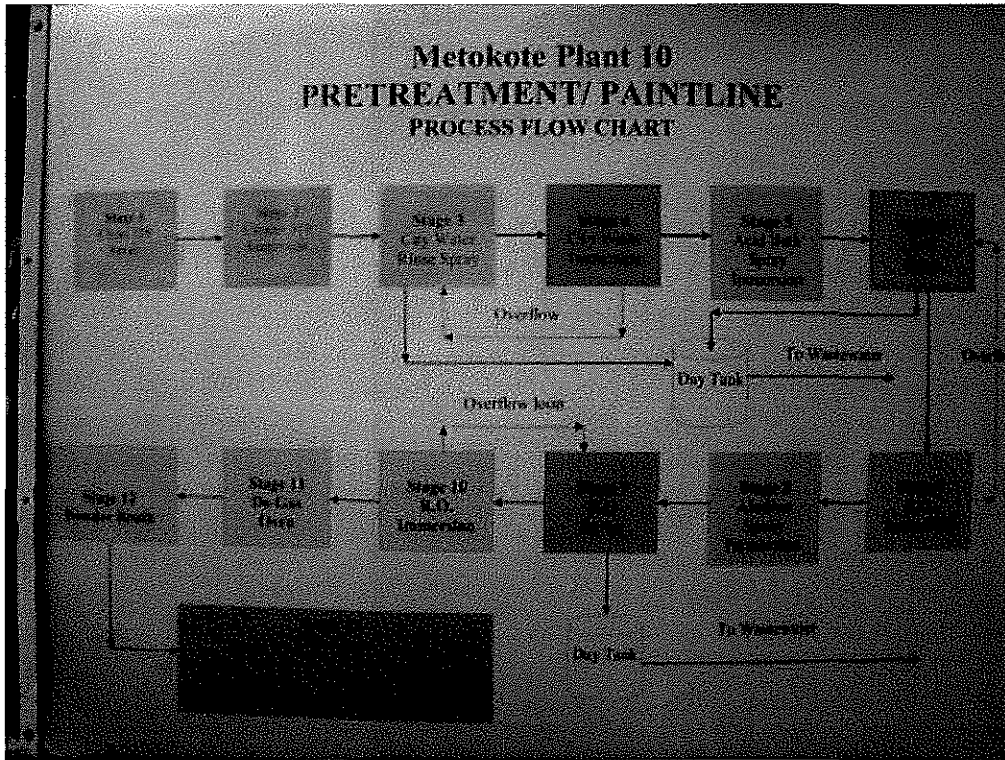
(1) Alkali Spray Cleaner (removes oil) → (2) Alkali Immersion (temperature kept at 115-140F, allows for cleaner to get into the small crevices of the part) → (3) City water rinse spray → (4) City water immersion → (5) Acetic Acid Spray (2 sections) and immersion (1 bath) (opens up pores in metal to prep for primer/corrosion protectant) → (6) Deionized (DI) water spray → (7) DI water immersion → (8) Alodine immersion and spray (primer/corrosion protectant) → (9) DI water spray → (10) DI water immersion → (11) De-gas oven (removes impurities from metal, otherwise gas bubbles can form in the coating) → (12) Powder Coating (textured and satin finishes, one booth for each finish, 2 booths total) → (13) Curing oven

Image 1(Process Schematic) : 13-stage process flow chart for metal treatment through coating process.

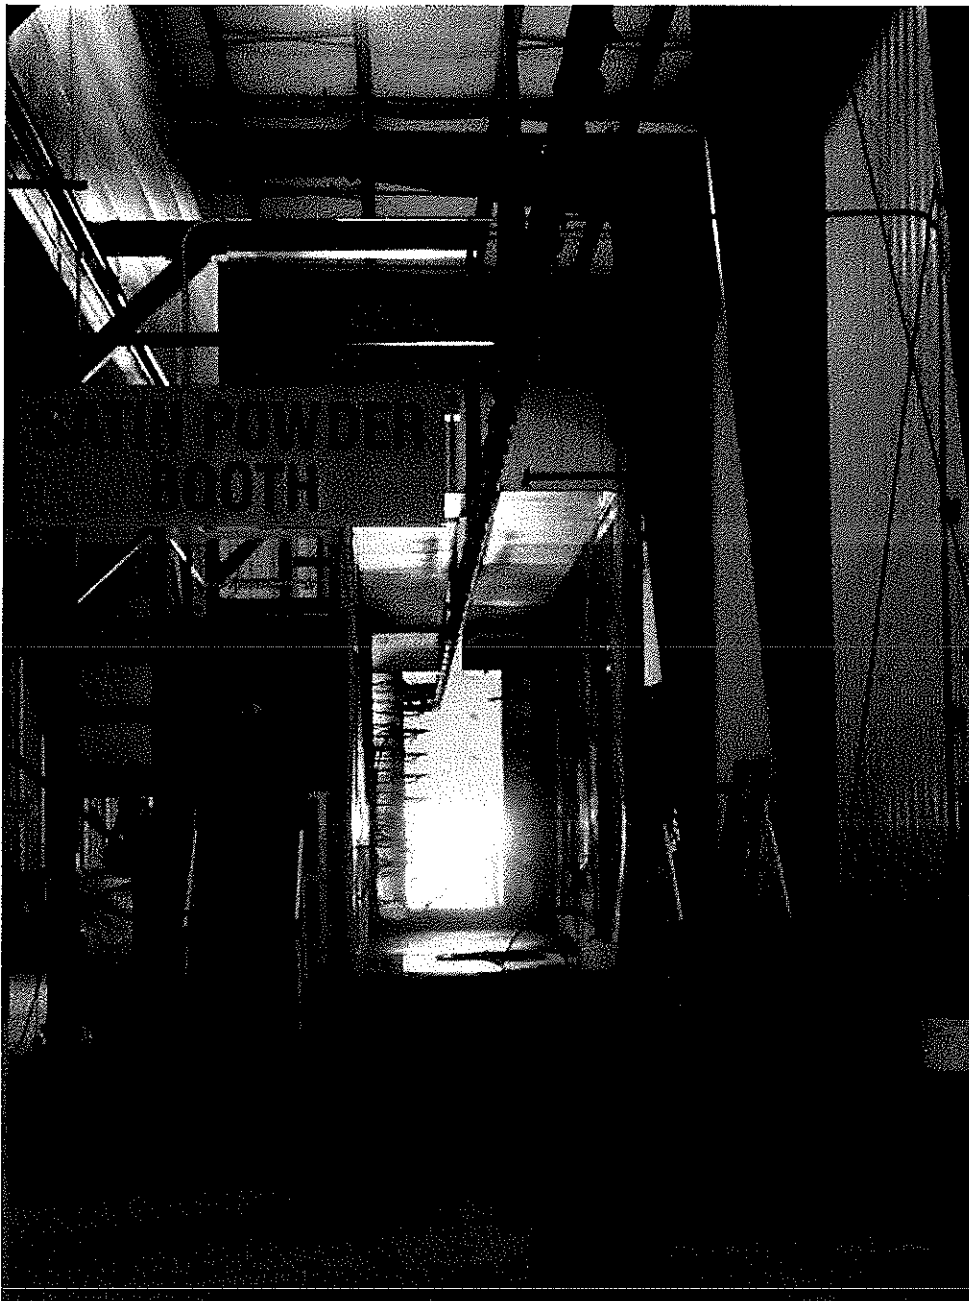
The powder coating booths and its associated curing oven are exempt under Rule 287(2)(d). Both booths appear to be vented to the general in-plant environment, I did not observe any ventilation or stacks originating from these booths. (see attached photos for both booths)

Image 2(Satin Booth) : Satin Powder Coat booth. No stacks for venting to outside

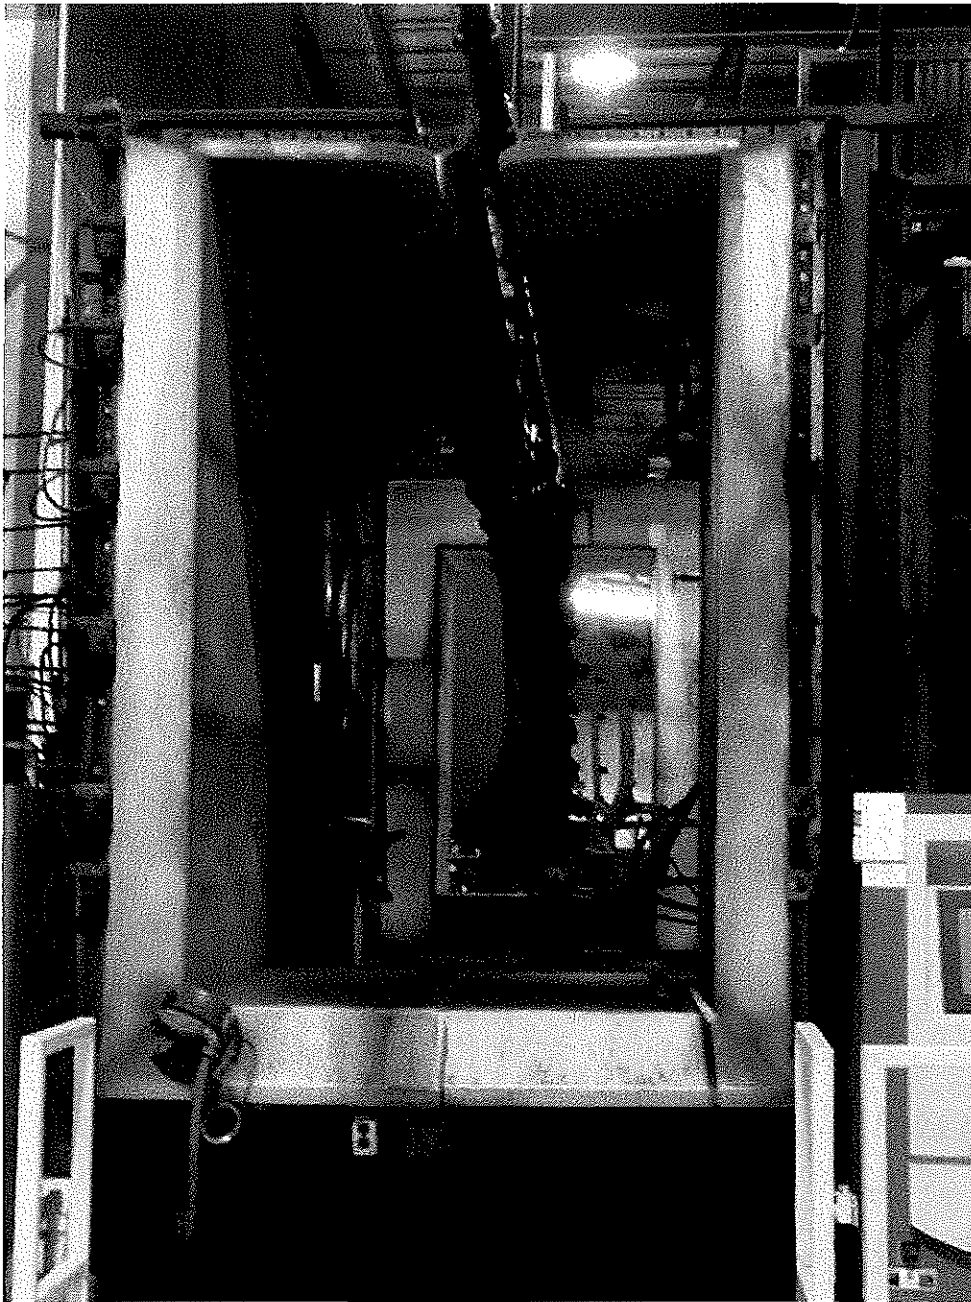
Image 3(Textured Booth) : Textured Powder Coat booth. No stack connected to this booth.

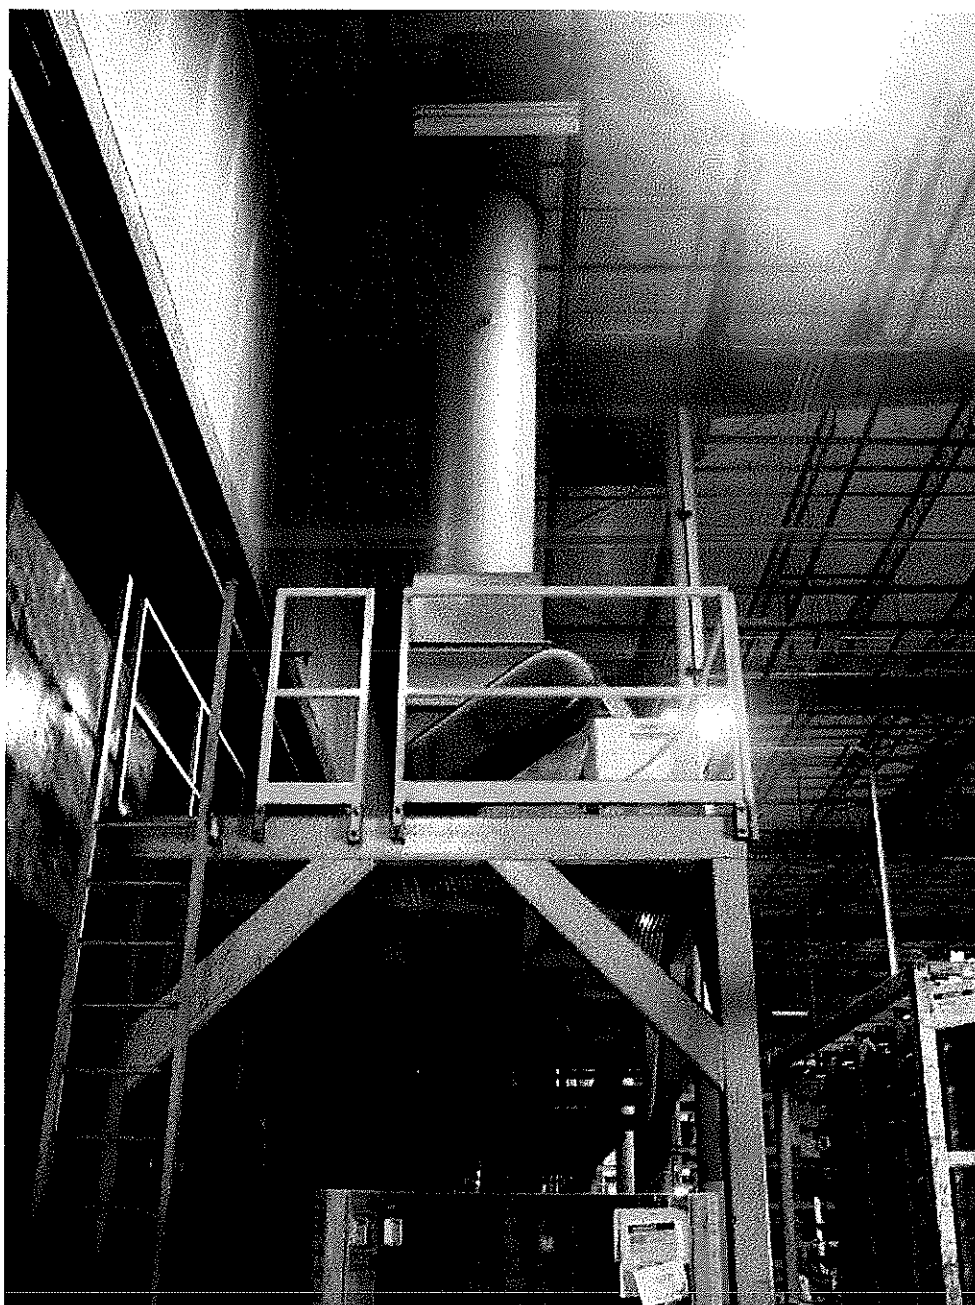
The mist eliminator system is required to be installed and operating properly and equipped with properly designed hooding and ductwork to control the emissions from the acid tank (see attached for photos of the mist eliminator system). J. Limon said that in order to ensure that the mist eliminator is operating when the entire system is operating they have installed a safe check which is connected to a switch on a pump that is connected to the mister. He said if the mister stops, the pump shuts the entire system down. He also said that the amount of water they push to the misters is calculated based on the acid usage. Based on this information MetoKote appears to be in compliance with mist eliminator operation and design requirements.

Image 4(Mist Eliminator) : Mist eliminator with stack, side view

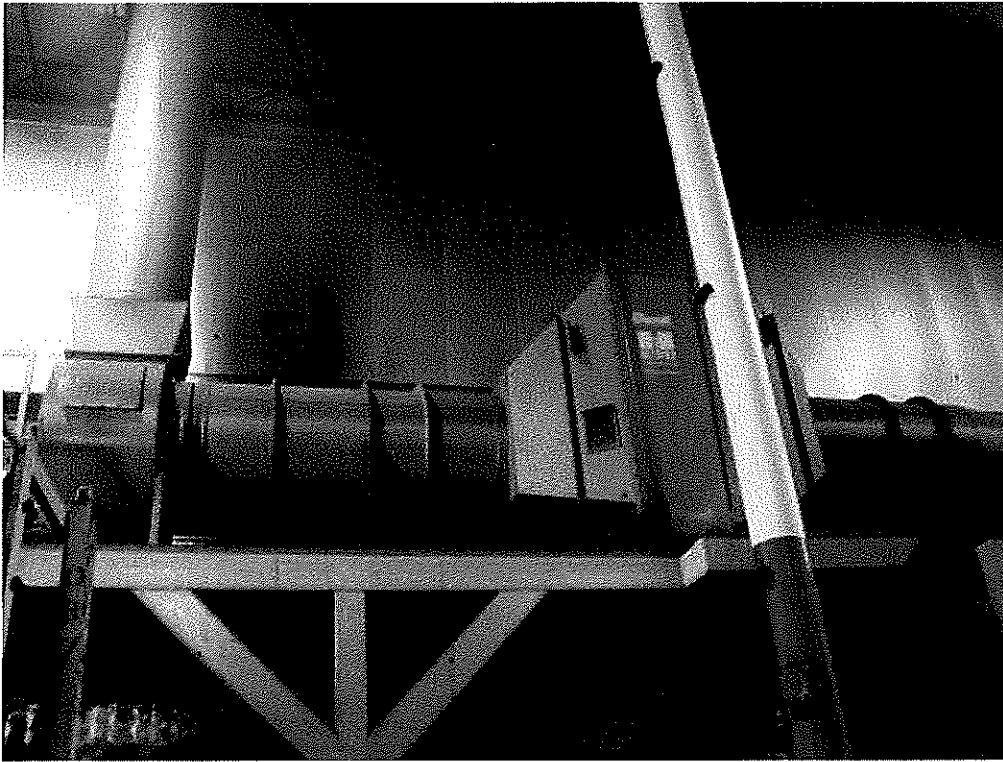
Image 5(MIst Eliminator) : Longitudinal view of mist eliminator system with stack

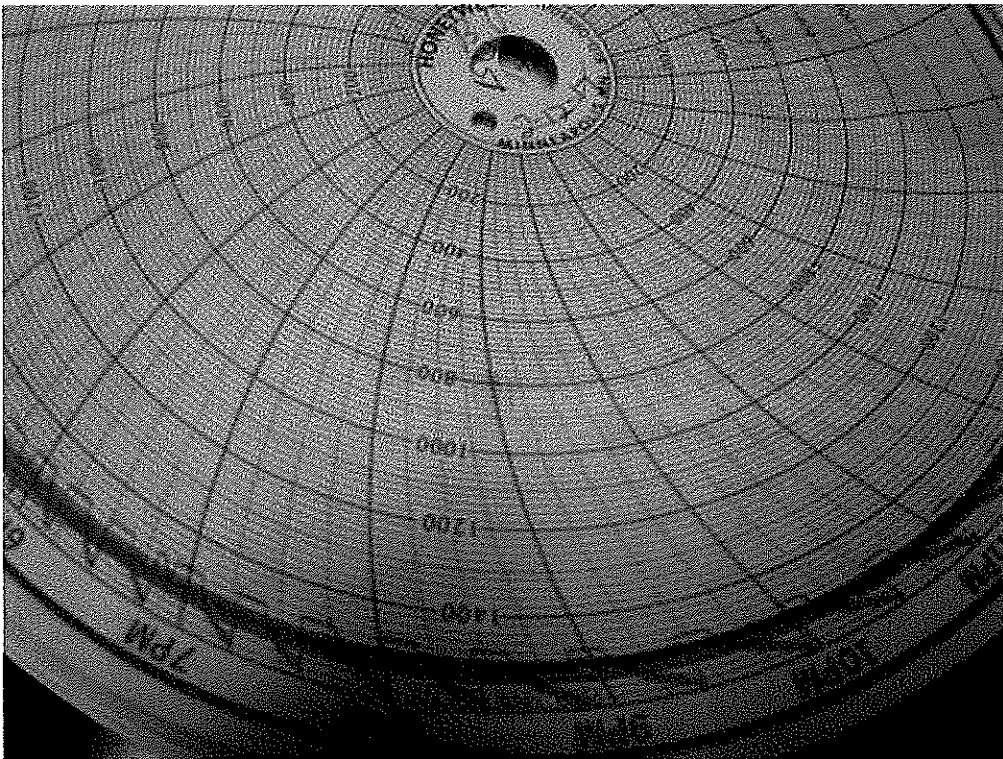
The afterburner is required to be installed, maintained and operated in a satisfactory manner, where satisfactory operation includes maintaining a minimum of 1400°F in the afterburner. J. Limon said that Technical Maintenance Inc (TMI) calibrates the unit annually (as required under the permit's "Monitoring" requirements). The recent calibration I noted during the inspection was 1/9/2017, where TMI also documented that the next calibration was due 1/9/2018. This would currently ensure that the afterburner was being operated in a satisfactory manner by ensuring that the temperature readout was accurate. Additionally, J. Limon said that they keep spare parts: for example spare parts for the igniter are kept because they last ~1.5 years and MetoKote will change them every 6 months as part of their "predictive maintenance." The temperature is recorded on a continuous basis when the unit is running on a chart recorder (continuous monitoring is also required under the permit's "Monitoring" requirements), but there is also a digital readout display for the unit. He provided me with chart records from January and February 2017, which all indicated that temperatures were above 1400°F, consistently at ~1500°F (see attached photo for example of the chart record).

Image 6(Chart Recorder) : Continuous monitoring consistently at 1500F

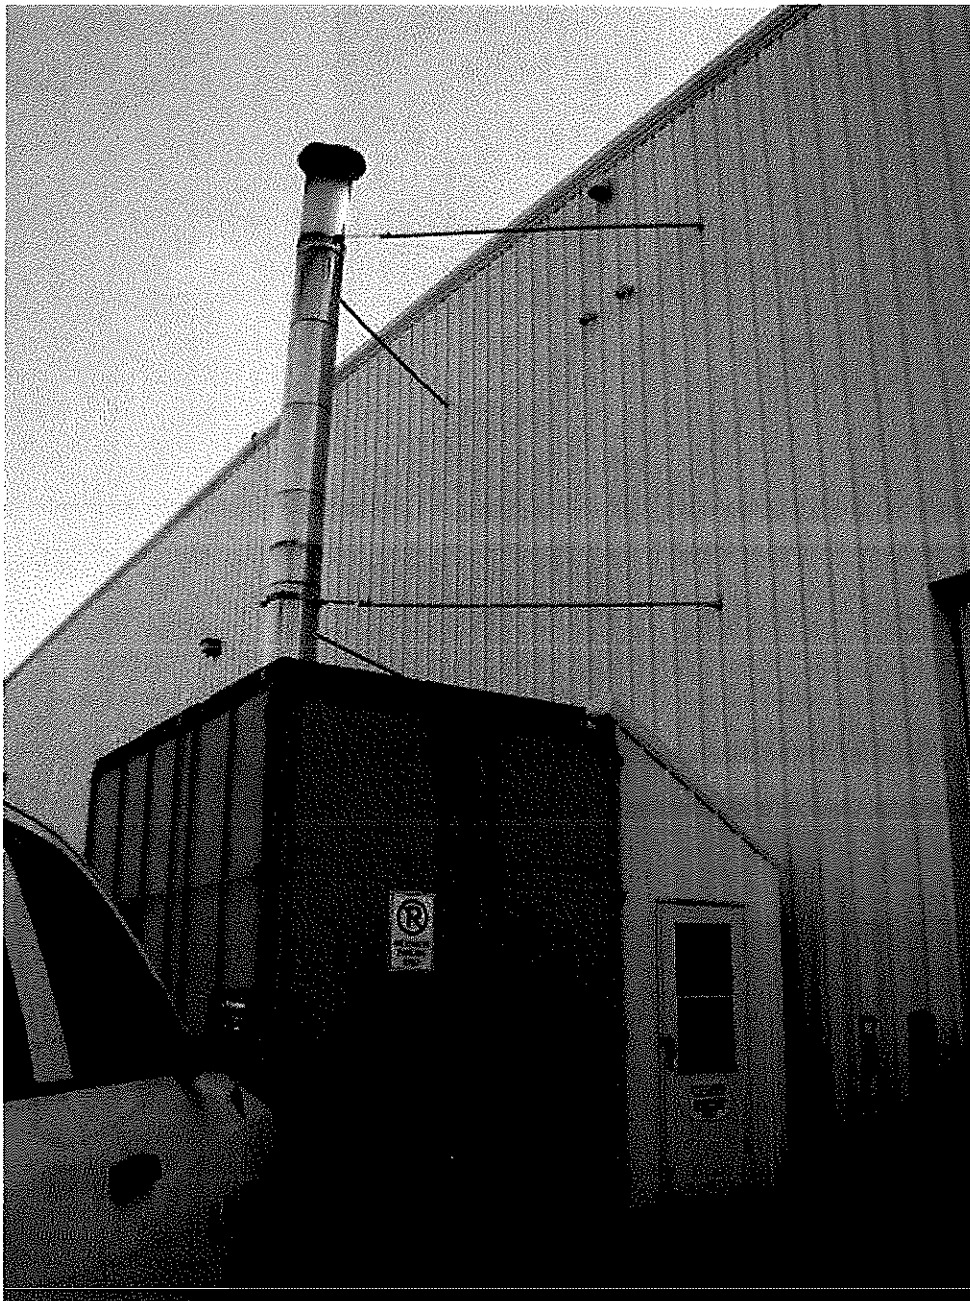
The exhaust gases from EUBURNOFF are to be discharged unobstructed vertically upwards to the ambient air with an exit point not less than 1.5 times the building height. Attached is a photo of the exterior burnoff oven with stack. From my vantage point it appeared that the stack was 1.5 times the stack of the burnoff oven building; however, although the stack was oriented vertically upwards, a raincap had been installed at the exit point of the stack. MetoKote is not meeting the general PTI requirement for the stack to be unobstructed. I have informed J. Limon that within 2 weeks of March 17, 2017 either the

Image 7(Burnoff Oven) : burnoff oven stack - note the raincap

raincap should be removed from the stack (verified by photo evidence), or the submittal of a site-specific Permit to Install for the burnoff oven be submitted to allow for an obstructed stack, otherwise a violation notice may be necessary.
