DEPARTMENT OF ENVIRONMENTAL QUALITY  
AIR QUALITY DIVISION  
ACTIVITY REPORT: Self Initiated Inspection

FACILITY: JOURNEY'S END PET SERVICES		SRN / ID: N7481
LOCATION: 8271 DUNN RD., MUNITH		DISTRICT: Jackson
CITY: MUNITH		COUNTY: JACKSON
CONTACT: Sandy Clark , Owner/Operator		ACTIVITY DATE: 04/07/2014.
STAFF: Sersena White	COMPLIANCE STATUS: Compliance	SOURCE CLASS:
SUBJECT: Announced inspection in conjunction with Jackson County Health Department.		
RESOLVED COMPLAINTS:

Purpose of the inspection is to determine compliance with Federal and State of Michigan Air Quality regulations, namely permit to install 119-05 issued on May 31, 2005.

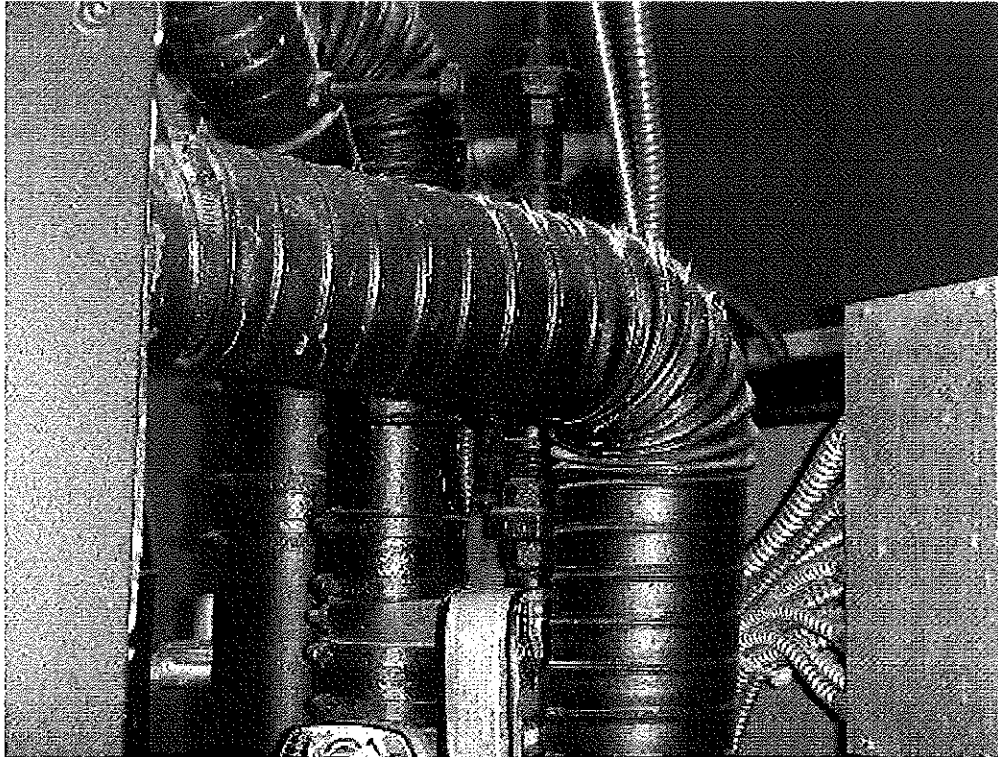
Image 1(Ductwork of unit) : Photo showing wear of ductwork on unit. Photo taken 4-7-2014

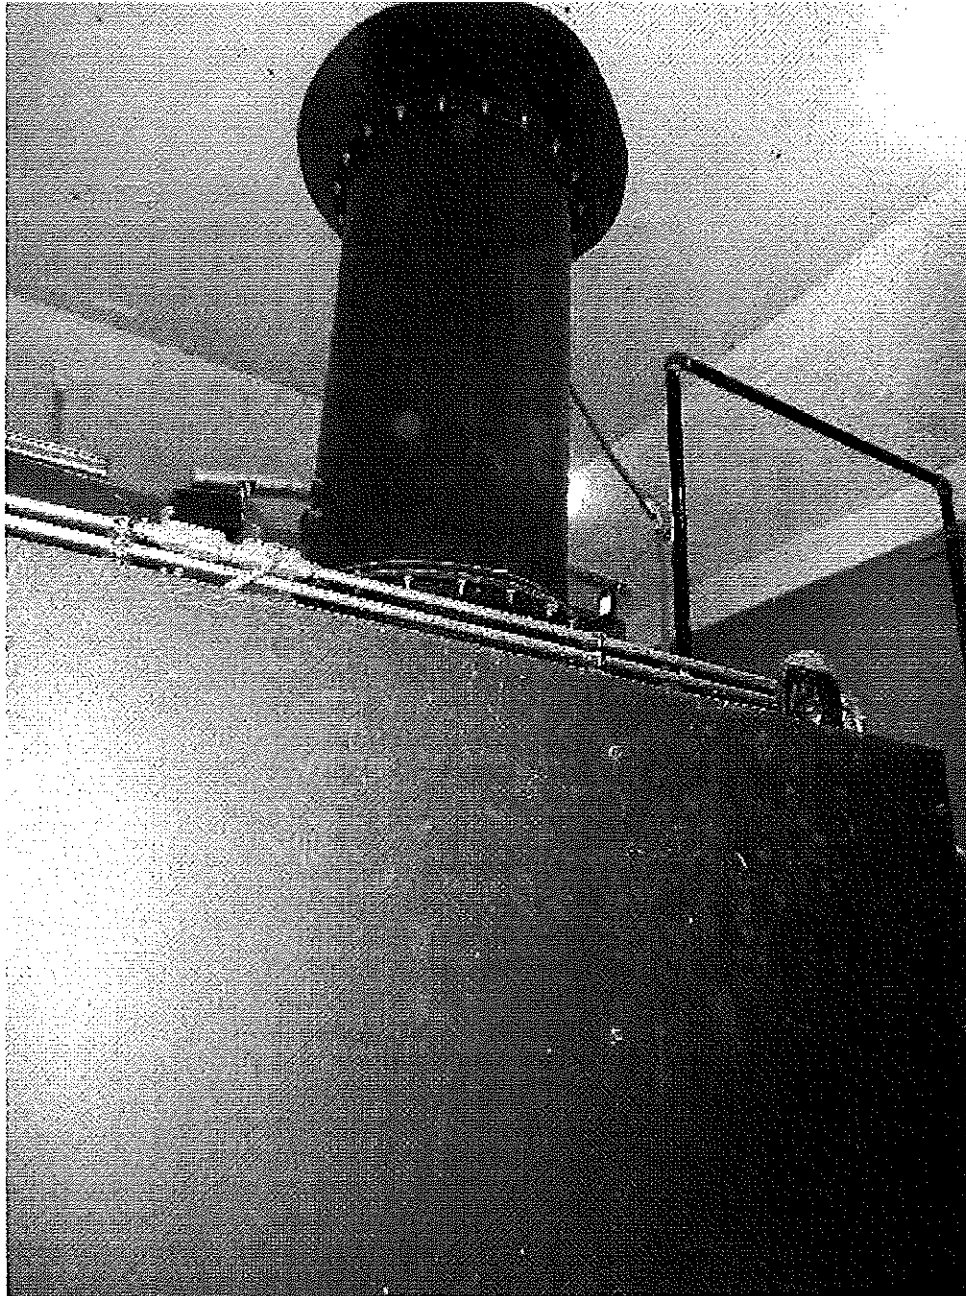
**Image 2(Stack dimension)** : Photo of stack exhaust going through ceiling. Taken 4-7-2104

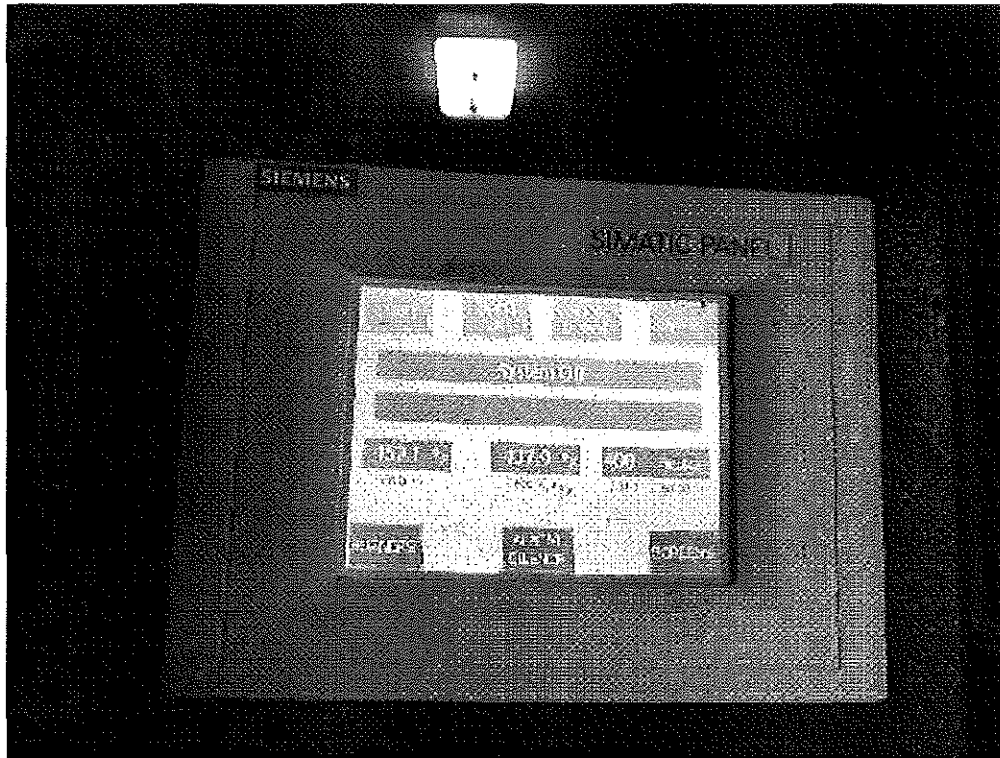
**Image 3(Control Panel) :** Photo shows information on control panel of the unit. Taken 4-7-2014

She took us behind the building where the incinerator is located to show us where she stores bagged animals in freezers. At the time of our inspection there was only one more animal to be cremated. We went into the building where the incinerator is located and it was going through a cool down stage due to a recent cremation. I took photos of the unit and the circular chart area which showed no chart. She explained to me later when she provided the records, that she removes the charts after a certain point because the ink will blot on the chart due to slower changes in temperature. The charts show this occurring. Another photo shows that part of a hose is showing wear and will need to be repaired in the future. A photo of the exhaust stack through the ceiling with clearance from the walls shows that the diameter appears to meet the permit requirement of 19 inches maximum. The height of the stack also appears to meet the minimum height of 15 feet above ground level based on the height of the ceiling in the building and the roof height. A photo of the digital readout of the process shows the current temperature of the primary and secondary chambers and the number of minutes remaining for the cremation.

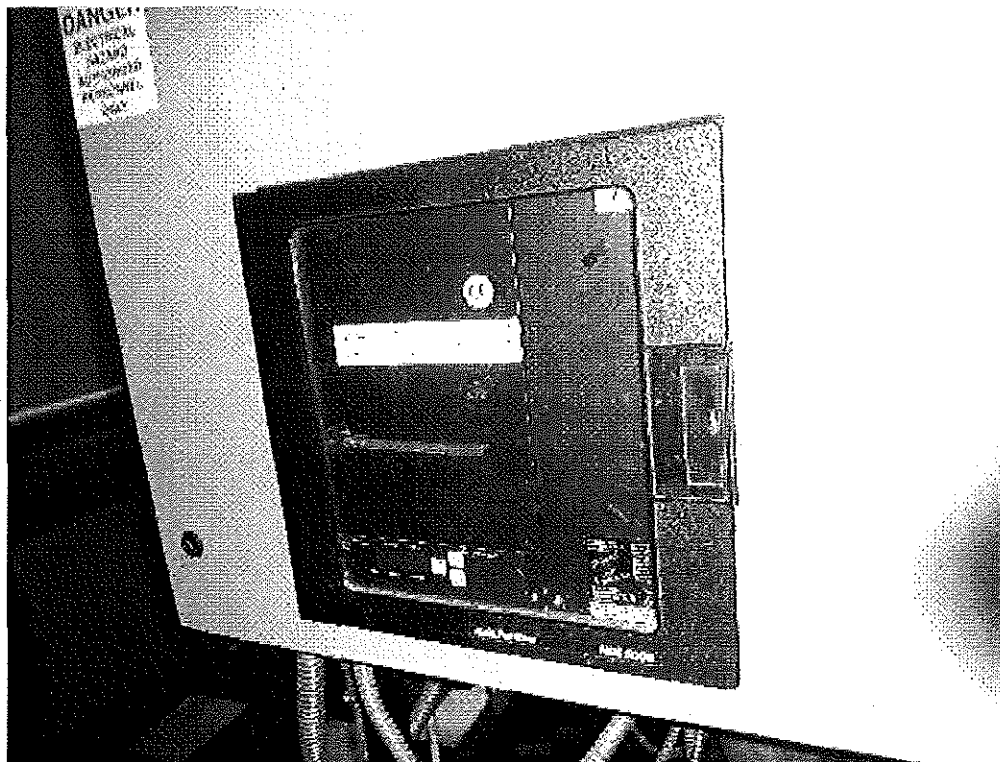
**Image 4(Temperature Chart) :** Photo shows where the temperature chart recording occurs. The chart had been removed due to blotting of ink during the cool down stage. Taken 4-7-2014

Based upon the records received, the unit met the minimum temperature of 1600 degrees Fahrenheit during the process including documenting the dates and weights.
