DEPARTMENT OF ENVIRONMENTAL QUALITY
AIR QUALITY DIVISION
ACTIVITY REPORT: Scheduled Inspection

FACILITY: CHELSEA MILLING CO.		SRN / ID: N7626
LOCATION: 201 W. NORTH ST, CHELSEA		DISTRICT: Jackson
CITY: CHELSEA		COUNTY: WASHTENAW
CONTACT: Randy Kepple , Plant Engineer		ACTIVITY DATE: 09/12/2017
STAFF: Mike Kovalchick	COMPLIANCE STATUS: Compliance	SOURCE CLASS: MINOR
SUBJECT: Inspection of a grain elevator, flour mill and mix plant.		
RESOLVED COMPLAINTS:

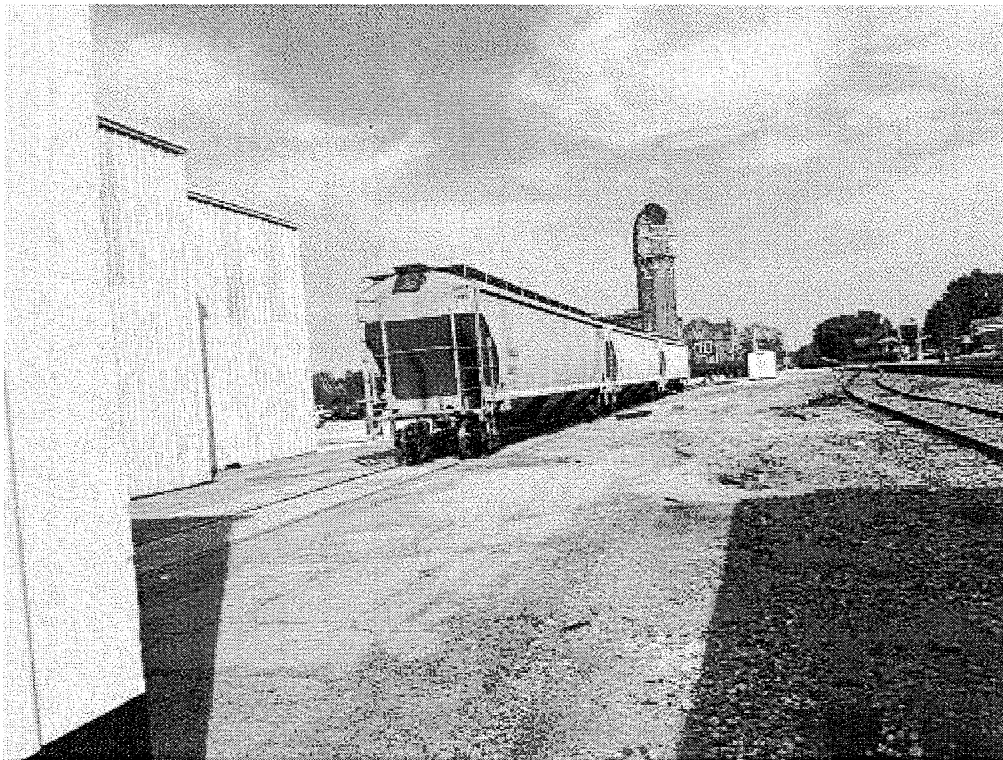
RK showed me the truck unloading bay. See attached photo. He indicated that 99% of the materials come in via trucks with some corn/sugar coming in by rail. The rail cars are brought inside and product is transferred out of it pneumatically. No dust was seen.

Image 3(Train car unloading) : Train car unloading

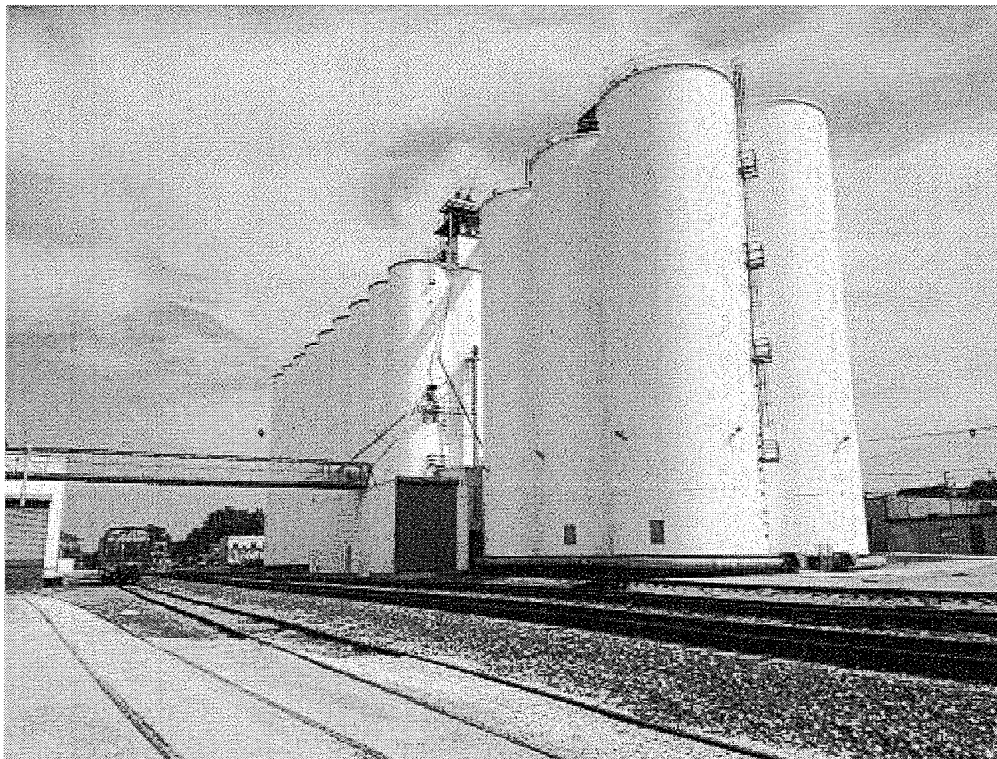
RK showed me 6 storage silos that had been added to the grain elevator storage area. He said that they had lost a lot of capacity as the interstices area in between the original cylindrical storage silos were cracked and no longer judged safe for storage. See attached photo.

Image 6(New storage silos) : New storage silos associated with grain elevator.

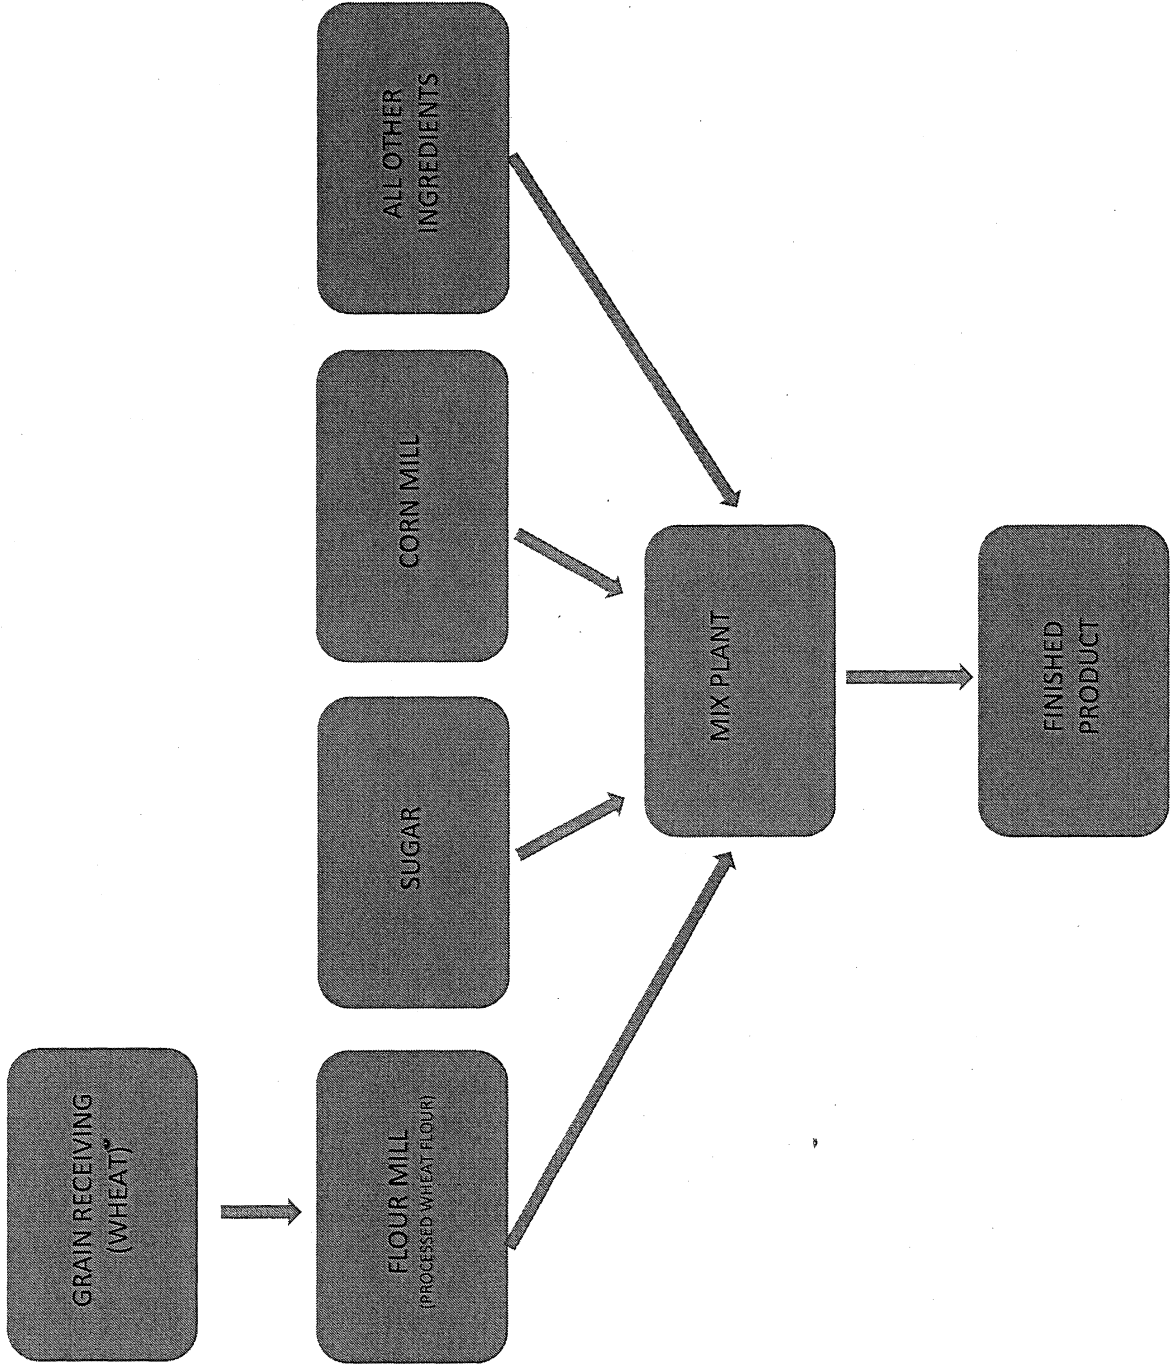
Attachment (1)

transferred to the new building and most of the new potential mixing capacity will not be installed until new business is brought in. The old 50 pound dry mix process has been mothballed. This new process will not increase the throughput through the grain storage elevator as the capacity of the flour mill hasn't been increased. (Attachment 1 shows a basic flow diagram of the facility.)

Chelsea Milling Flowchart
