DEPARTMENT OF ENVIRONMENTAL QUALITY
AIR QUALITY DIVISION
ACTIVITY REPORT: On-site Inspection

FACILITY: BORDINE NURSERY		SRN / ID: N7799
LOCATION: 9100 TORREY RD, GRAND BLANC		DISTRICT: Lansing
CITY: GRAND BLANC		COUNTY: GENESEE
CONTACT: Brian Parker , Vice President		ACTIVITY DATE: 05/14/2021
STAFF: Daniel McGeen	COMPLIANCE STATUS: Non Compliance	SOURCE CLASS: MINOR
SUBJECT: Scheduled inspection of facility most recently inspected by AQD in 2013.		
RESOLVED COMPLAINTS:

On 5/14/20201, the Michigan Department of Environment, Great Lakes, and Energy (EGLE), Air Quality Division (AQD) conducted a scheduled inspection of Bordine Nursery's wood-fired boiler. This facility was last inspected by AQD in 2013.

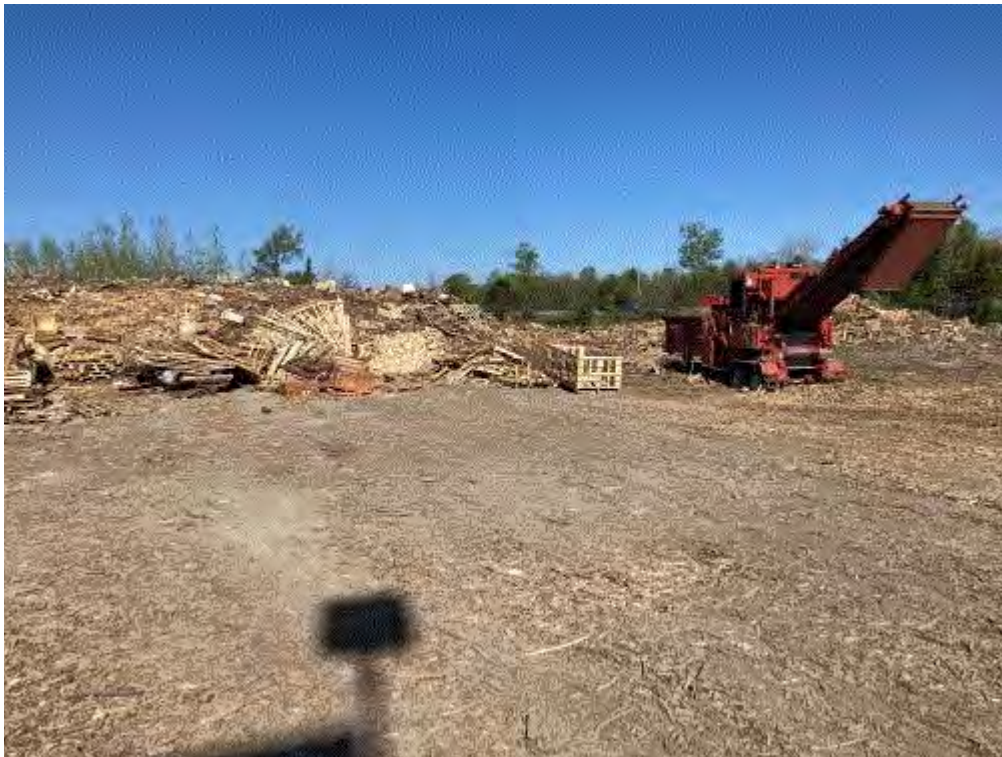
Mr. Hric explained that they pick up any pieces of plastic or metal before they bulldoze the wood waste. It is my understanding that they use a wood chipper to grind the wood waste into a small enough size to feed the boiler. This unit is also shown in photo 001. It can be considered exempt from needing an air use permit under Michigan Air Pollution Control Rule 285(2)(gg) as long as it only processes wood or wood residues which are not demolition waste materials.

Image 1(001) : Wood chipper to right of wood pile.

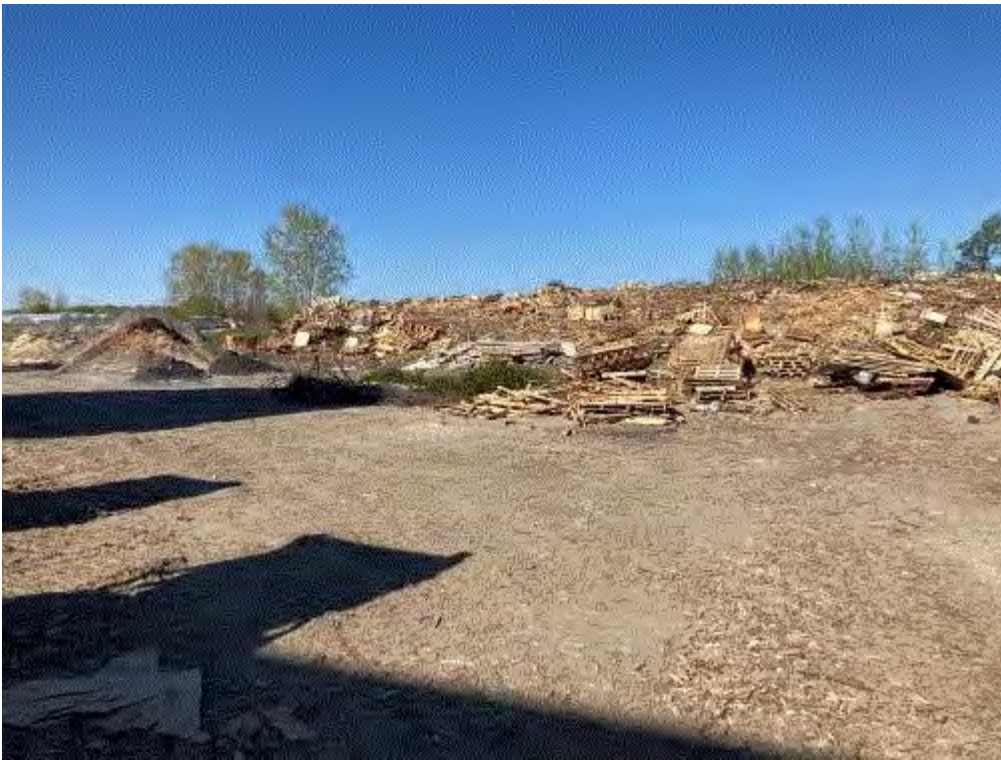
I did not see any painted or treated wood. The overall wood pile is shown in photo 002, with the ash pile to the far left.

Image 2(002) : Wood pile, with ash pile at far left.

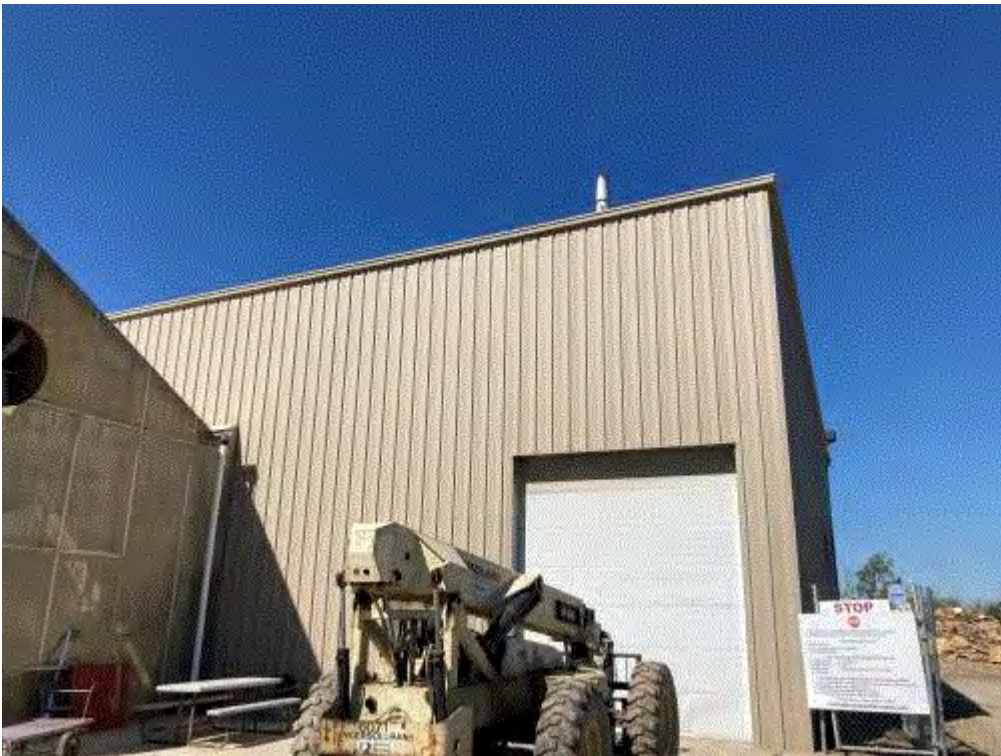
There were no visible emissions witnessed at any time from the boiler exhaust stack during the inspection. Please see photo 003, of the boiler exhaust stack.

Image 3(003) : Boiler exhaust stack, with no opacity.
