DEPARTMENT OF ENVIRONMENTAL QUALITY  
AIR QUALITY DIVISION  
ACTIVITY REPORT: On-site Inspection

<b>FACILITY:</b> SUPERIOR ASPHALT INC	<b>SRN / ID:</b> N8295
<b>LOCATION:</b> 6900 EAST PARIS INDUSTRIAL, CALEDONIA	<b>DISTRICT:</b> Grand Rapids
<b>CITY:</b> CALEDONIA	<b>COUNTY:</b> KENT
<b>CONTACT:</b> Jeff Kresnak , Owner	<b>ACTIVITY DATE:</b> 10/29/2020
<b>STAFF:</b> April Lazzaro	<b>COMPLIANCE STATUS:</b> Compliance
<b>SUBJECT:</b> Unannounced, scheduled inspection.	<b>SOURCE CLASS:</b> SM OPT OUT
<b>RESOLVED COMPLAINTS:</b>

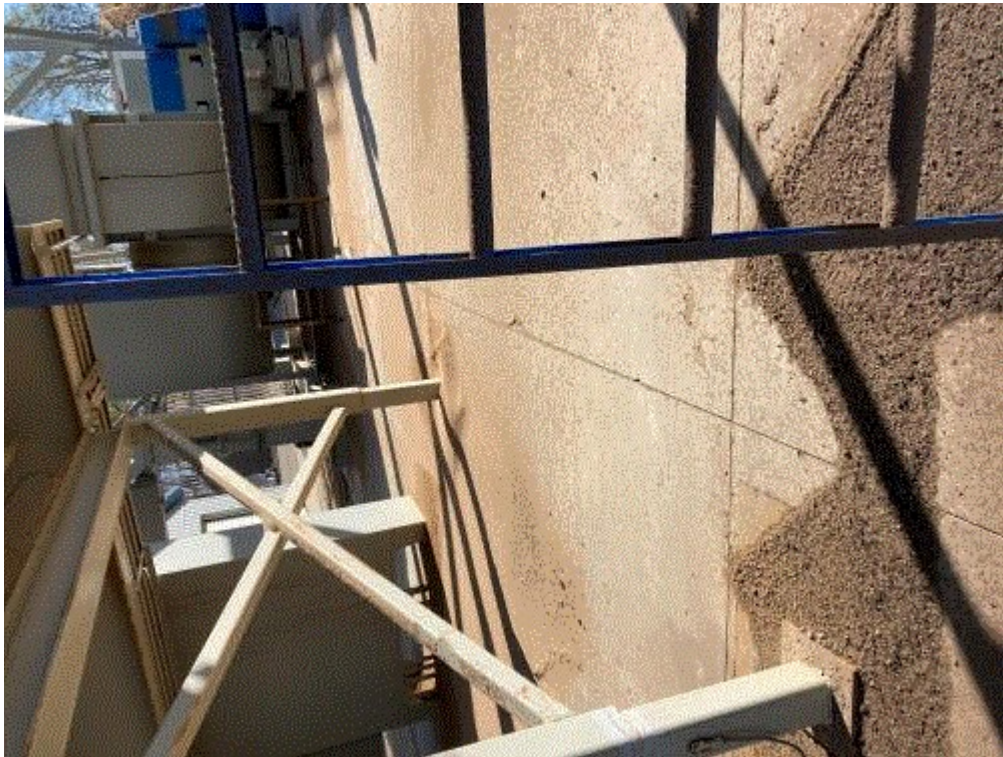
Appendix A also addresses fugitive emissions from process equipment and fabric filter dust collector. I identified a concern regarding fugitive emissions from process equipment during the inspection. The area where aggregate materials (sand/stones) are fed into the drum via conveyor is called the slinger and is considered part of the transfer system. The slinger had a significant amount of sand being emitted as fugitive emissions.(see photos at end of report) Per my request, the facility will work with the drum manufacturer (Gencor) to evaluate whether improvements can be made in this area.

**Image 1(Sand and aggregate)** : Accumulation of sand and aggregate from slinger.

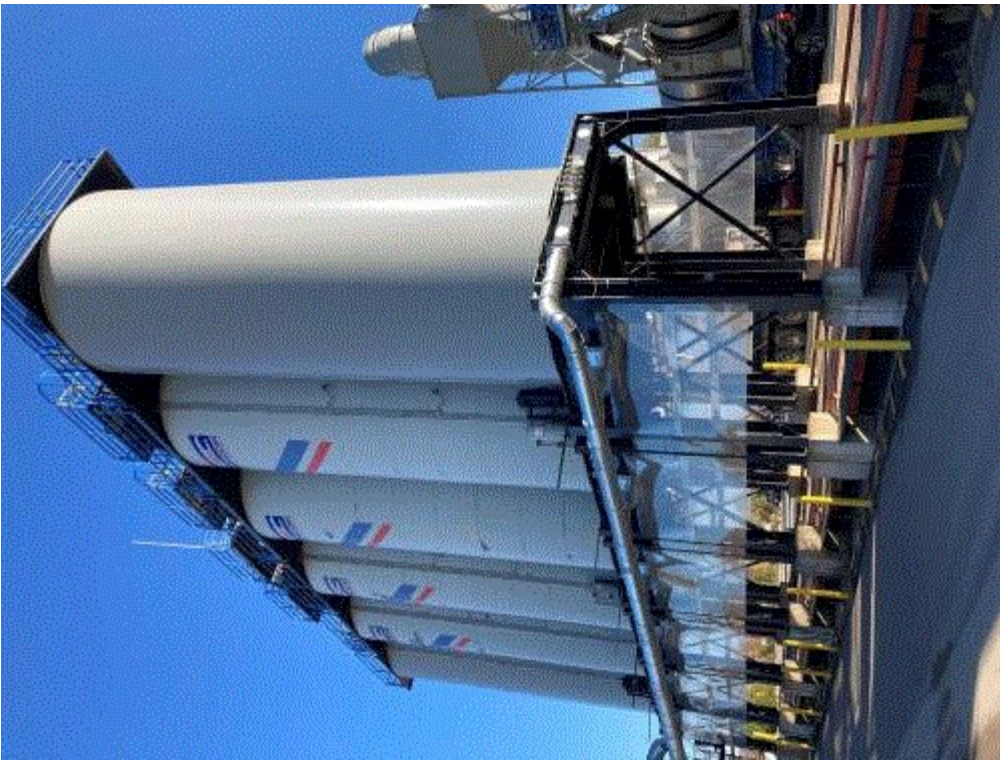
The PMP required by Appendix B was reviewed and includes maintenance and inspection activities for the asphalt load-out control system. The system consists of plexi glass sides that extend from the bottom of the silos to a minimum of five feet above the top of the road grade. I inspected the enclosure and found it to be acceptable and meets the criteria listed above and in the permit. At the top along each of the sides of the enclosure are five air intake areas where load-out emissions are captured adjacent to the associated HMA silo dispensing area which are ducted to a media-type filtration system that has a short rectangular stack. According to facility staff, the media filters have not been replaced this year, and per the PMP they are to be replaced annually. Photos of the enclosure and media filtration box are included at the end of this report. Daily visual inspection of the enclosure is conducted as part of the daily facility walk around and recorded on the Daily Production Log tab of the spreadsheet. It is recommended that the company make note in their records of the days where the twice annual media inspection is conducted. The unit is not equipped with a pressure drop gauge which would be a good addition to monitor system performance.

**Image 2(Load-out Enclosure)** : Silo load-out enclosure with plexi-glass sides.

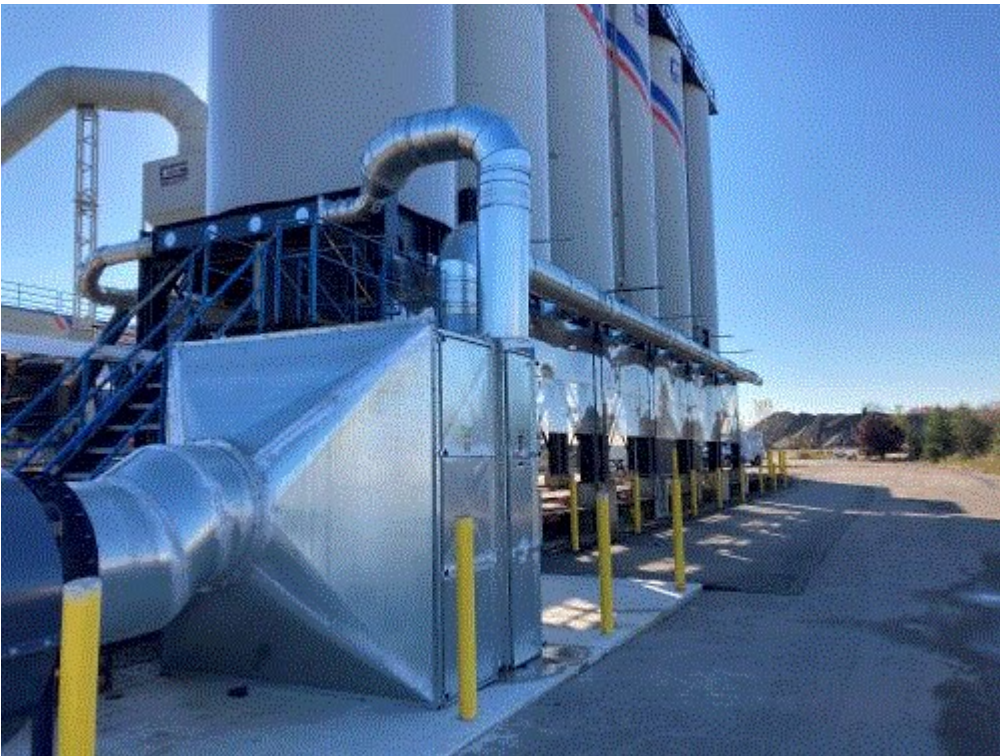
**Image 3(Media filtration box)** : Load-out control media filtration box.

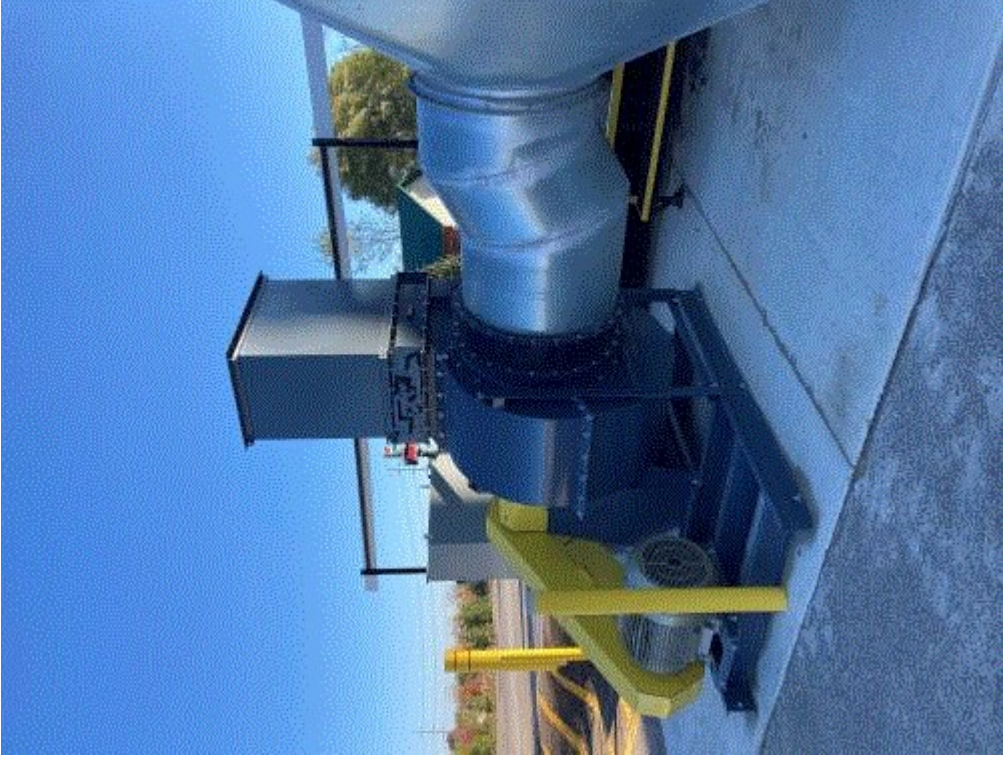
**Image 4(Load-out stack)** : Load-out media filtration stack.

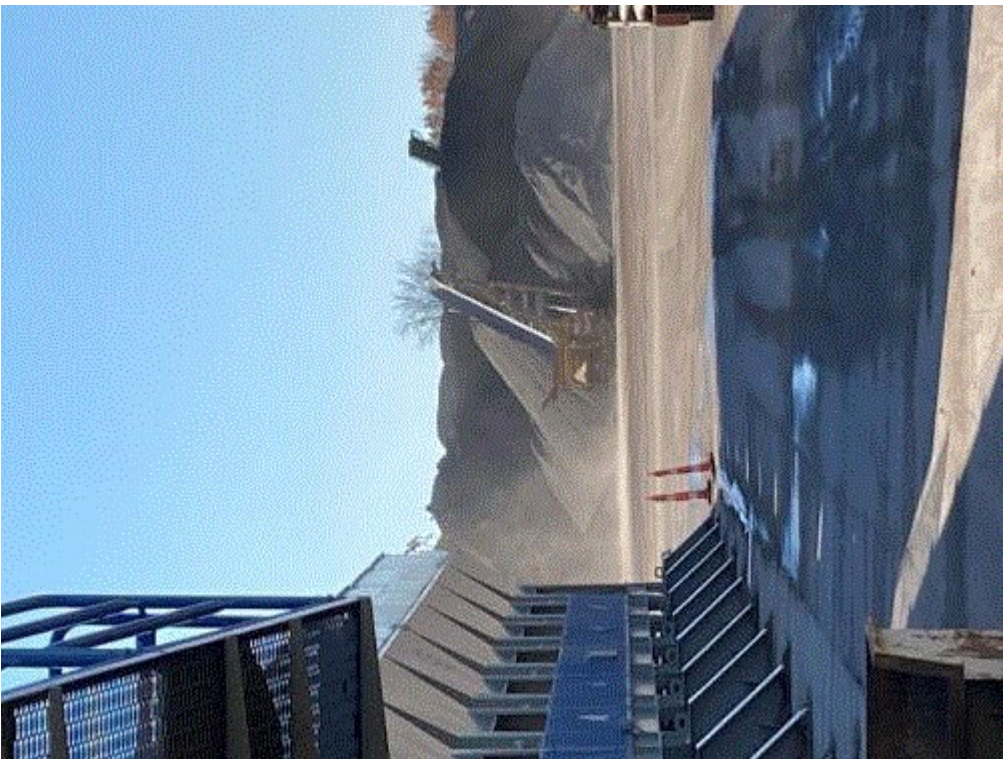
**Upon my arrival on Wednesday, it was quite windy with the wind out of the northeast. I observed that the vehicular traffic was creating fugitive dust at a noticeable level. I discussed this with plant personnel and with Jeff Kresniak, who addressed the issue immediately.**

The requirements of the FDCP were evaluated related to activities conducted by facility staff. During my review I noted that there were only 5 days where dust control measures were conducted through the entire 2020 season. As previously indicated, I requested dust control measures upon

my arrival at the facility because fugitive dust was being generated by truck traffic moving raw materials.

**Image 5(Yard fugitive dust)** : Fugitive dust observed from truck traffic.

**Upon my arrival on Thursday, the yard had been swept and watered, and no fugitive dust was observed.**

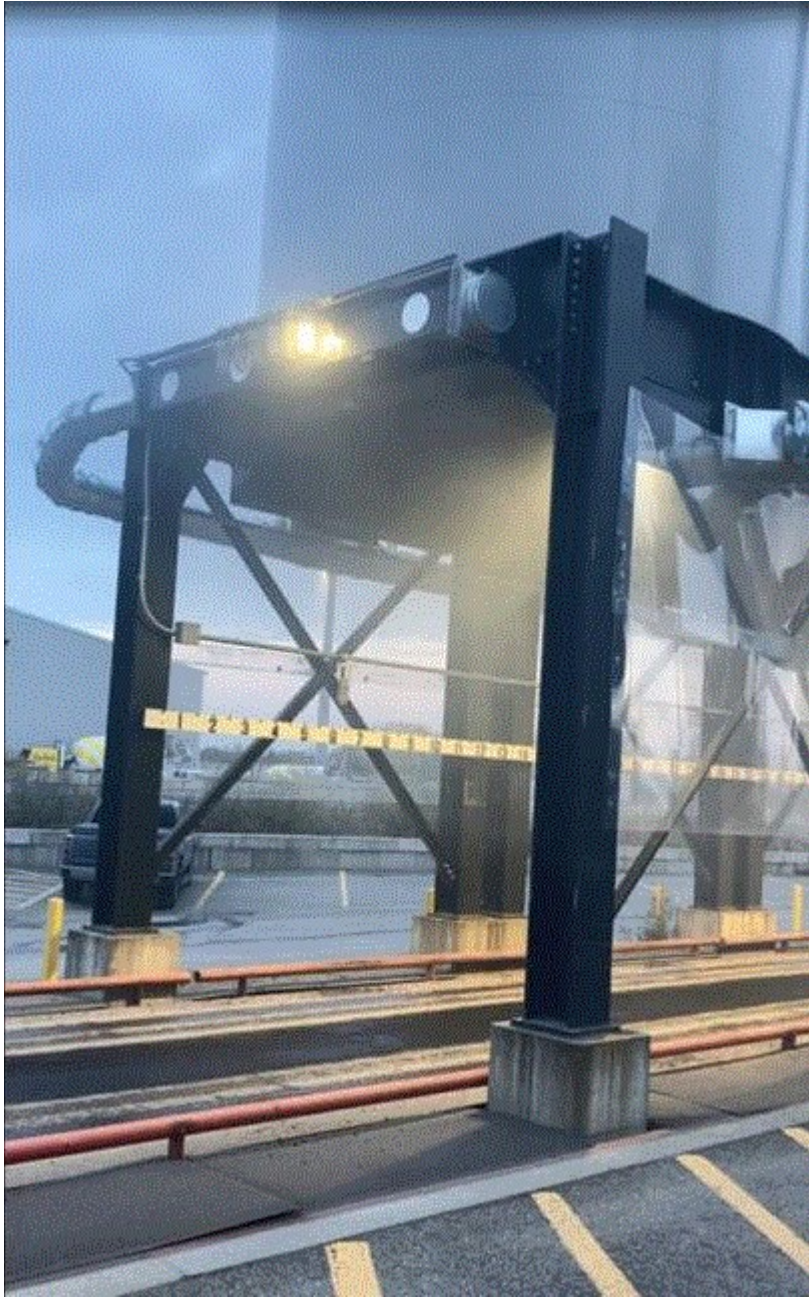
It is noted that the load out area and silos is visible to the operators, and any issues would be noticed immediately. During the inspection we discussed that the system appeared well engineered, however it was struggling to keep up with load out emissions due to the wind direction. It was noted by the operator that the system works very well, however today the wind speed was high and the wind direction atypical.

**The load-out control has been installed and is operating and appears to meet all criteria of the requirements in this section as discussed in the above section of this report. The wind direction was out of the north on the day of the inspection, it is noted that typical prevailing winds are out of the west. The load-out area is north/south oriented which is appropriate to reduce the chance of issues affecting capture. As discussed in the above section of this report, the design of the load-out control enclosure included sides that extended to five feet above the top of the road grade at the entrance to the scale. Due to the reduced capture observed as a result of the atypical wind out of the north, I asked the facility if they had considered wind blocking for the entrance and exit points. At this point, the facility is not considering wind blocking, and will monitor operations during the 2021 season.**

**Image 6(Load-out) :** Load-out occurring with north wind and short truck (truck not pictured)
