DEPARTMENT OF ENVIRONMENTAL QUALITY
AIR QUALITY DIVISION
ACTIVITY REPORT: Complaint Investigation

FACILITY: Target Trucking, LLC		SRN / ID: N8341
LOCATION: BOHNE RD, JACKSON		DISTRICT: Jackson
CITY: JACKSON		COUNTY: JACKSON
CONTACT:		ACTIVITY DATE: 10/16/2017
STAFF: Mike Kovalchick	COMPLIANCE STATUS: Non Compliance	SOURCE CLASS: MINOR
SUBJECT: Investigating dust complaints.		
RESOLVED COMPLAINTS:

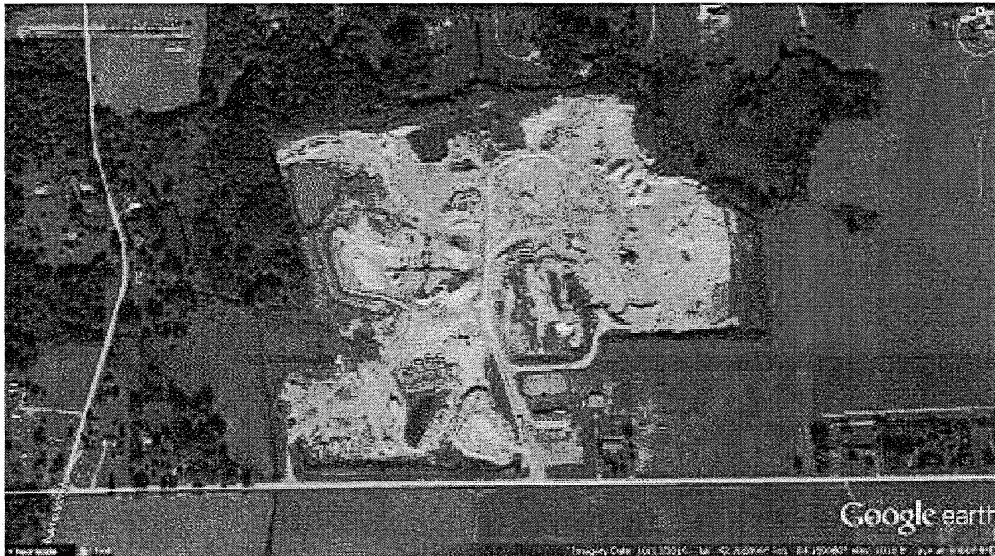
Image 1(Aerial photo) : Aerial photo of Target Trucking.

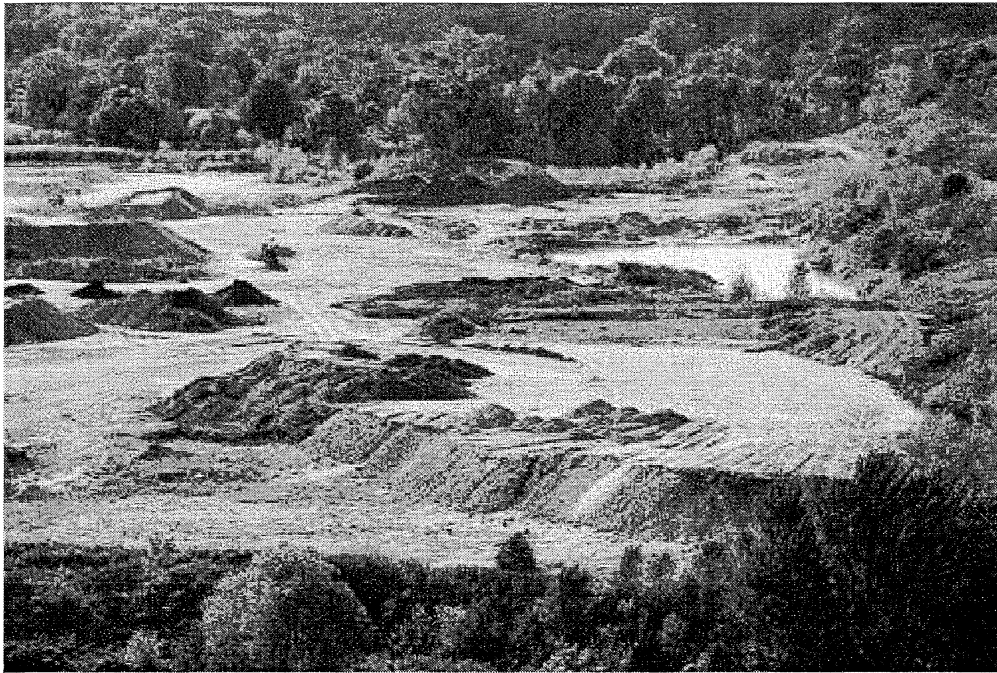
Image 2(Quarry 1 image) : One of 3 photos supplied by complainant.

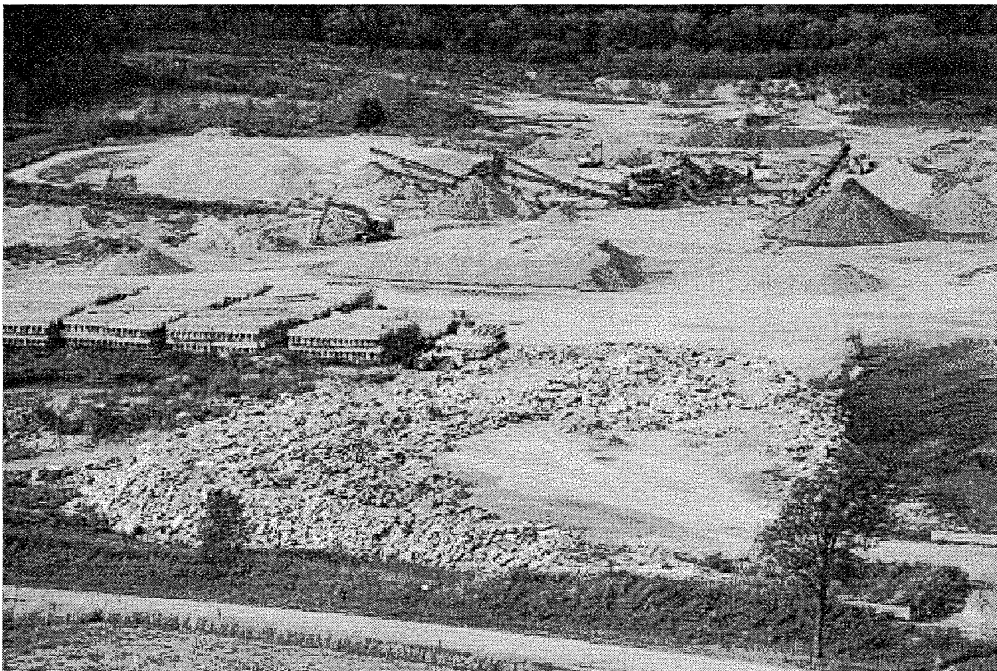
Image 3(Quarry Photo 2) : One of 3 photos supplied by complainant.

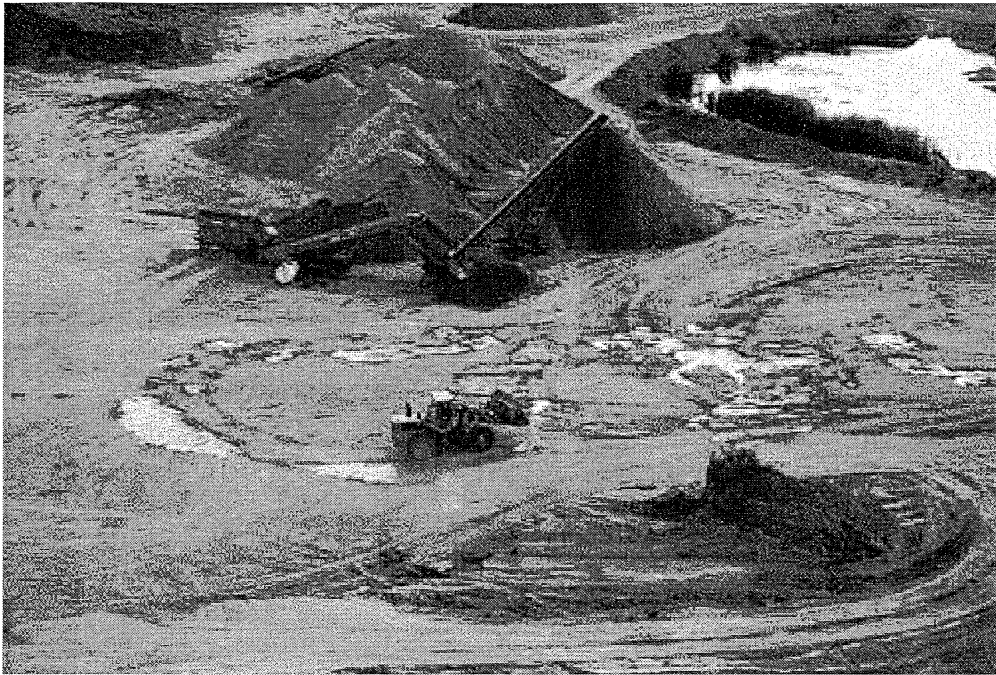
Image 4(Quarry photo 3) : One of 3 photos supplied by complainant.

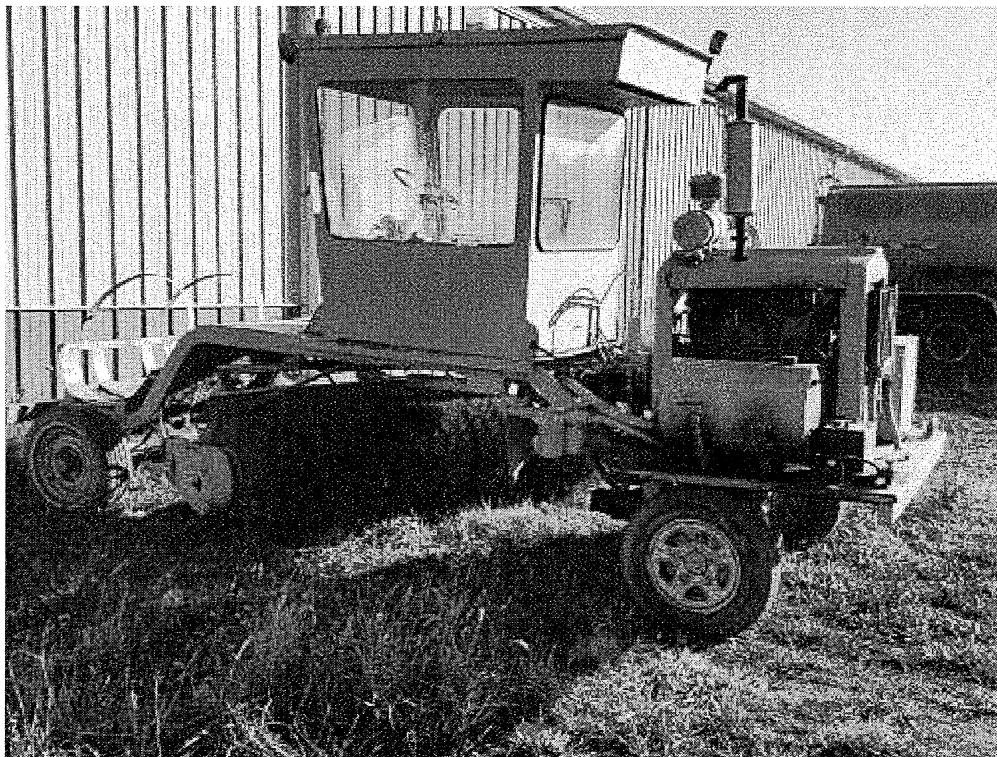
TB indicated that due to citizen complaints received over the Summer, the Company has acquired a sweeper truck to help minimize track out onto Bohne Road. They also contracted with Barney's out of Howell to come in twice over the last few months to apply a dust suppressant solution to the haul roads in and out of the quarry.

Image 5(Sweeper) : Sweeper that was purchased 2 or 3 months ago.

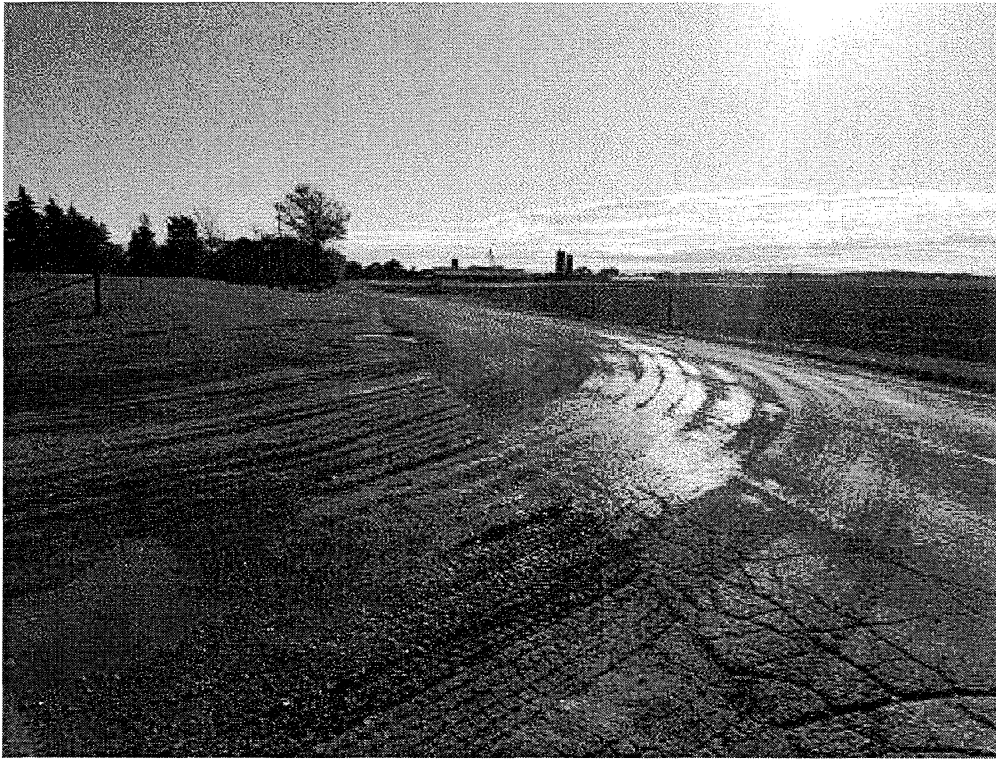
Overall, the facility appeared to be well maintained. No dust was noted anywhere although the ground was thoroughly soaked due to recent rains. Very minor amounts of track out was noted on Bohne road.

Image 6(Bohne Road) : Minor track out on Bohne Road

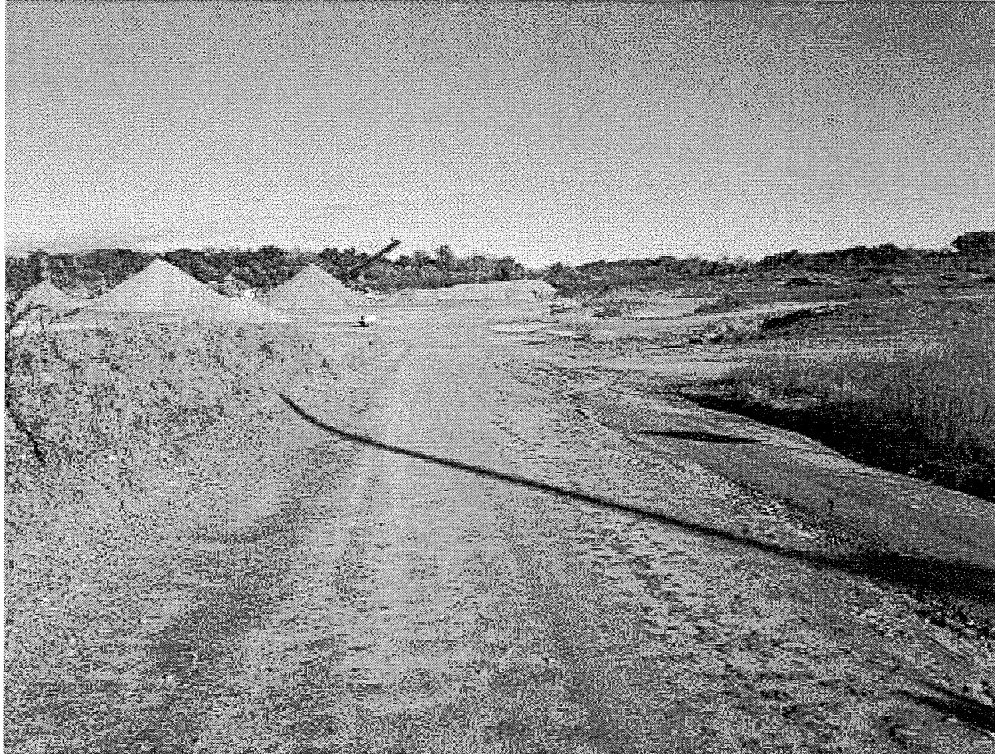
Image 7(Haul Road) : Sand haul road going into quarry.

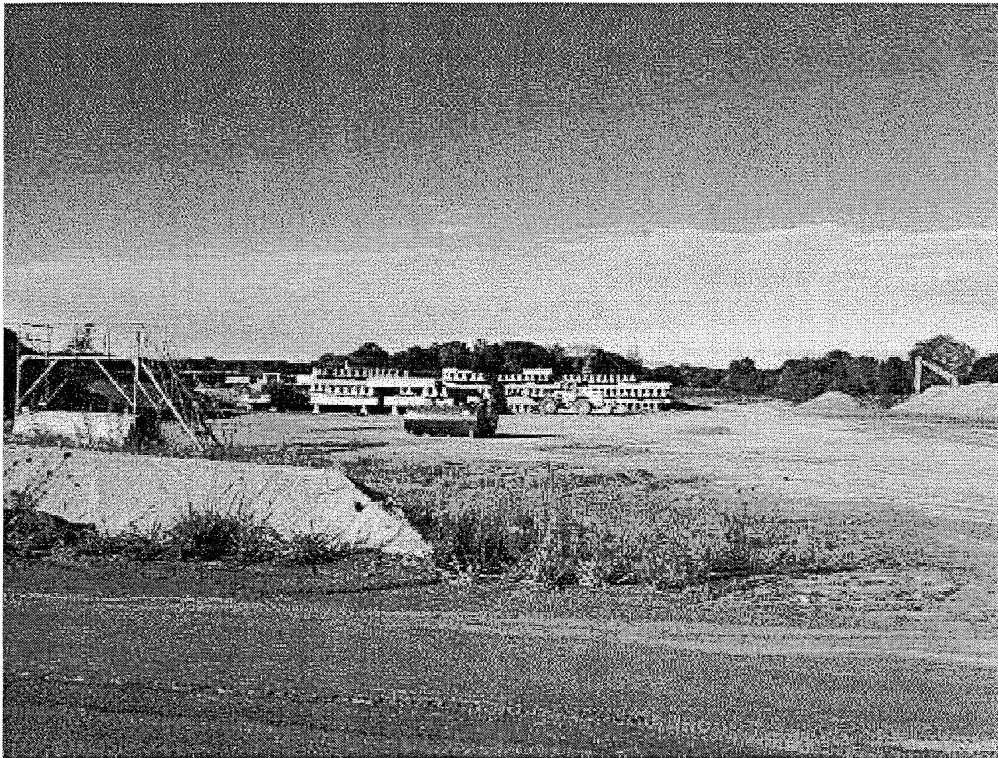
Image 8(Cement dividers) : Cement dividers owned by Bailey Sand & Gravel. Bailey is in the process of slowly removing them.

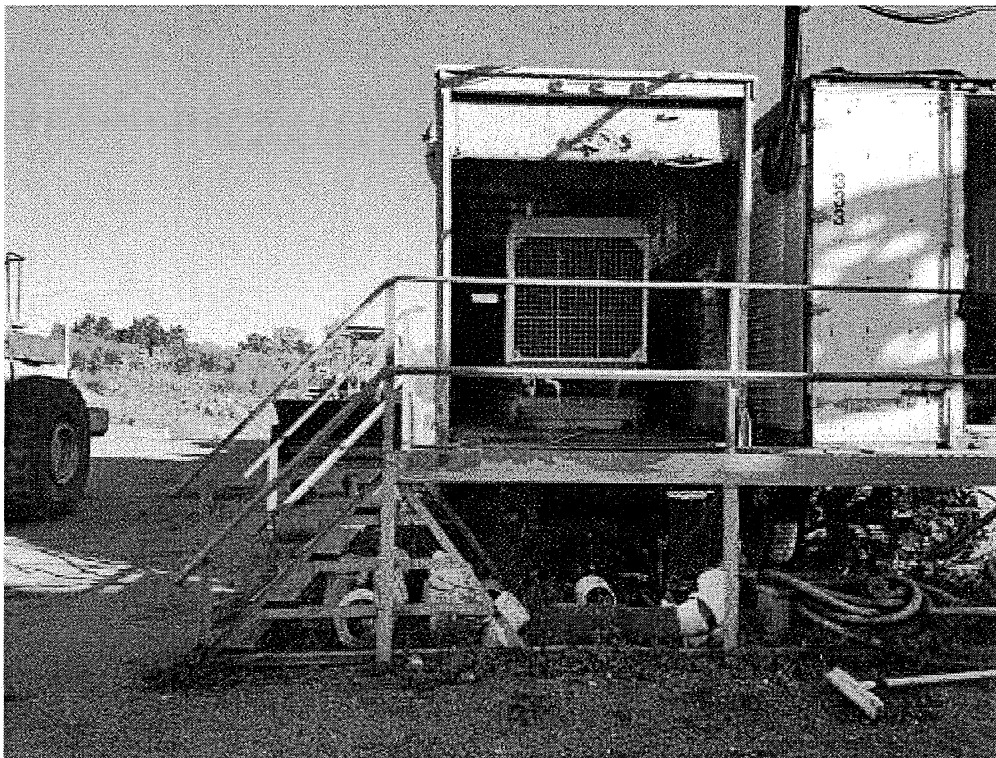
TB showed me the wash plant. The diesel engine that operates it was operating during the inspection but the wash plant wasn't on. TB estimated that diesel engine was about 300 hp in size. He didn't know how old it is was as it came with the property when they bought it. The engine had logged 9079 hours of operation. TB said they typically have it on 8 hours a day. It has a 250 gallon tank which is filled as needed every Monday. See attached photos.

Image 9(Diesel engine) : Diesel engine for wash plant.

I held a brief post-inspection meeting with TB. I noted to him that I would be sending him a letter regarding the 3 diesel engines since they are subject to federal RICE MACT requirements. I also indicated that I would require a fugitive dust control program if/when I can verify dust is negatively impacting nearby residents. I further indicated to him that rock crushing requires a permit. He said they are still investigating on whether they should purchase their own crusher unit and simply bring in a portable unit owned by somebody to take care of the concrete, asphalt and native stone. He said they are currently working with the township on some permitting issues related to the crushing.

40 CFR Part 63 Subpart ZZZZ (RICE MACT) for 3 diesel engines.

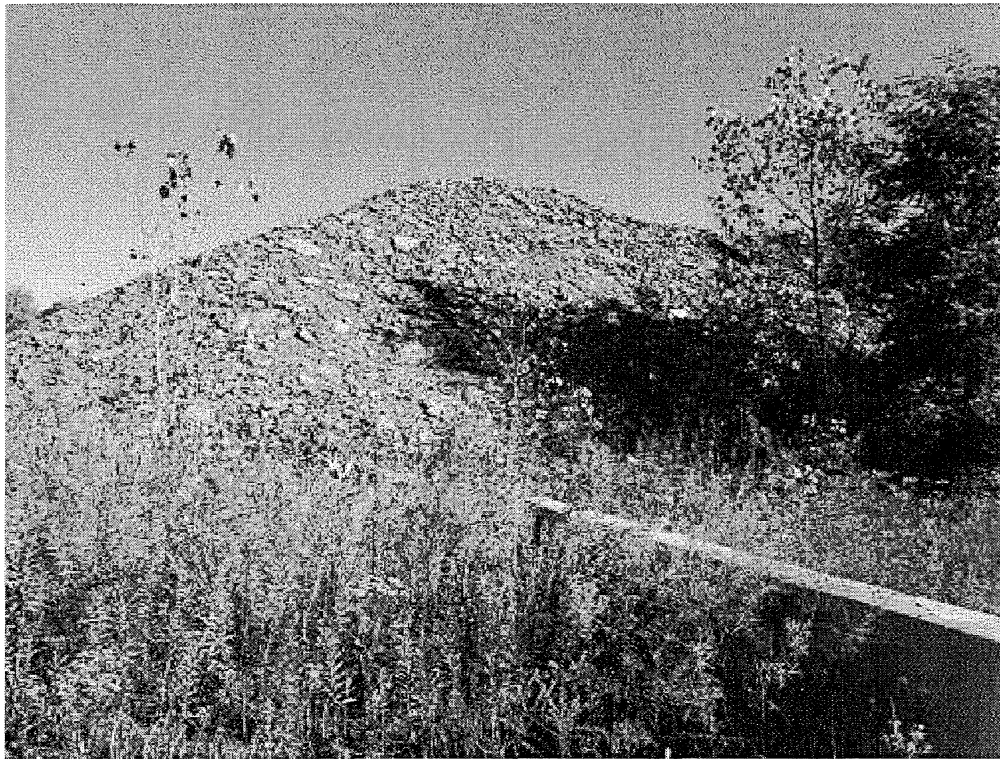
They also have a large pile of broken/waste concrete and another pile recycled asphalt material that is left over from the previous owner.(Bailey.) They have done little to these piles since they took over ownership.

Image 10(Recycled asphalt) : Recycled asphalt pile.

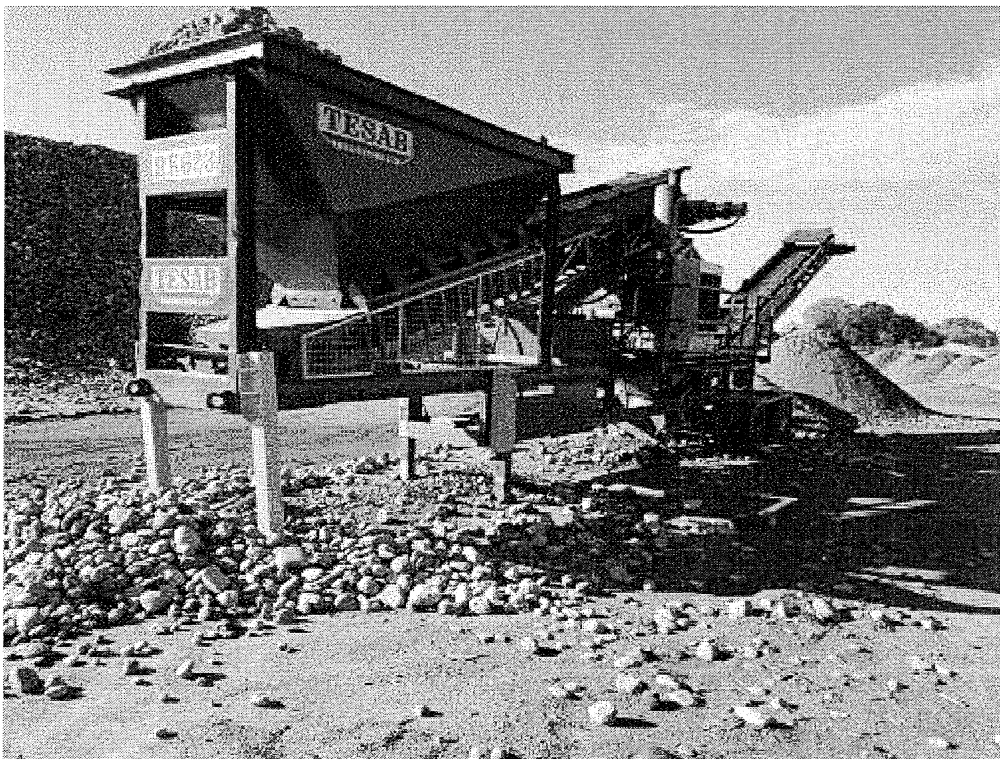
TB showed me a small portable rock crusher (less than 150 tons/hour capacity) powered by diesel engine that was located adjacent to a large pile of native rock. TB indicated that it had been site for 2 weeks but now the engine was broken. It was brought in by D & L Equipment as the Company was investigating the feasibility of crushing the large native stones that were essentially a waste product from the wash plant. A small pile of processed product was noted. TB indicated that crusher was not equipped with an operating water spray bar and wasn't being used on a production basis. (Note: Rule 283 exemption can't be used since crusher being operated without control device.)

Rule 201-No PTI for portable rock crusher.

Image 11(Rock Crusher) : Portable rock crusher. Note pile of finished product on the rock and large pile of uncrushed stone in background.

A Violation Notice (VN) will be sent to the Company that outlines these violations. The Company will have 21 days to respond.

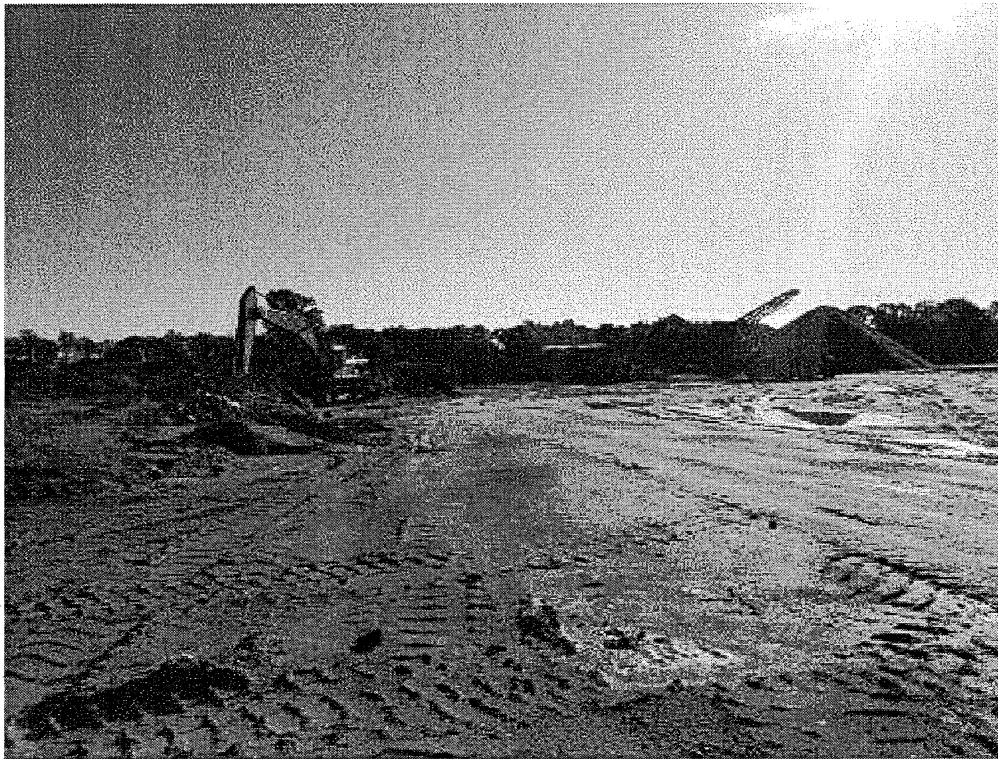
TB walked me around the quarry showing me the various storage piles and water features. There was no obvious signs of contaminants in any of the surface water although a settling type pond associated with the wash plant was very cloudy as expected. The quarry itself isn't that deep nor are the side walls very steep in most locations. The tops of some residential homes were visible from the bottom of the quarry generally behind berms. I noted several acres of land in between storage piles that was free of vegetation with a very sandy moist surface. See attached photos.

Image 12(Quarry floor) : Quarry floor and distant screening operations.

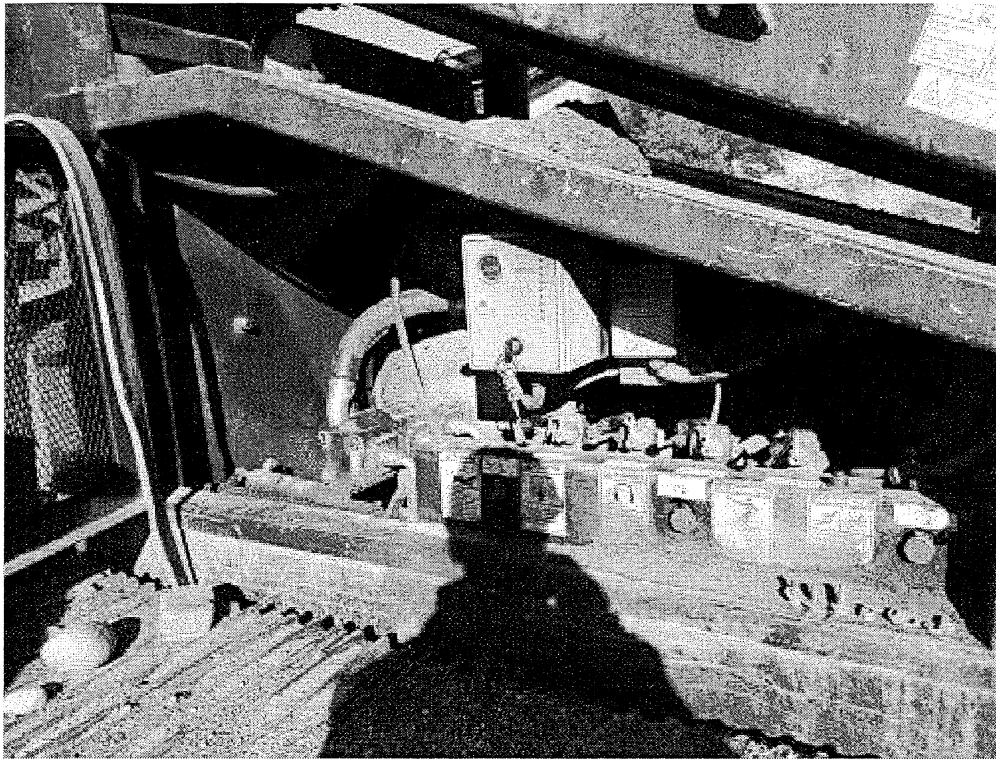
TB showed me 2 dry screening operations on the east side of the quarry. Both were not operating and one of them was surrounded by water due to the recent heavy rains. TB showed me the diesel engine associated with the screening operation that wasn't surrounded by water. The engine had logged 9773 hours of operation. TB indicated that both of the screening engines were brought in approximately a year ago. They are portable but have not left the facility in the last year. TB estimated the engines to be approximately 180 hp in size.

Image 13(Diesel engine) : Diesel engine for one of the dry screening operations.

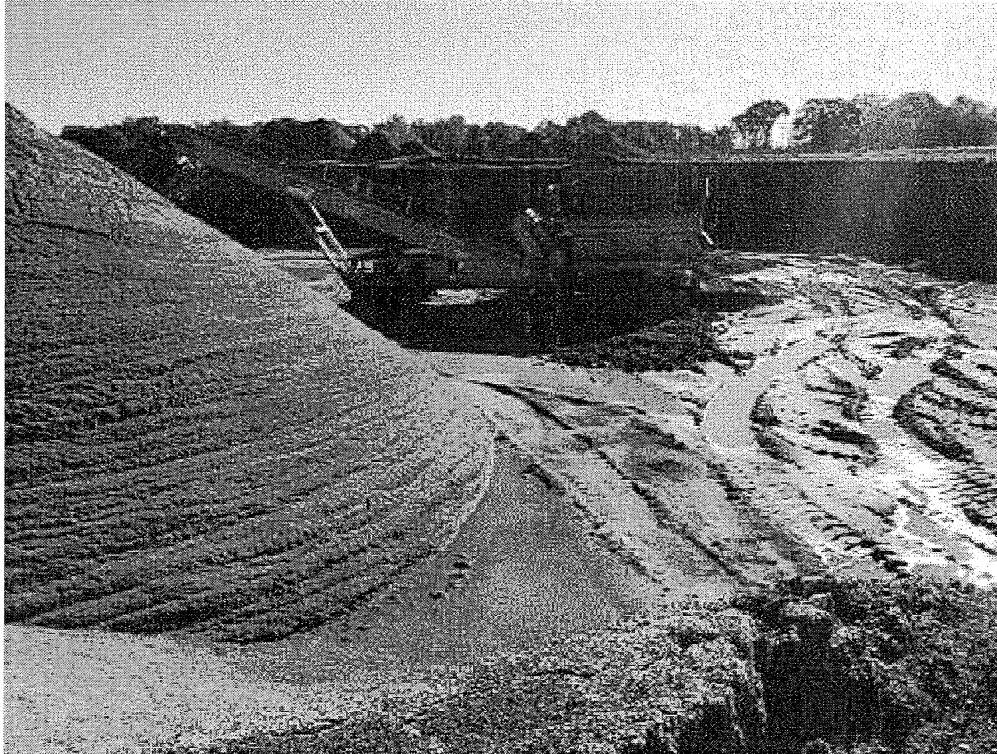
Image 14(Dry Screening) : Dry screening operation not accessible due to mud. This operation also has a diesel engine.

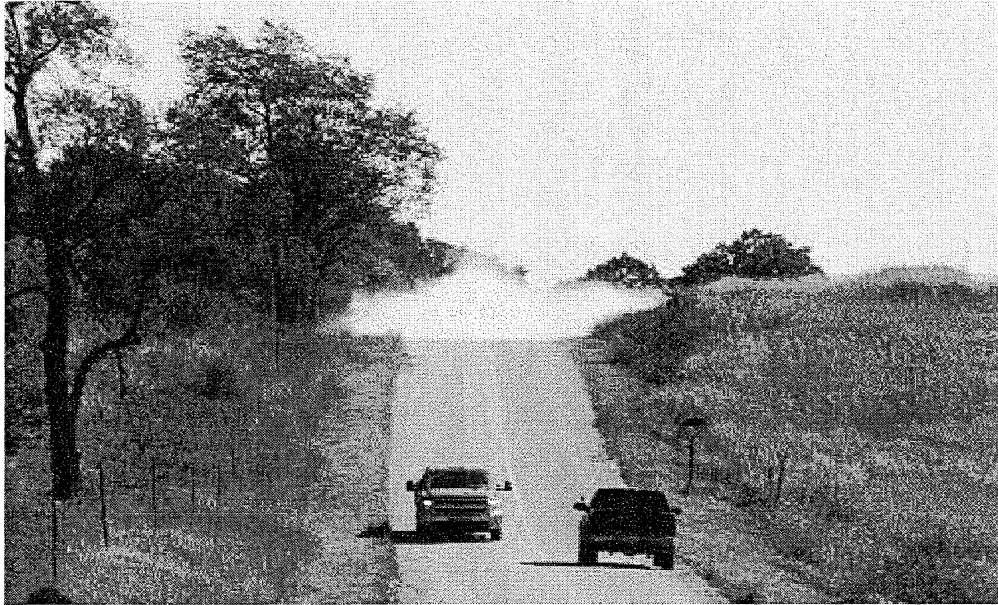
Image 15(Dust) : Dust on Bohne Road. (From one of the complainants.)

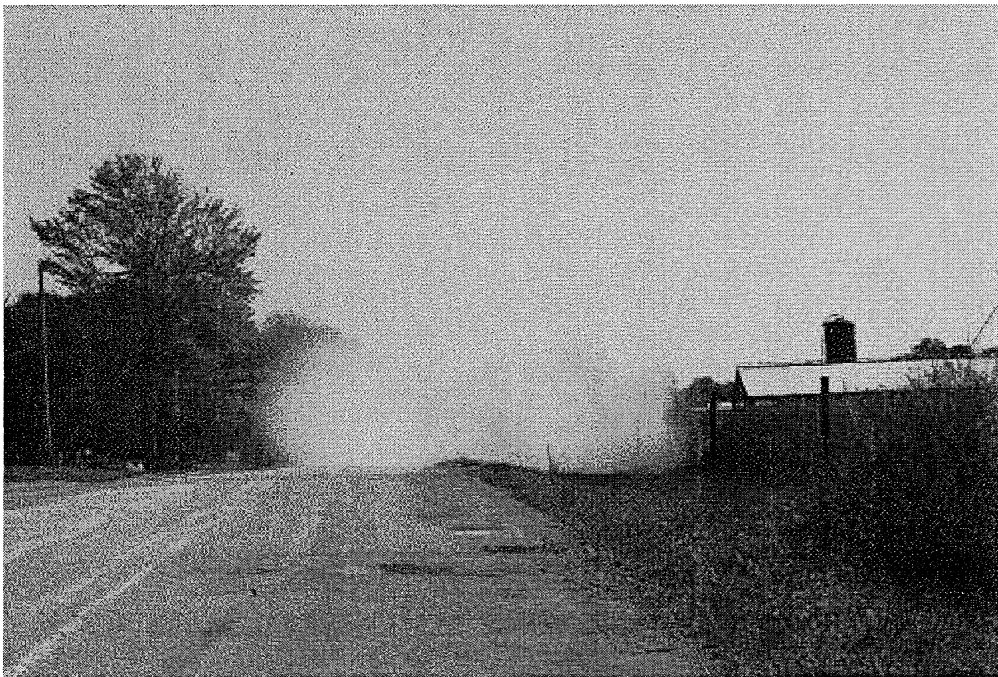
Image 16(Dust) : Dust on Bohne road near quarry entrance. (Photo supplied by complainant.)
