DEPARTMENT OF ENVIRONMENTAL QUALITY
AIR QUALITY DIVISION
ACTIVITY REPORT: Scheduled Inspection

FACILITY: CHEMETALL US, INC		SRN / ID: P0359
LOCATION: 1100 TECHNOLOGY DRIVE, JACKSON		DISTRICT: Jackson
CITY: JACKSON		COUNTY: JACKSON
CONTACT: Brian Sauer , Safety Health & Environmental Coordinator		ACTIVITY DATE: 06/15/2017
STAFF: Mike Kovalchick	COMPLIANCE STATUS: Non Compliance	SOURCE CLASS: MINOR
SUBJECT: Unannounced compliance inspection. Company found to be subject to MACT Subpart VVVVVV and RICE MACT.		
RESOLVED COMPLAINTS:

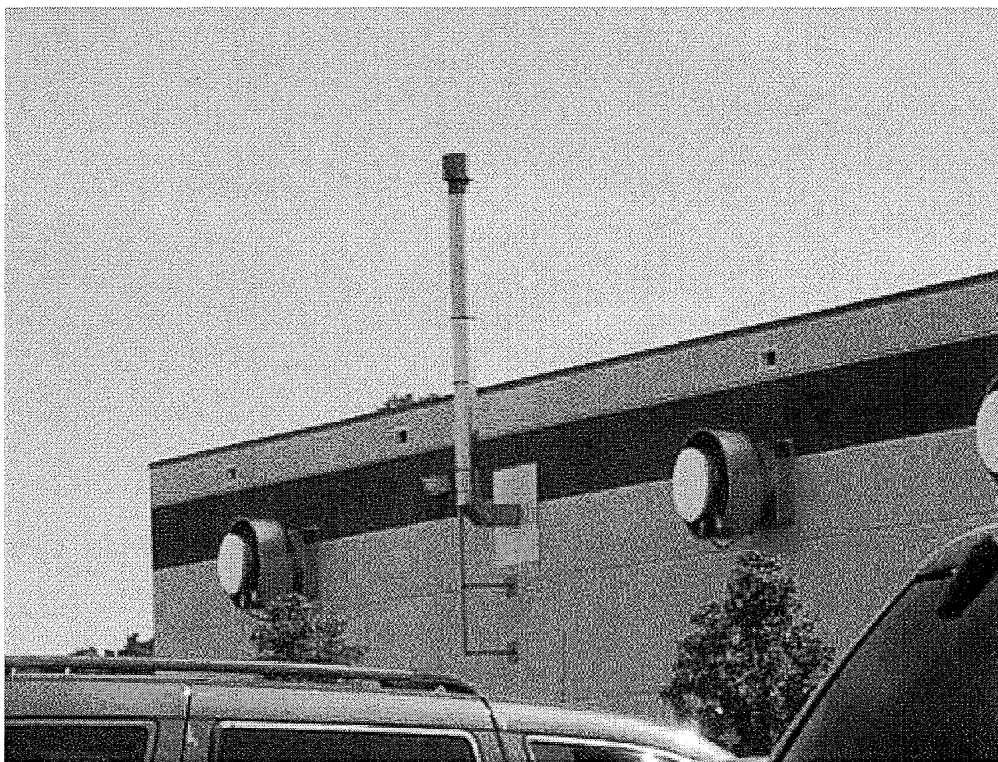
We first visited the FLMMIX Emission unit area. (SC5) The wet scrubber associated with this unit was inspected. No pH meter was present. (Permit requirement.) Brian indicated that they manually check pH of the scrubber water solution once per day as they haven't been able to find a pH that was intrinsically safe. The magnehelic gauge was showing less than 0 so was assumed to not be operating properly. (Permit requirement.) The recirculation rate of the scrubber solution was 14 gallons/min. It was noted that scrubber water solution was hitting the glass side panel of the scrubber.(Refer to MAP Page 7 "Spray pattern from nozzles should be adjusted so spray does not hit scrubber side wall".) The scrubber water discharge rate was zero. Brian noted that the liquid was discharged once a day every morning manually into totes. We went outside to view the stack associated with the scrubber. See attached picture. No opacity was noted.

Image 2(SC5 Stack) : Stack associated with FLMMIX emission unit

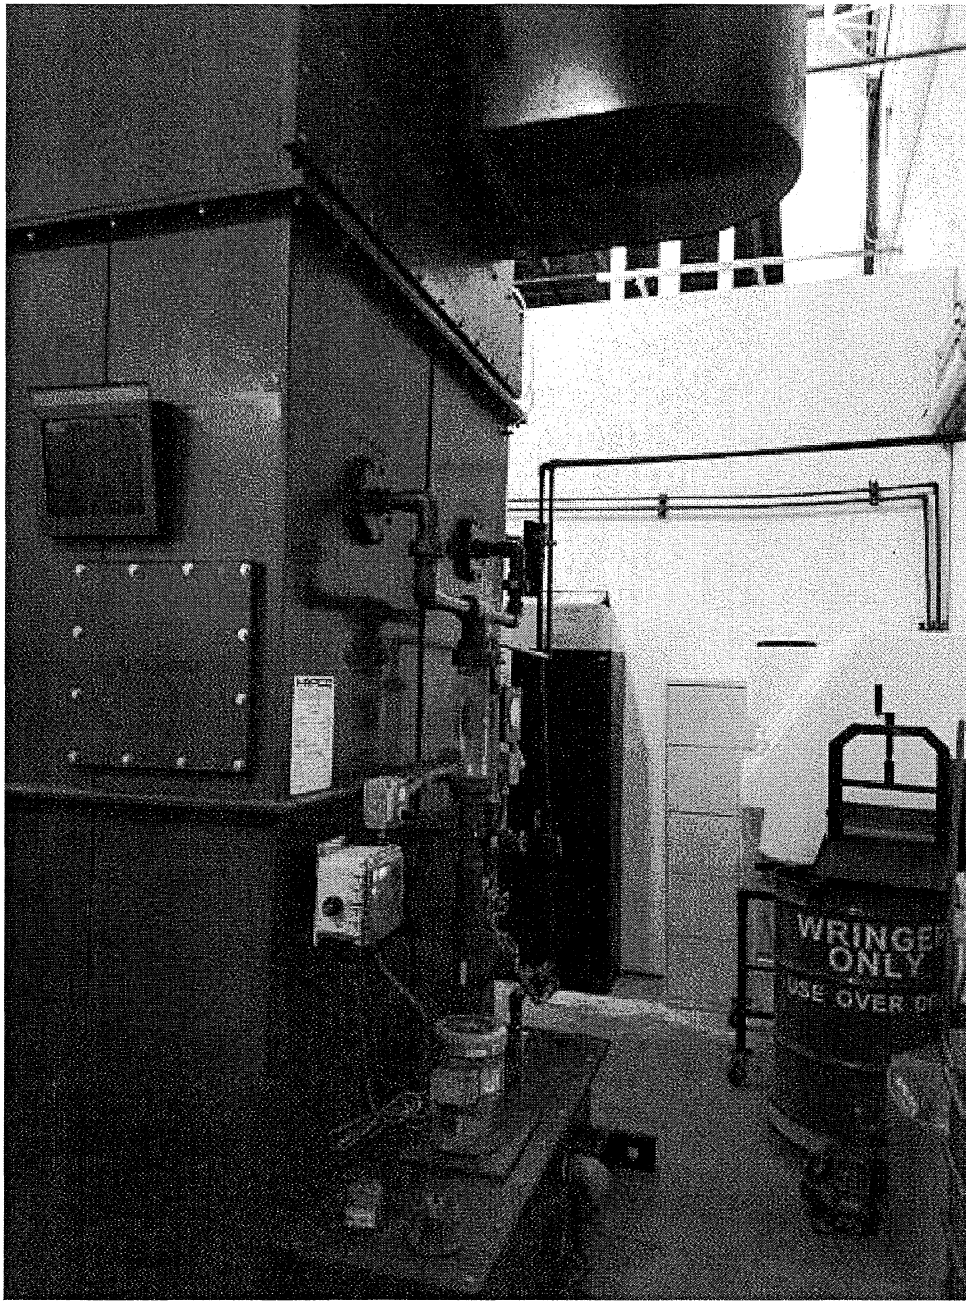
Next, we went to the SMBATMIX Emission unit area. (SC4) The wet scrubber associated with this unit was inspected. See attached pictures. The pH was reading 7.87. The magnehelic gauge was showing 0.5". The recirculation rate of the scrubber solution was 12 gallons/min. The scrubber water discharge rate was zero. Brian noted again that the liquid was manually discharged. We went outside to view the stack associated with the scrubber. See attached picture. No opacity was noted.

Image 3(SC4 Scrubber) : SC4 Scrubber

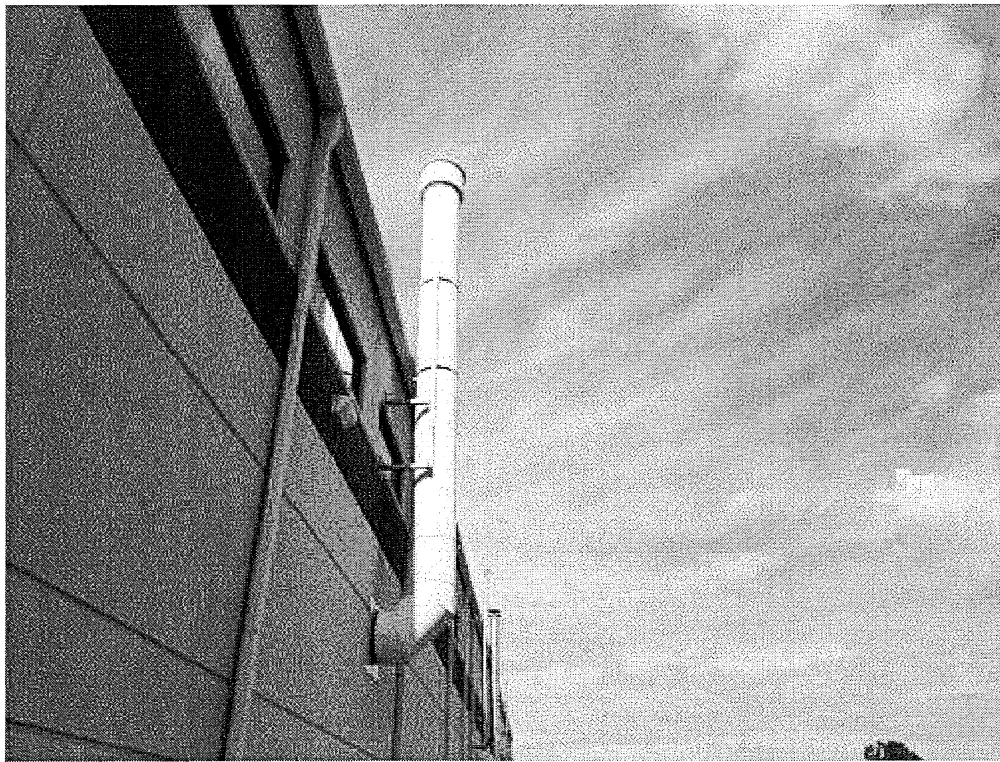
Image 4(SC4 Stack) : SC4 Scrubber Stack

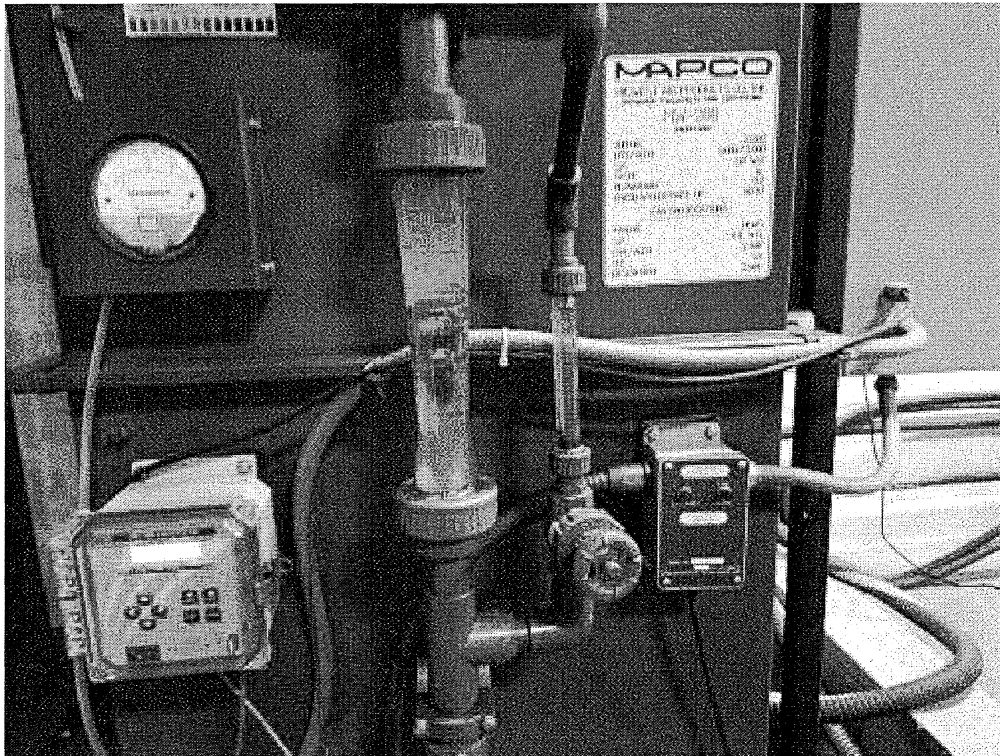
Next, we went to the CRMIX Emission unit area. (SC1) The wet scrubber associated with this unit was inspected. See attached pictures. The pH was reading 9.94. The magnehelic gauge was showing 0.75". The recirculation rate of the scrubber solution was 12 gallons/min. The scrubber water discharge rate was zero. Brian noted again that the liquid was manually discharged and was treated as hazardous waste from this emission unit. We went outside to view the stack associated with the scrubber. See attached picture. No opacity was noted.

Image 5(SC1 Scrubber) : SC1 Scrubber panel

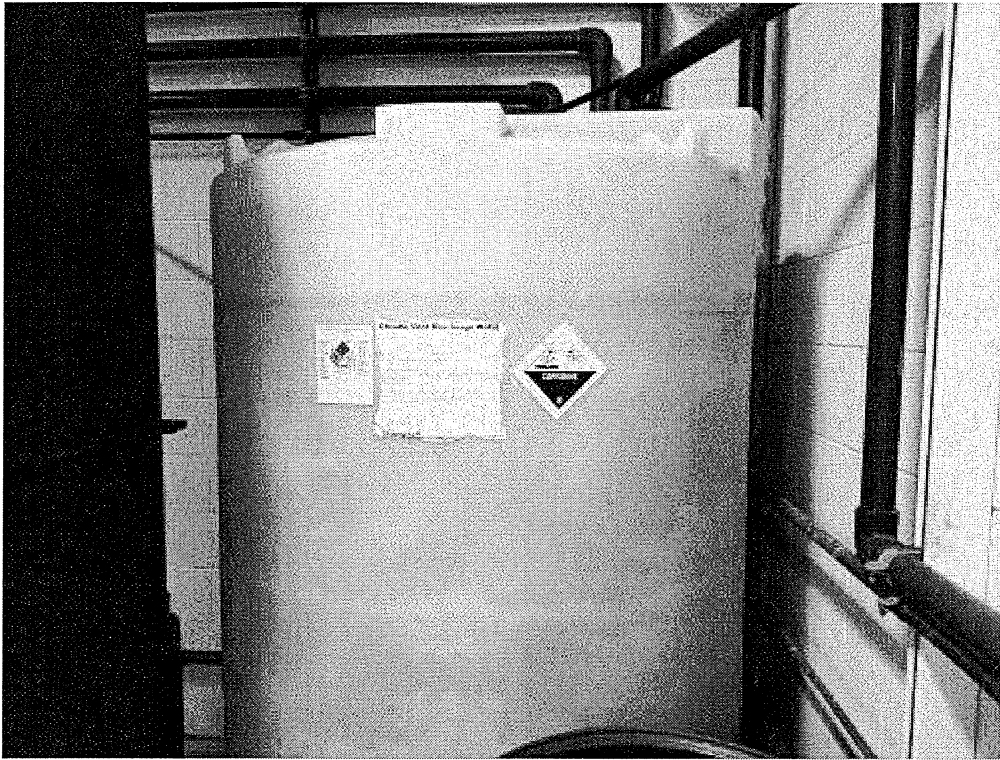
Brian discussed how records are kept and how waste products are handled at the facility. He noted that wastewater from the chrome emission unit is treated as hazardous waste and is collected in 275 gallon totes 2 to 4 times a month. Other wastewater from the 4 other scrubbers is sent to an offsite POTW after first being treated for pH. (The full onsite treatment plant is no longer used due to numerous problems.)

Image 6(Chromium Waste) : Wastewater tank from Chromium scrubber (SC1)

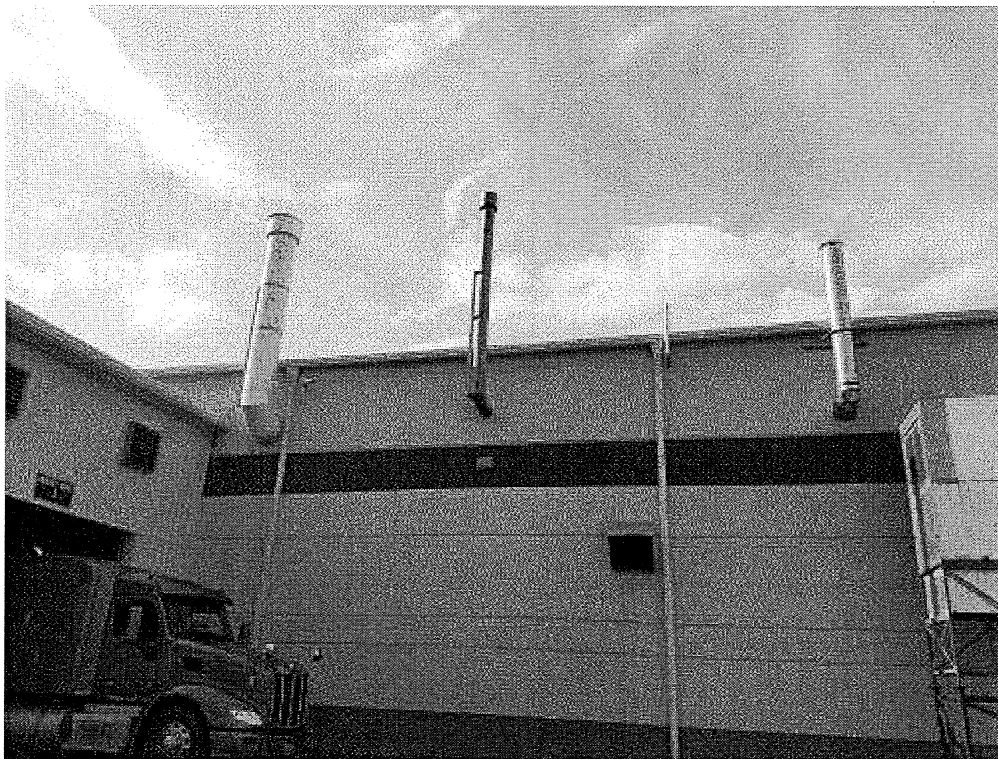
Image 7(Scrubber Stacks) : Scrubber stacks for SC1 and SC2. (SC2 is the stack on the left.)

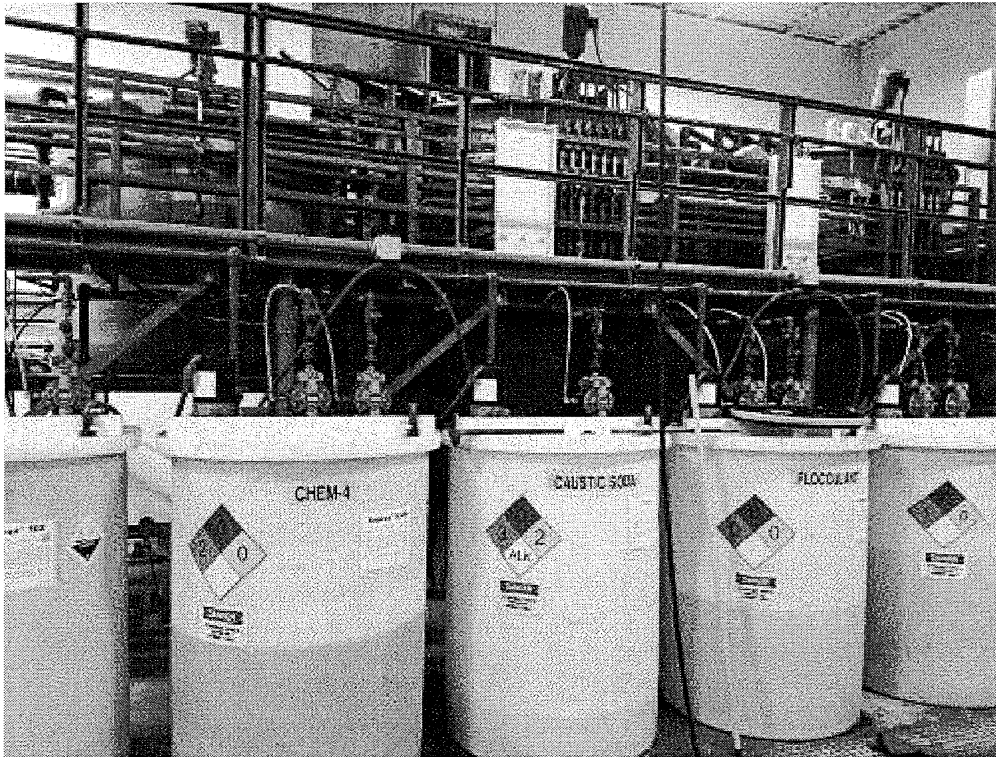
Directly next to CRMIX Emission unit area was the wastewater treatment plant. See attached picture. Note that only part of the treatment plant is still being used. They use part of it to make simple pH adjustments to the wastewater.

Image 8(wastewater treatment) : Wastewater treatment plant

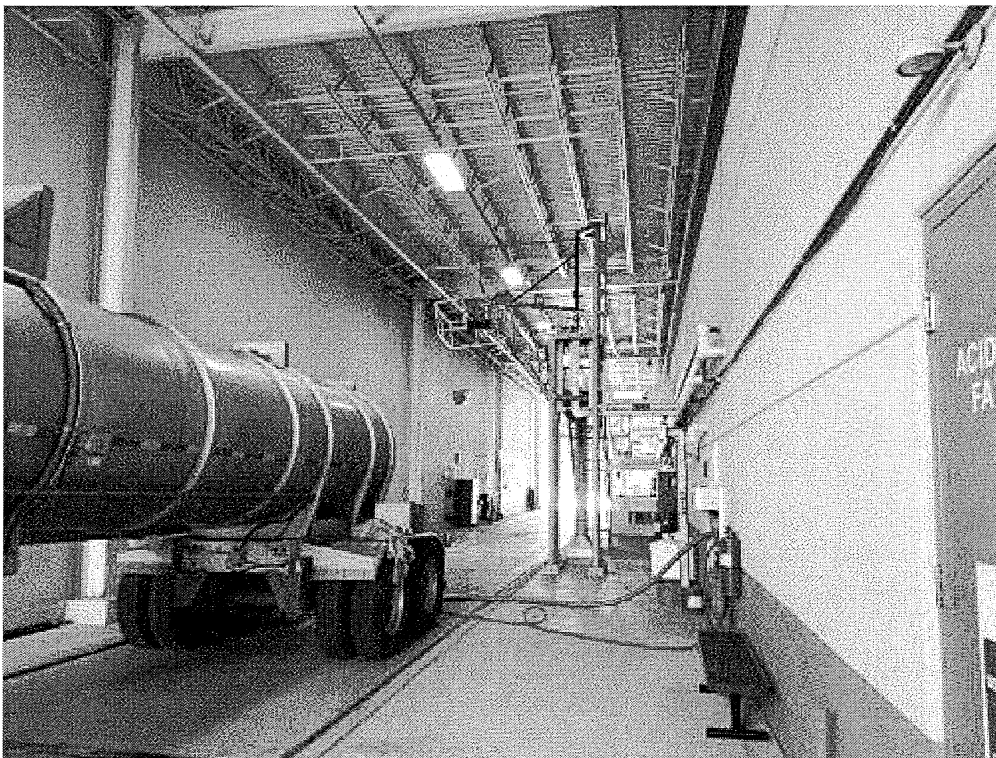
Image 9(Truck unloading) : Truck unloading bay

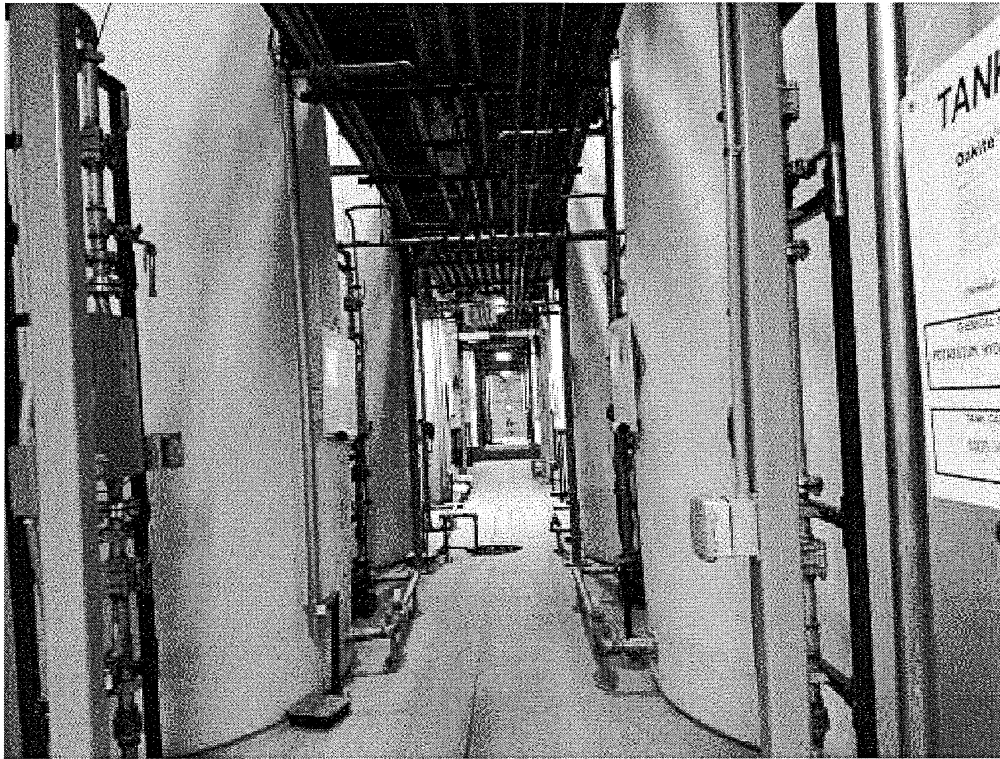
Image 10(Raw Material Area) : Raw Material Storage Area

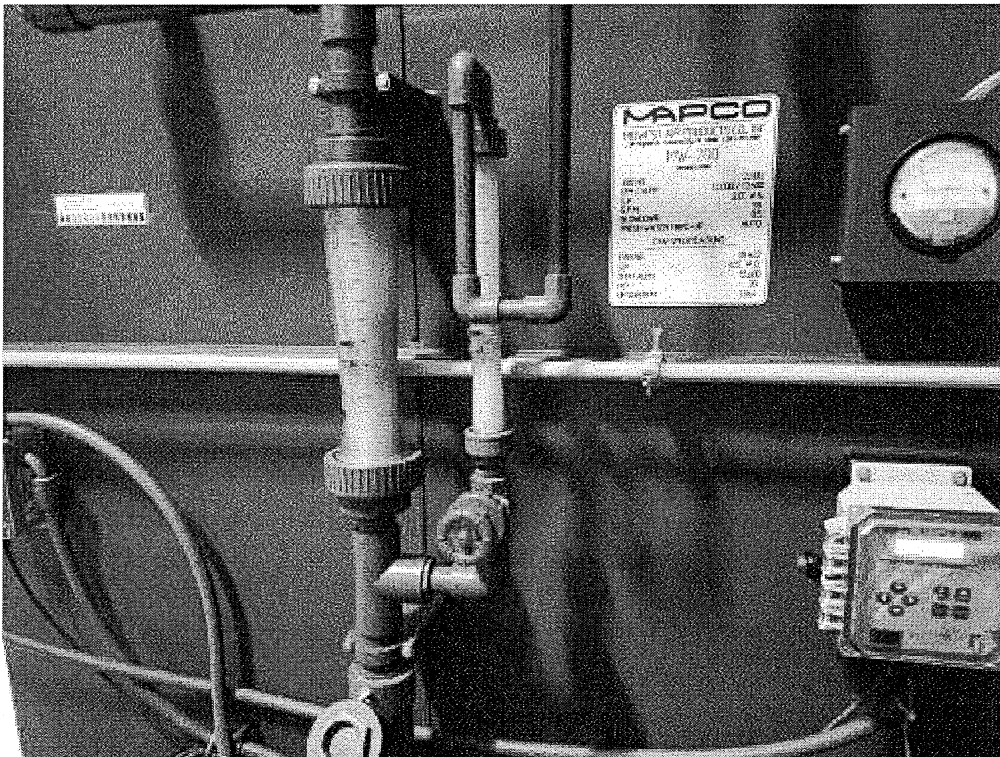
Next, we went to the GENMIX Emission unit area. (SC2) The wet scrubber associated with this unit was inspected. See attached pictures. The pH was reading 7.53. The magnehelic gauge was showing 2.2". The recirculation rate of the scrubber solution was 44 gallons/min. The scrubber water discharge rate was 0.8 gallons/minute. We went outside to view the stack associated with the scrubber. See attached picture. No opacity was noted.

Image 11(SC2) : SC2 scrubber

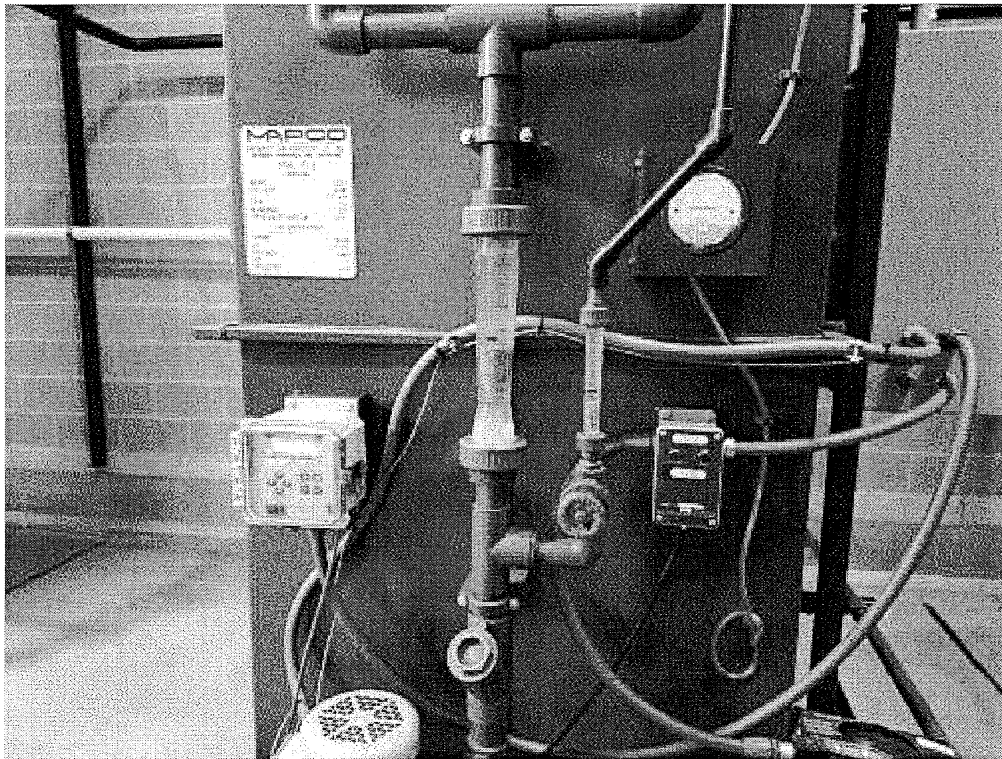
The last scrubber to visit was the one associated with the OILMIX Emission unit area. (SC3). The wet scrubber associated with this unit was inspected. See attached pictures. The pH was reading 8.52. The magnehelic gauge was showing 1". The recirculation rate of the scrubber solution was 10 gallons/min. The scrubber water discharge rate was 0.15 gallons/minute. We went outside to view the stack associated with the scrubber. See attached picture. No opacity was noted.

Image 12(SC3 Scrubber) : SC3 Scrubber

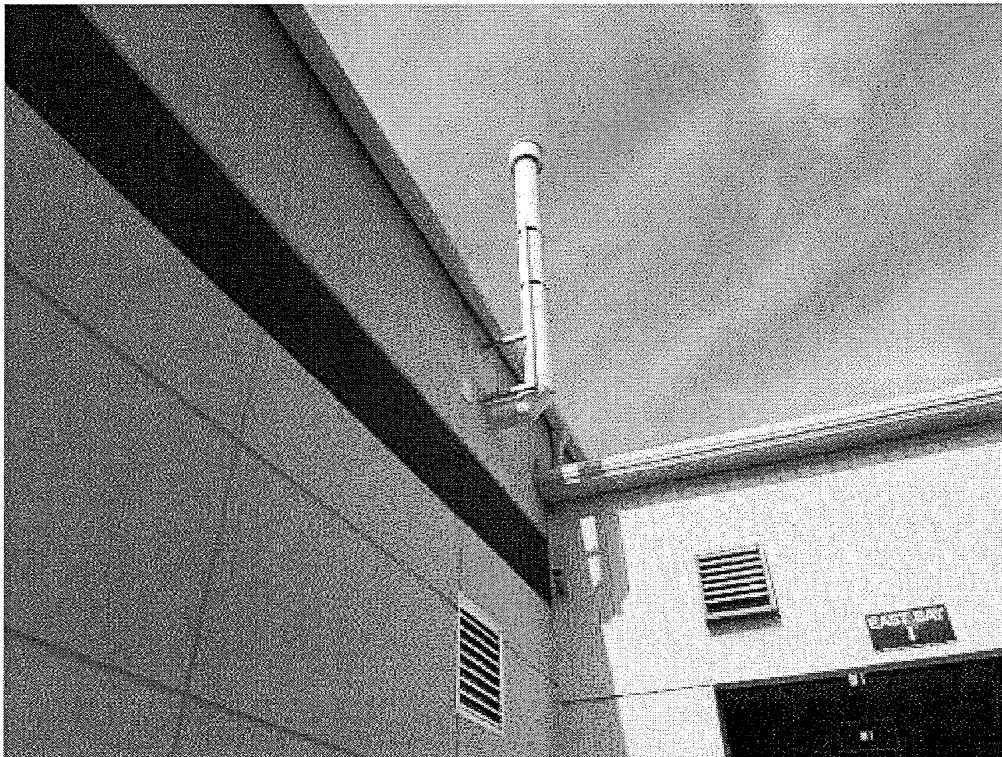
Image 13(SC 3 Stack) : SC3 Scrubber stack

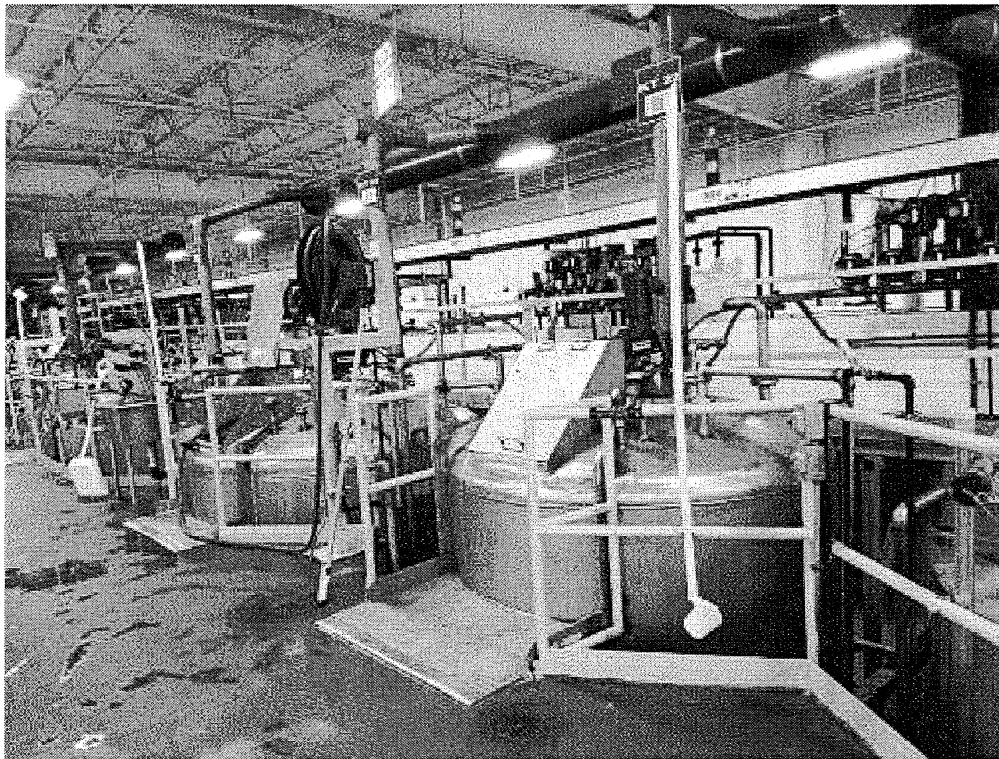
The mixing mezzanine area was inspected. There were no findings. See attached pictures. One of the pictures shows the mixing vessels with another showing inside one of the vessels and a paddle.

Image 14(Mixing tanks) : Mixing Tanks

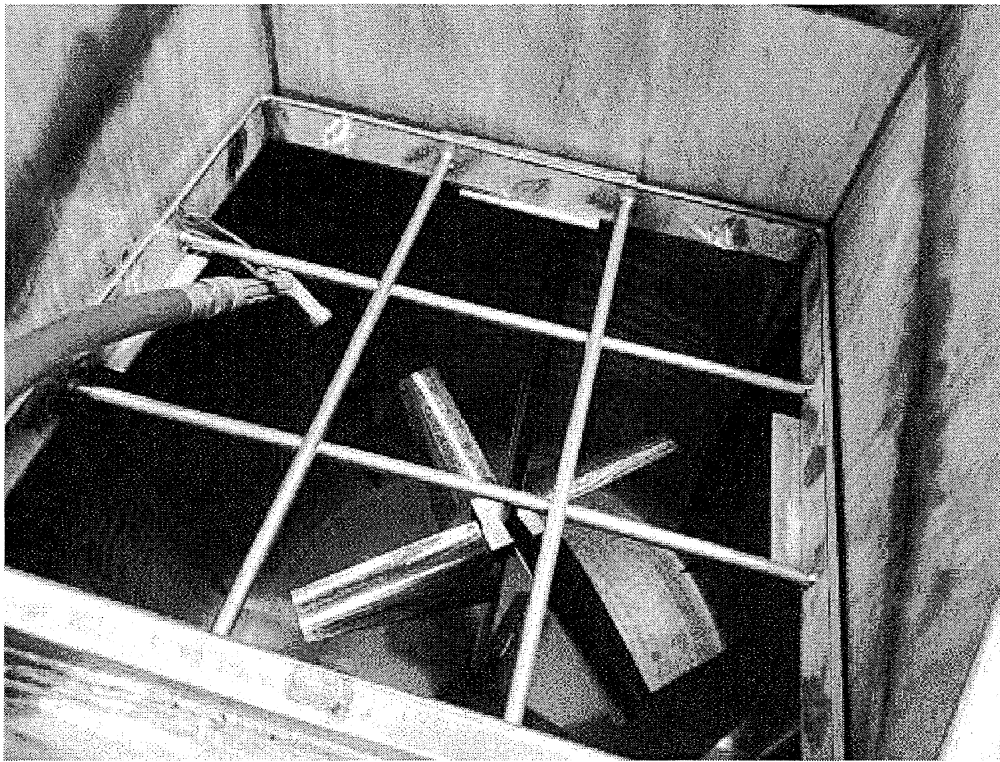
Image 15(Mixing Tank) : Baffle inside mixing tank

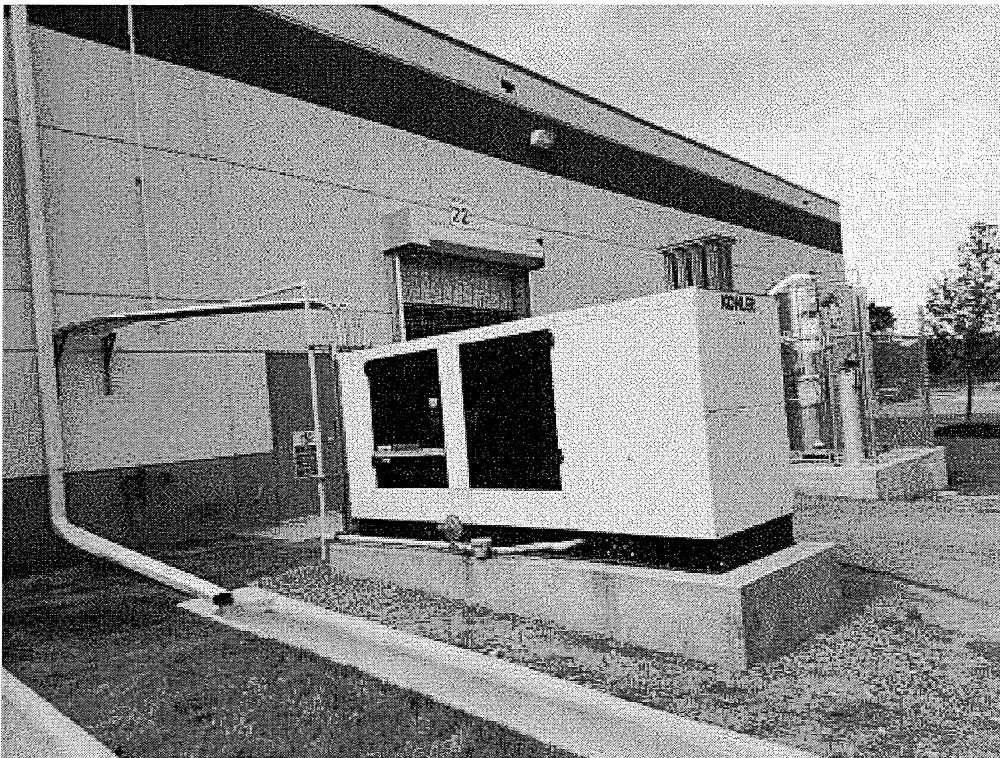
I asked Brian if the facility has any emergency generators. He said that one was installed last inspected. We went outside to take a look at it. See attached picture. Attachment (5) is the spec sheet for it. It is rated at 134 hp. They use to make sure the flammables area is supplied with power to continuously vent any generated vapors to prevent the possibility of a fire in the event of a power failure.

Image 16(Emergency Generator) : Emergency generator
