DEPARTMENT OF ENVIRONMENTAL QUALITY
AIR QUALITY DIVISION

ACTIVITY REPORT: **Self Initiated Inspection**

FACILITY: DYNAMIC CRUSHING LLC		SRN / ID: P0691
LOCATION: 6417 CENTERLINE RD, SARANAC		DISTRICT: Grand Rapids
CITY: SARANAC		COUNTY: IONIA
CONTACT: Greg Huyser , Owner		ACTIVITY DATE: 09/18/2018
STAFF: Michelle Luplow	COMPLIANCE STATUS: Compliance	SOURCE CLASS: MINOR
SUBJECT: Self-initiated inspection of crushing being conducted at 6132 N. Aurelius, Lansing, Ingham Co.		
RESOLVED COMPLAINTS:

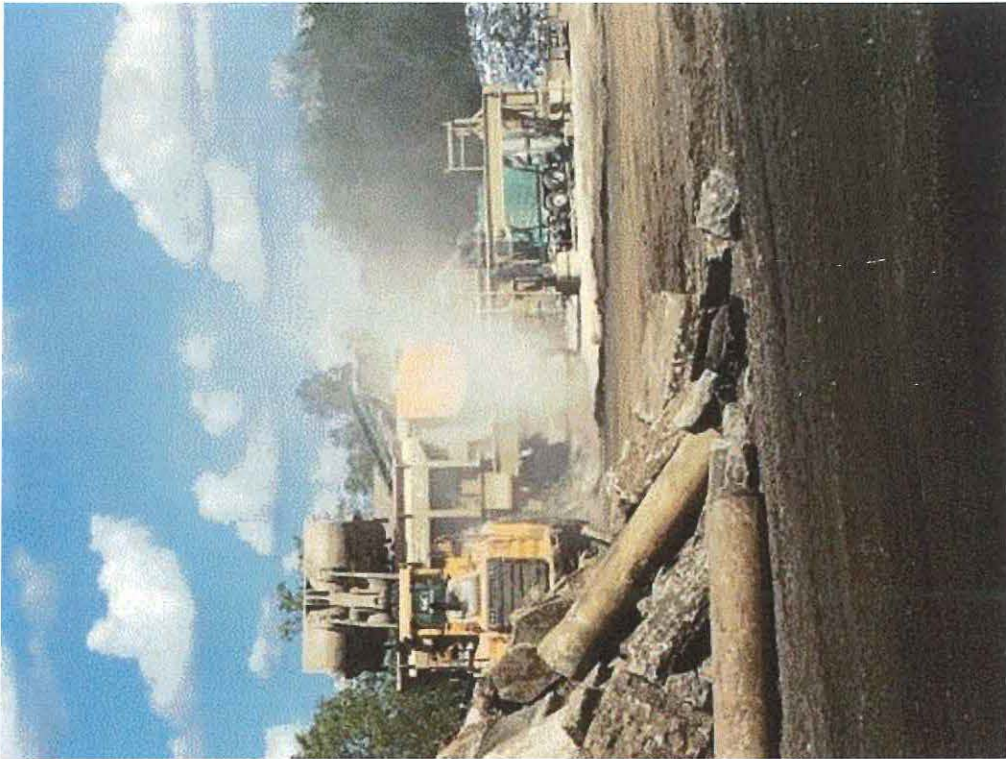
Crushers are limited to 15% opacity, and conveyors/transfer points are limited to 10% opacity. S. Braman and I observed all equipment appeared to be meeting their appropriate opacity limits, except for the transfer point below the primary crusher. Emissions in excess of 40% were witnessed for the 20 minutes that we stood by observing operations. There was opacity from the primary crusher itself, but it is my professional judgment that the opacity did not exceed 15% over a 6-minute average. The sun was within the Method 9-140 degree angle at our backs while we observed the excess opacity.

Image 1(Opacity Exceedance) : Opacity exceeding 10% limit from transfer point below crusher

I contacted Greg Huyser, Owner, concerning the excess emissions from this transfer point. He explained that soon after S. Braman and I left the site, he had reached the site and placed additional plastic seals around the emission point to enclose any dust being emitted from this transfer point. Attached are photos of before and after the plastic seal was installed. Emissions appeared to be greatly reduced, and likely less than 10% on a 6-minute average.

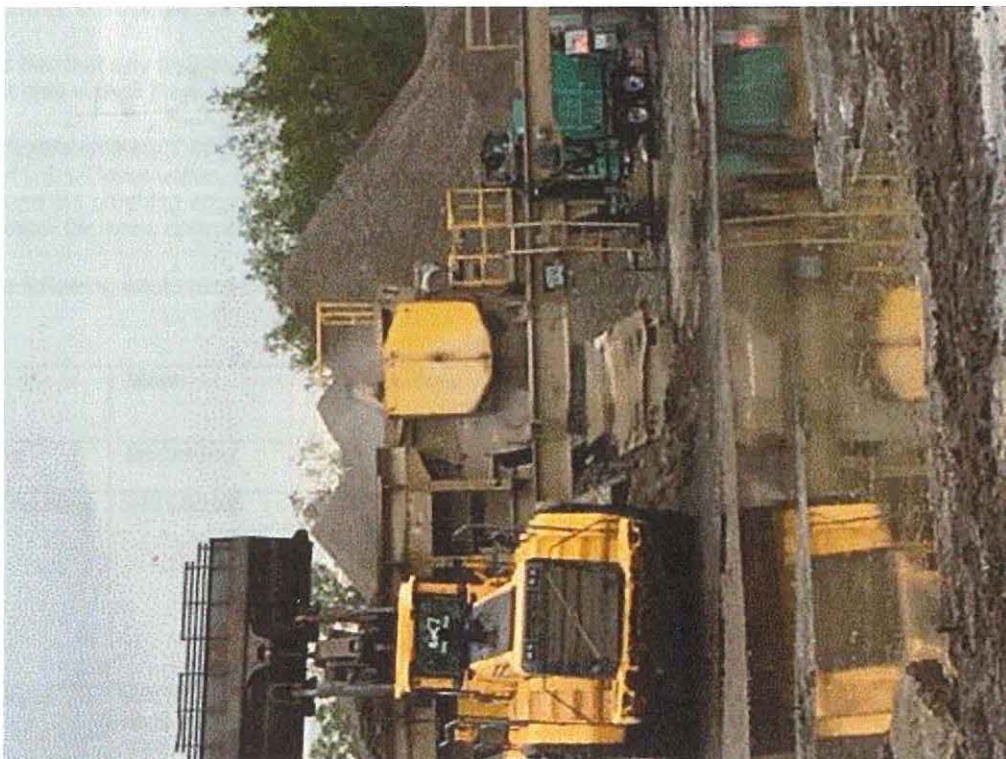
Image 2(Minimal Opacity) : Opacity the following day. Note plastic shielding is put into place at transfer point below crusher.

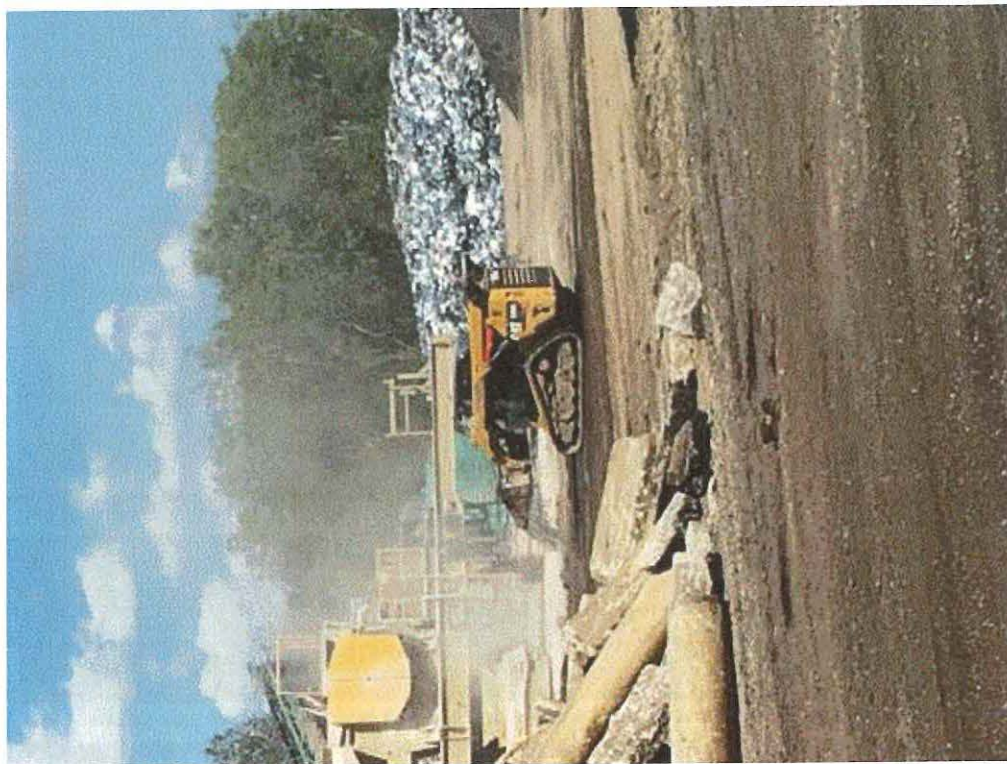
S. Braman and I noted that there was greater than 5% opacity being turned up from the front end loaded transferring the concrete to the crusher. We informed D. Earle of this and before we left, another employee onsite began applying loads of water to the working face to minimize fugitive dust.

Image 3(Water Application) : Water application to unpaved plant yard to control dust from moving front-end loader. Note saturated ground
