**DEPARTMENT OF ENVIRONMENTAL QUALITY  
AIR QUALITY DIVISION  
ACTIVITY REPORT: Scheduled Inspection**

<b>FACILITY:</b> Savoy Energy LP- Moore 1-14 CPF		<b>SRN / ID:</b> P0743
<b>LOCATION:</b> P.O. Box 1560, BROOKLYN		<b>DISTRICT:</b> Jackson
<b>CITY:</b> BROOKLYN		<b>COUNTY:</b> JACKSON
<b>CONTACT:</b> Dylan Foglesong , Production Engineer		<b>ACTIVITY DATE:</b> 07/12/2018
<b>STAFF:</b> Mike Kovalchick	<b>COMPLIANCE STATUS:</b> Compliance	<b>SOURCE CLASS:</b> MINOR
<b>SUBJECT:</b> Inspection of an oil/gas processing facility that is fed with 6 oil/gas wells.		
<b>RESOLVED COMPLAINTS:</b>

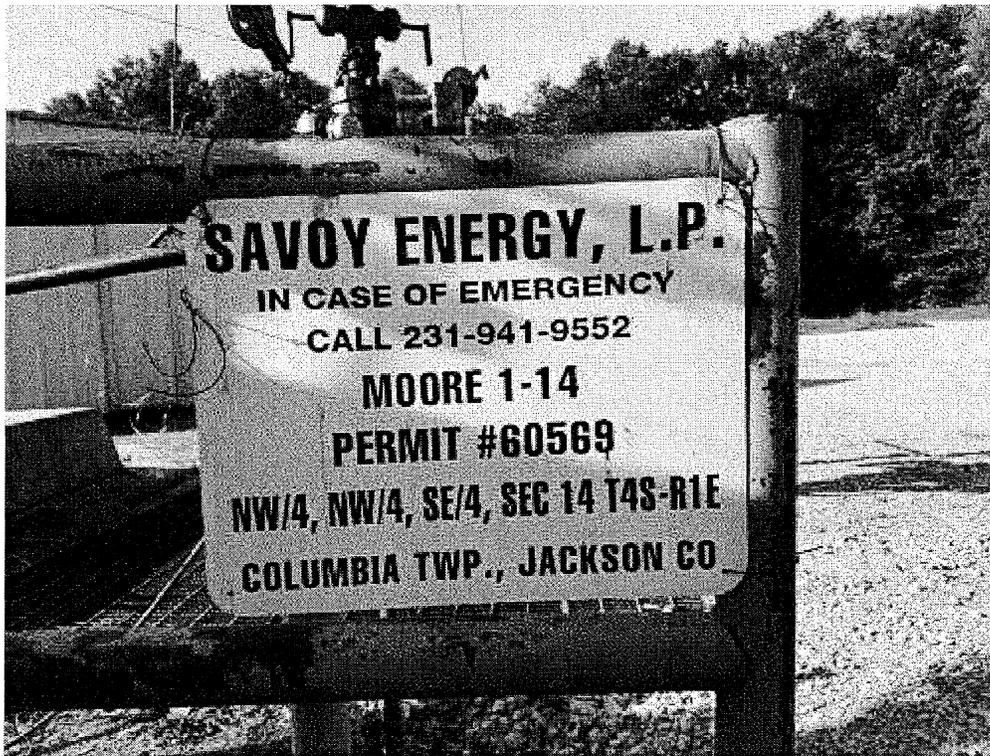
**Image 2(Well head)** : Moore 1-14 oil/gas well located at the central processing center.

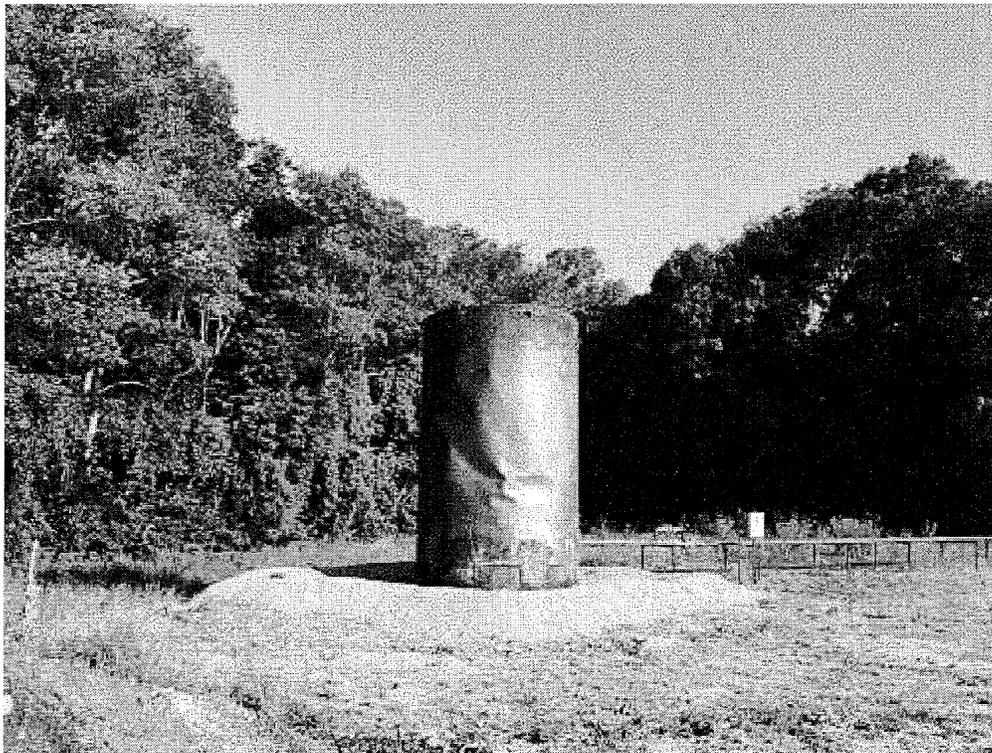
I observed the flare. It is enclosed in a metal sheath like vessel but can be viewed through a hole in the metal siding. The flare was lit and appeared to be simply acting as a pilot light with no emissions/smoke observed. See attached photos.

**Image 3(Enclosed flare)** : Enclosed flare.

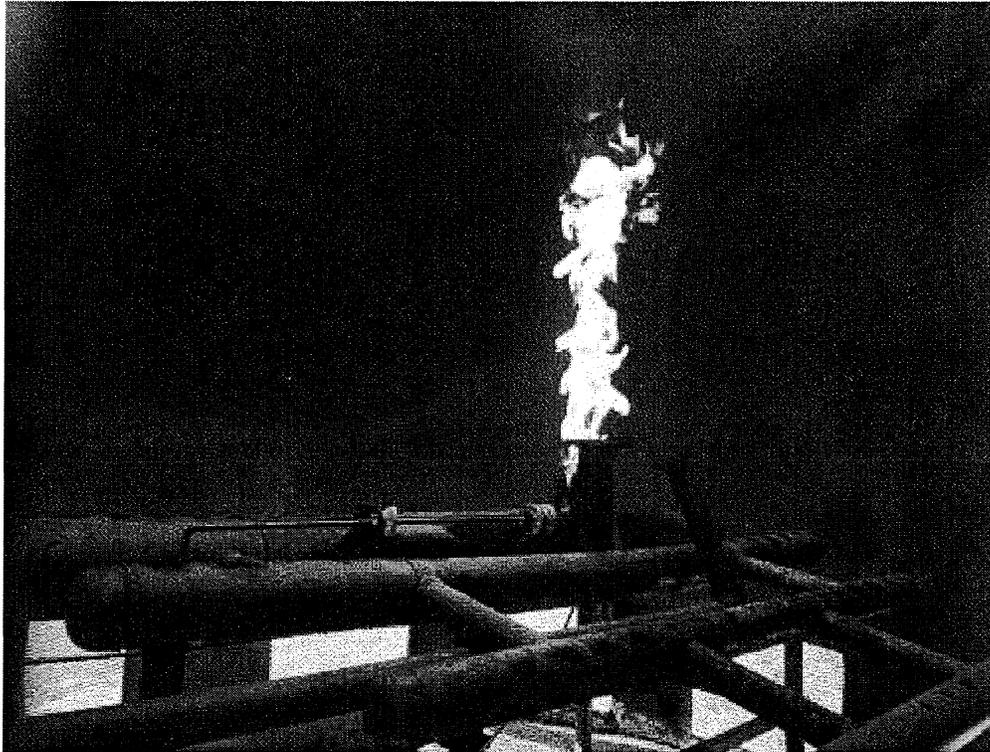
**Image 4(Flare)** : Flare

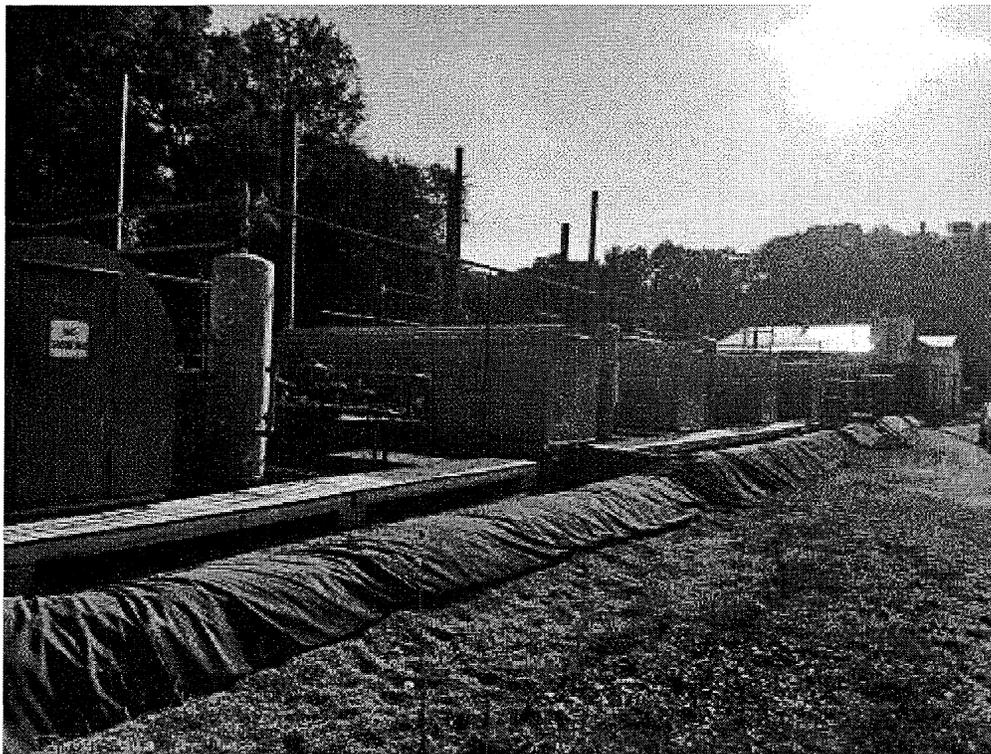
Six heater-treater units were observed. They were all operating with no smoke observed being exhausted. See attached photos.

**Image 5(Heater Treaters)** : Heater Treaters

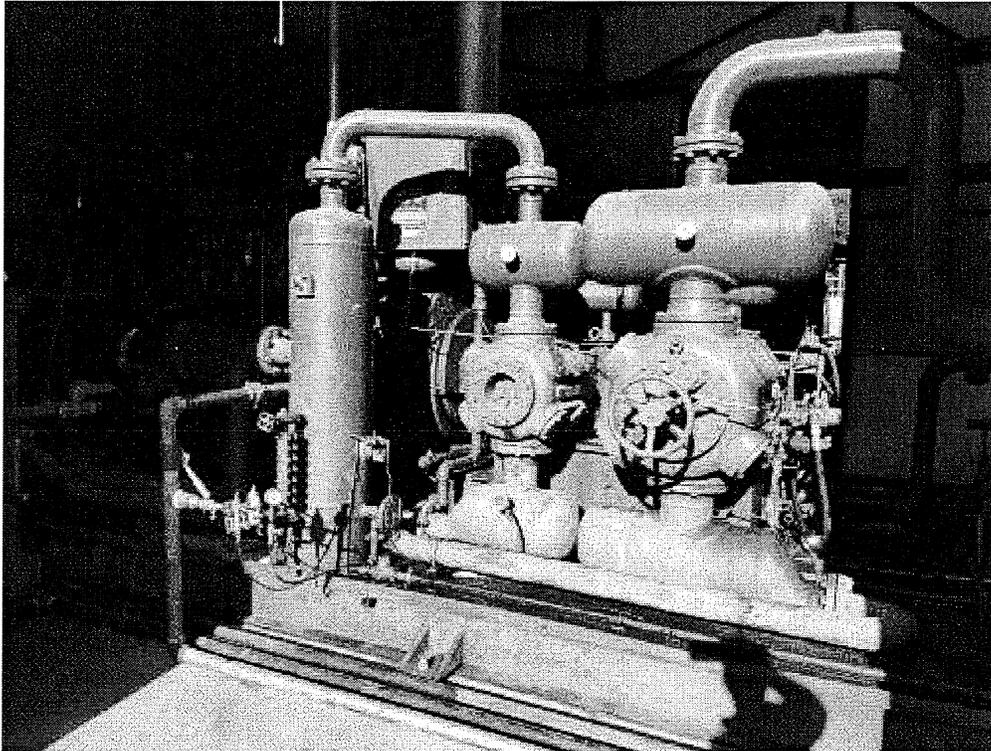
I observed a 600 HP natural gas fired compressor engine. It was not generating any opacity and appeared to be well maintained. It has a catalytic converter on it. See attached photos.

**Image 6(Compressor engine) :** Compressor engine

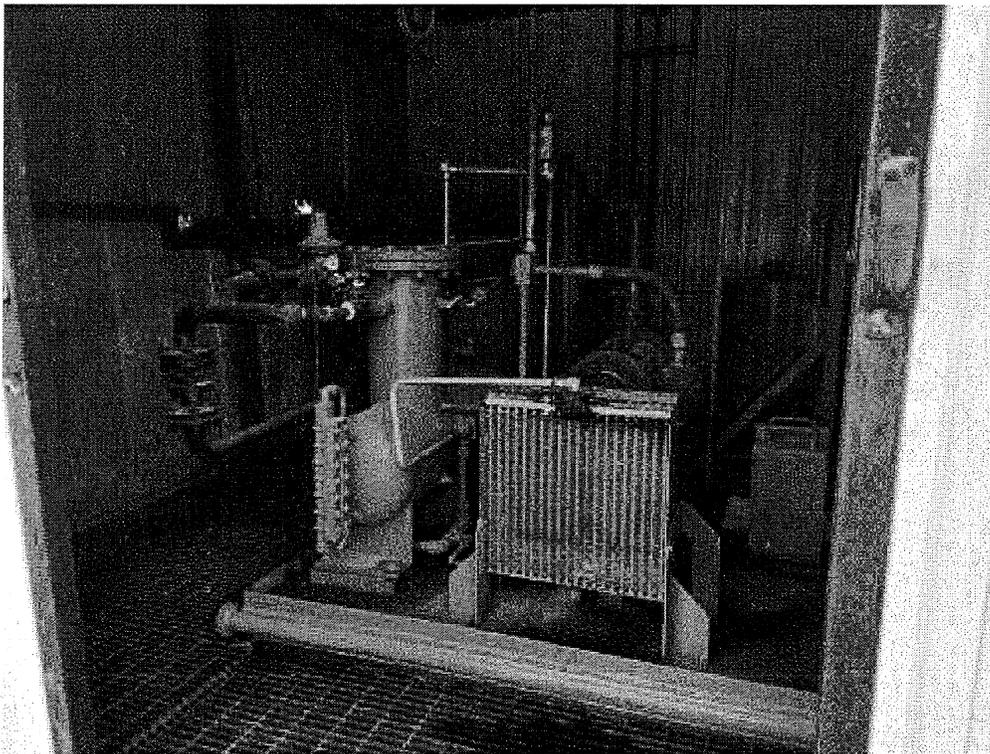
I observed a VRU unit. It pulls vapors off the crude oil/brine tanks and sends them to the compressor engine. In the event the compressor is down, the vapors are sent to the flare. See attached photo.

**Image 7(VRU) :** VRU unit

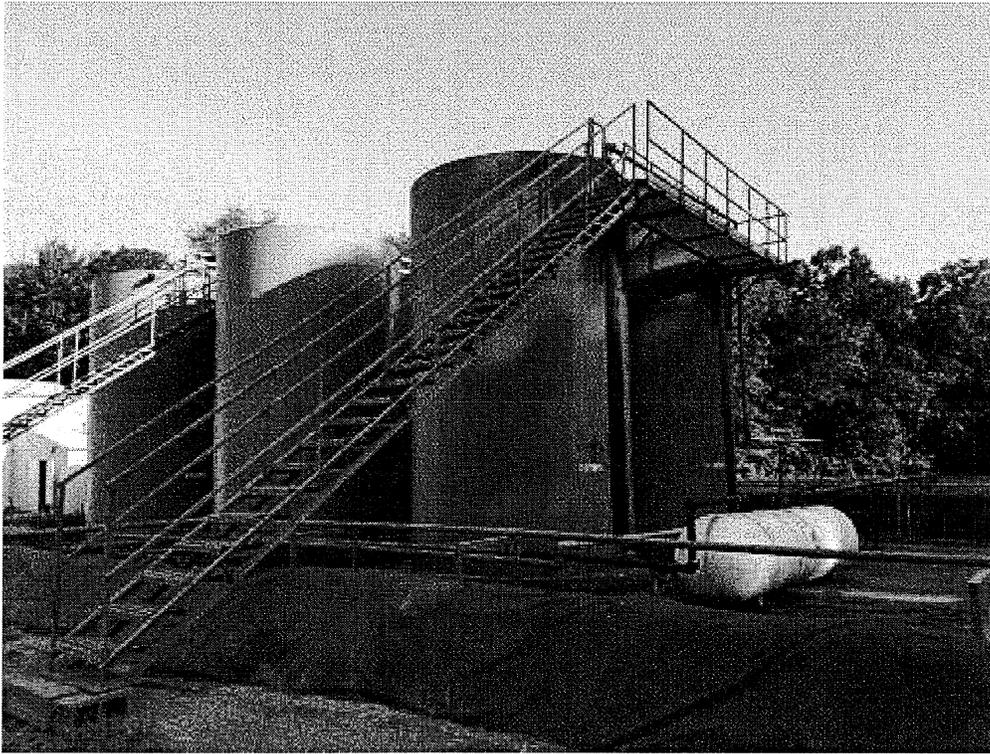
I observed 4 crude oil tanks, 2 brim tanks and one large propane tank that holds the higher molecular weight petroleum fractions. No odors or emissions were note except from the southern most brim tank. Closer inspection showed that a pressure relief hatch on the roof tank appeared to be leaking a small amount VOC's that had a sulfurous smell. LB indicated that it the seal to the pressure relief hatch needed to be replaced. He says the constant removal of the oil/brim using trucks causing wear on the seal due to pressure fluctuations from draw caused by emptying the tanks.

**Image 8(Crude Oil tanks)** : Crude oil tanks. The 2 tanks on the right side are brim tanks. The brim tank in front had a leaky pressure relief hatch.

Shortly thereafter, the operations manager arrived. He indicated that he would have the seal replaced/fixd that afternoon. (Note. This was confirmed later per Company representative Dylan Foglesong.)

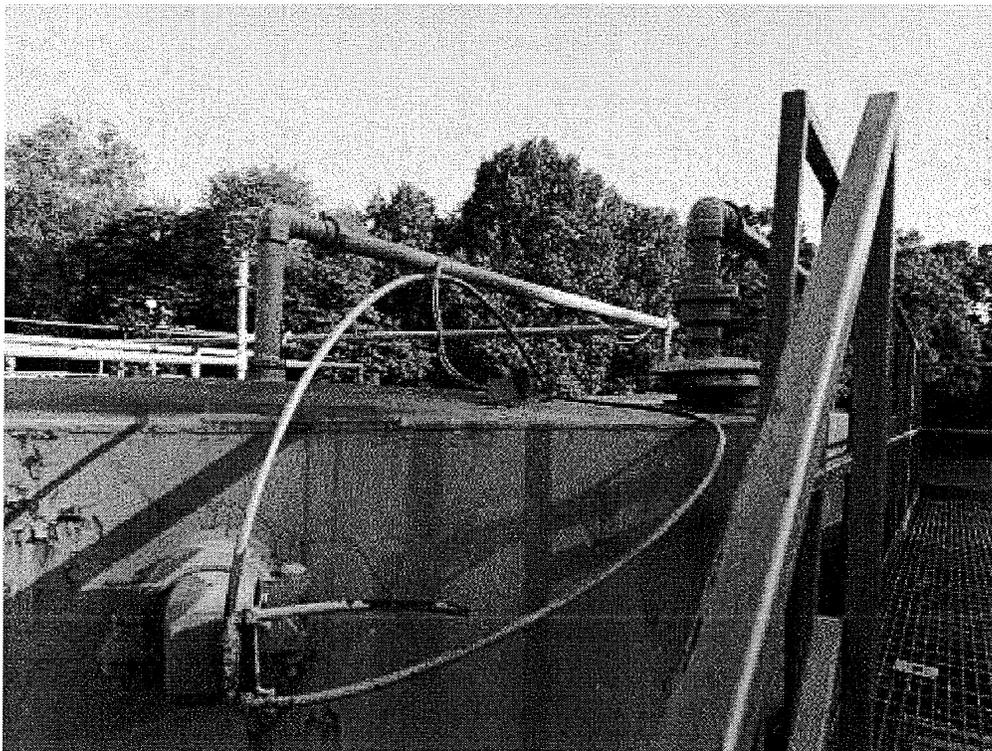
**Image 9(Pressure relief)** : Leaky pressure relief hatch visible on the top of the tank on the right side.

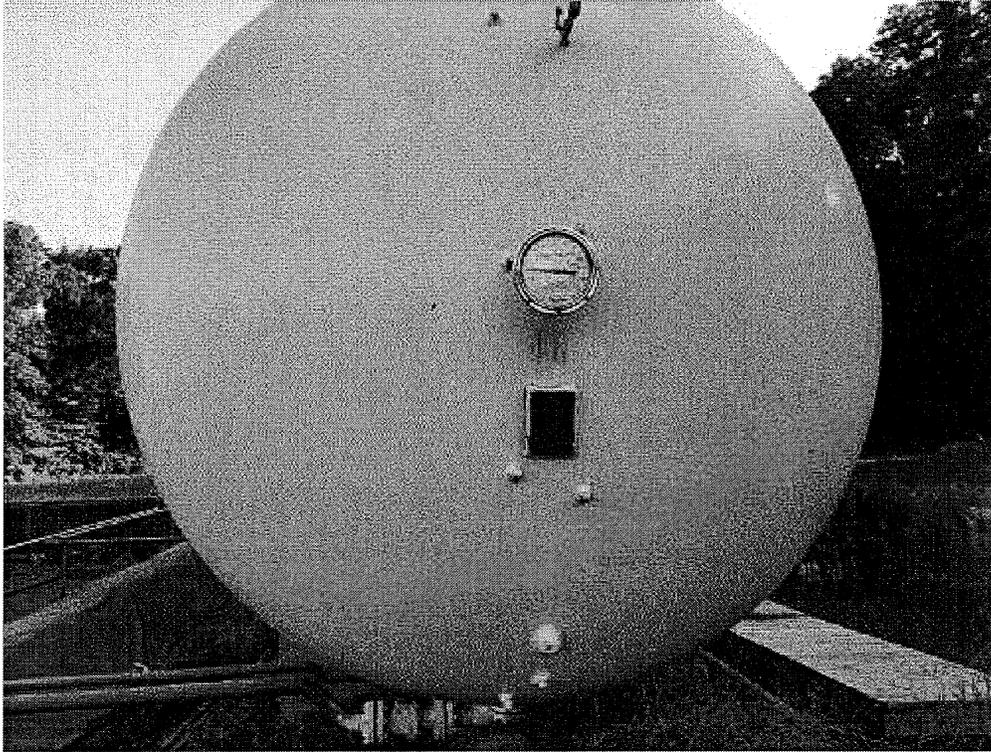
**Image 10(Propane tank)** : Large propane tank.
