**DEPARTMENT OF ENVIRONMENTAL QUALITY
AIR QUALITY DIVISION
ACTIVITY REPORT: On-site Inspection**

FACILITY: LENOX CREMATION SERVICES OF MICHIGAN, INC		SRN / ID: P0746
LOCATION: 10918 Gratiot Avenue, CASCO		DISTRICT: Warren
CITY: CASCO		COUNTY: SAINT CLAIR
CONTACT: Craig Harms , Owner		ACTIVITY DATE: 04/30/2021
STAFF: Robert Elmouchi	COMPLIANCE STATUS: Compliance	SOURCE CLASS: MINOR
SUBJECT: Targeted inspection.		
RESOLVED COMPLAINTS:

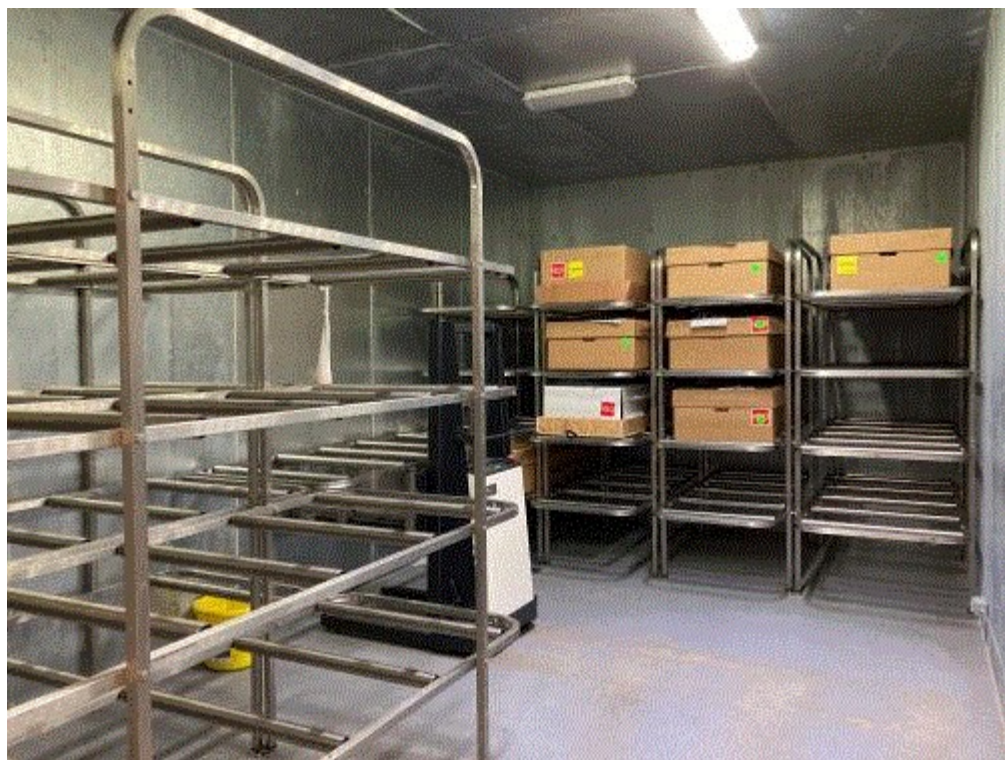
Image 1(IMG 0174.JPG) : Walk-in refrigeration unit with a 24-body capacity. The thermostat is set at 38-39 degrees F.

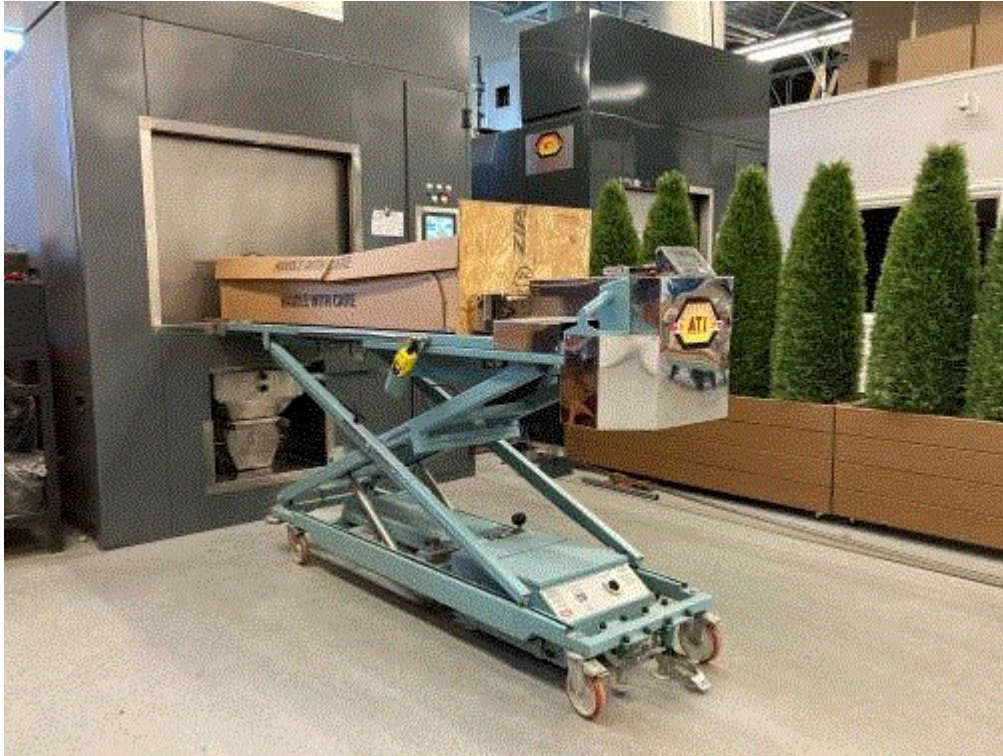
Image 3(IMG_0191.JPG) : Lift table with scale and ram. Note: the lift table must be set to lowest position to measure the charge weight. To conceal personal information, a piece of wood was placed between the charge and ram. The wood is not required for normal operation.

During charge insertion, the operator maintains control by using a scissor-lift table with a ram (see photo). Many crematory operators use thick cardboard tubes underneath the charge, which act as rollers, but this method can create a safety issue if the container veers off course and becomes lodged partway into the primary combustion chamber. If the container becomes lodged partway during insertion, the residual heat from the previous cremation can ignite the charge before it is completely inserted, which can result in an uncontrolled fire. The lift table latches to the front of the cremation unit to ensure the lift table does not move during insertion. The floor of the primary combustion chamber is covered with refractory tiles, which permits a relatively easy repair when portions of the floor wear out due to abrasion or thermal cycling. The scissor lift has a built-in scale to comply with recordkeeping requirements. Mr. Harms states that the scissors-lift table must be lowered to the bottom before an accurate charge weight can be measured.

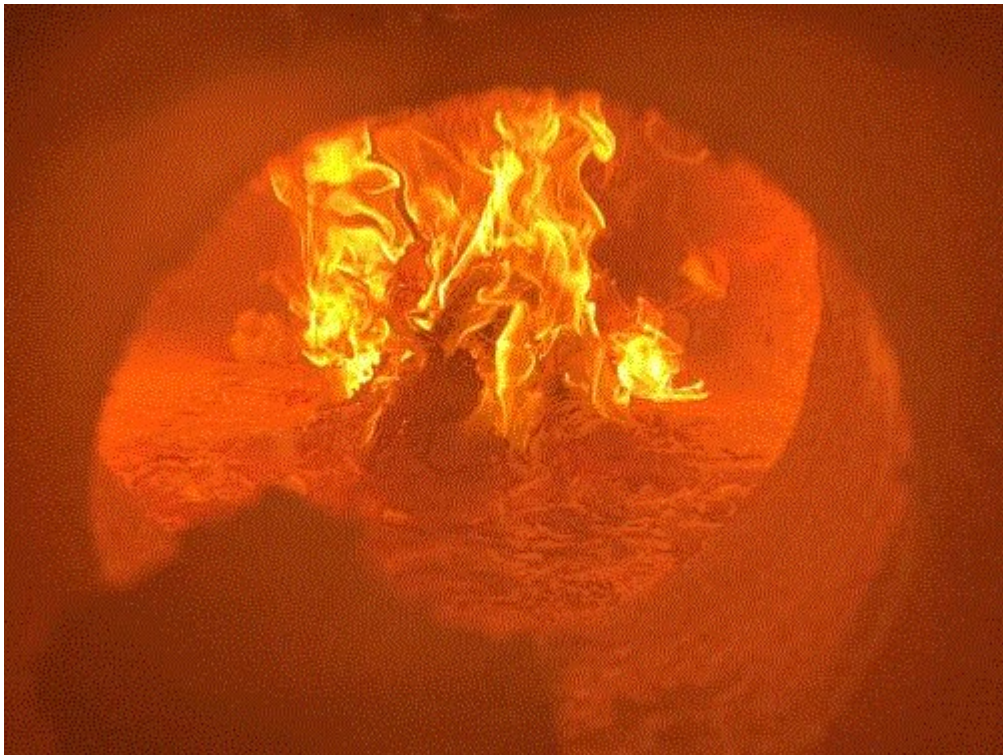
Image 4(IMG_0183.JPG) : View of cremation in progress through a sight glass located at the rear of the primary combustion chamber.

The manufacturer has instructed Lenox cremation to keep the primary combustion chamber door closed throughout the cremation cycle, which is a different procedure from other manufacturers. This procedure prevents a short-term temperature drop in the secondary combustion chamber and helps prevent intermittent visible emissions during the cremation. Mr. Harms showed me the viewing port at the rear of the primary combustion chamber, which the operator uses to determine if the cremation is complete (see photo). If the cremation is not complete, the operator can extend the cremation in 15-minute intervals.
