DEPARTMENT OF ENVIRONMENTAL QUALITY
AIR QUALITY DIVISION
ACTIVITY REPORT: Scheduled Inspection

FACILITY: Westlund Plating		SRN / ID: P0800
LOCATION: 1415 South Cooper, JACKSON		DISTRICT: Jackson
CITY: JACKSON		COUNTY: JACKSON
CONTACT: Thomas Frankini, Owner		ACTIVITY DATE: 05/08/2018
STAFF: Mike Kovalchick	COMPLIANCE STATUS: Compliance	SOURCE CLASS: MINOR
SUBJECT: Inspection of a very small decorative plating operation with no exhaust system.		
RESOLVED COMPLAINTS:

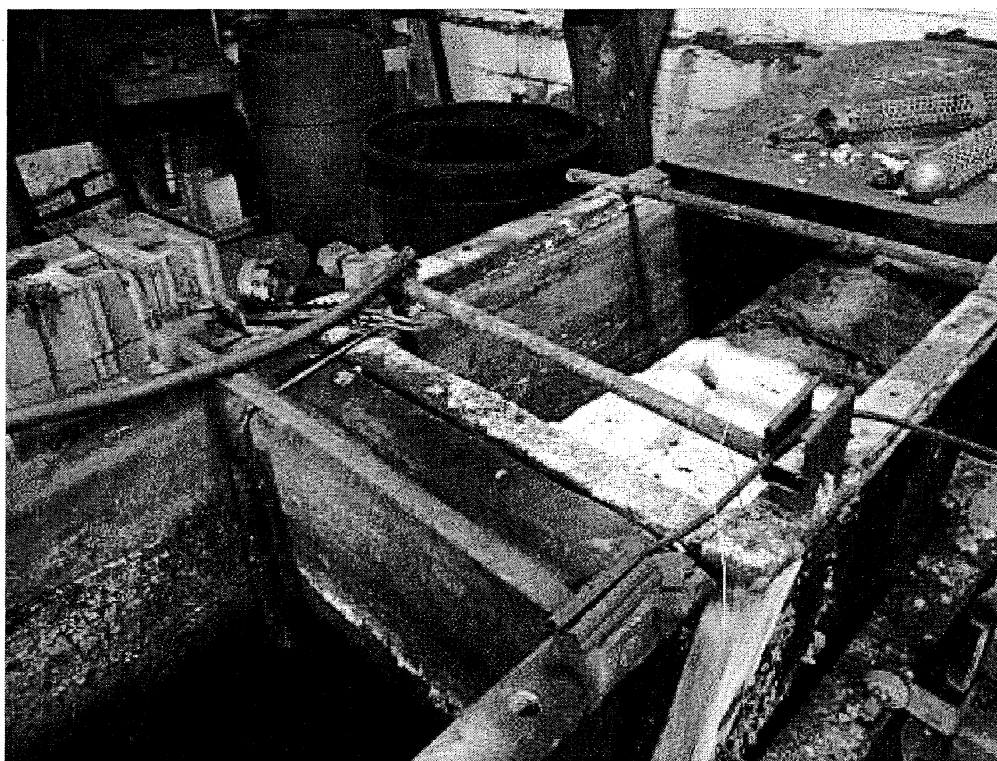
Next, I examined the evaporation tanks. They all contained a dry sludge material at the bottom. Recently, he had pumped water into them from water that had seeped into the building from heavy rains and accumulated in a low spot in the floor where the city sewer lid is located.

Image 4(Evaporation Tanks) : Evaporation Tanks

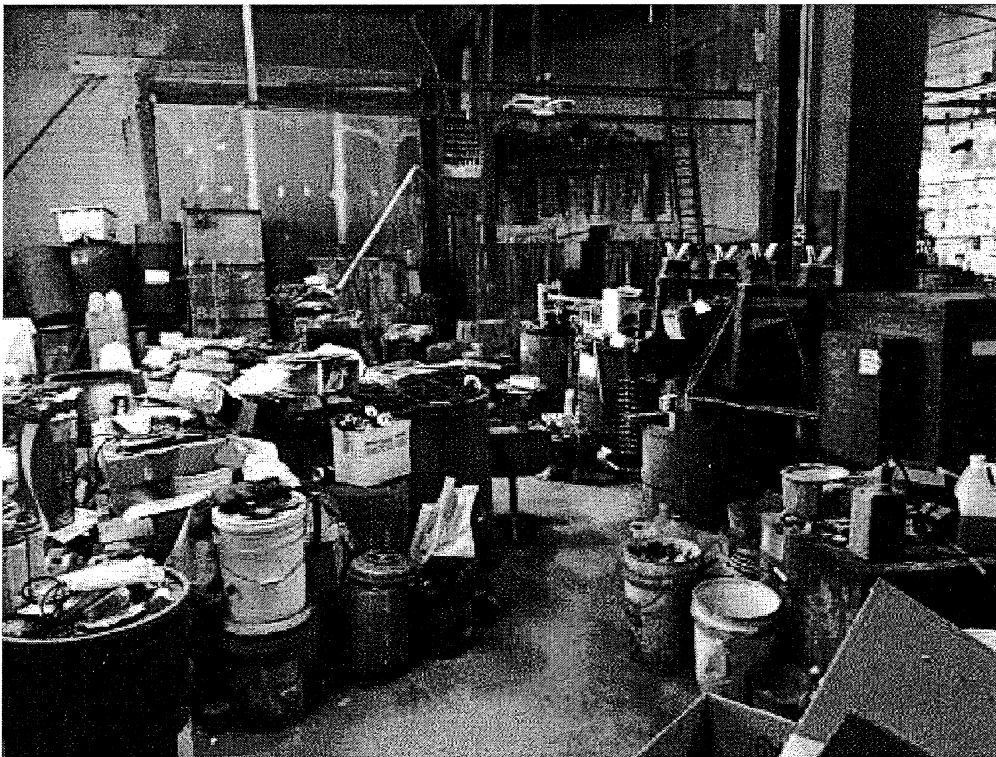
TF gave me a brief tour of the facility. Little had changed from the previous inspection that was conducted on 3/07/2017. It basically consists of a main room and smaller adjacent room. The main room contains a 50 gallon in size decorative chrome plating tank, a ten gallon decorative chrome plating tank, 2 nickel plating tanks (160 gallons), several dilute acid containers/tanks (hydrochloric and sulfuric acid) and some containers containing detergent. There was also some evaporation tanks that are used to concentrate sludge from the plating tanks. A 1928 vintage boiler was being used to heat the water in the plating tanks. 3 small rectifiers were being used to provide low voltage current to the plating tanks. He indicated that had several but only 3 are currently in working order. He said they are rated at 100, 200 and 750 amps. In a separate room, a grinding wheel was being used to grind/polish metal. Overall, both the main room and the adjacent room were very disorderly. (See attached photo.) The ceiling had no ventilation openings but along the edges of the roof line there was some small openings. The floor of the building was cement.

Image 6(Main room) : Main room
