DEPARTMENT OF ENVIRONMENTAL QUALITY  
AIR QUALITY DIVISION  
ACTIVITY REPORT: On-site Inspection

<b>FACILITY:</b> BPV Environmental LLC	<b>SRN / ID:</b> P1036
<b>LOCATION:</b> 511 76th Street SW, BYRON CENTER	<b>DISTRICT:</b> Grand Rapids
<b>CITY:</b> BYRON CENTER	<b>COUNTY:</b> KENT
<b>CONTACT:</b> Jacob Draaisma , Plant Manager	<b>ACTIVITY DATE:</b> 02/07/2024
<b>STAFF:</b> April Lazzaro	<b>COMPLIANCE STATUS:</b> Non Compliance
<b>SUBJECT:</b> Unannounced, self-initiated inspection.	<b>SOURCE CLASS:</b> MINOR
<b>RESOLVED COMPLAINTS:</b>

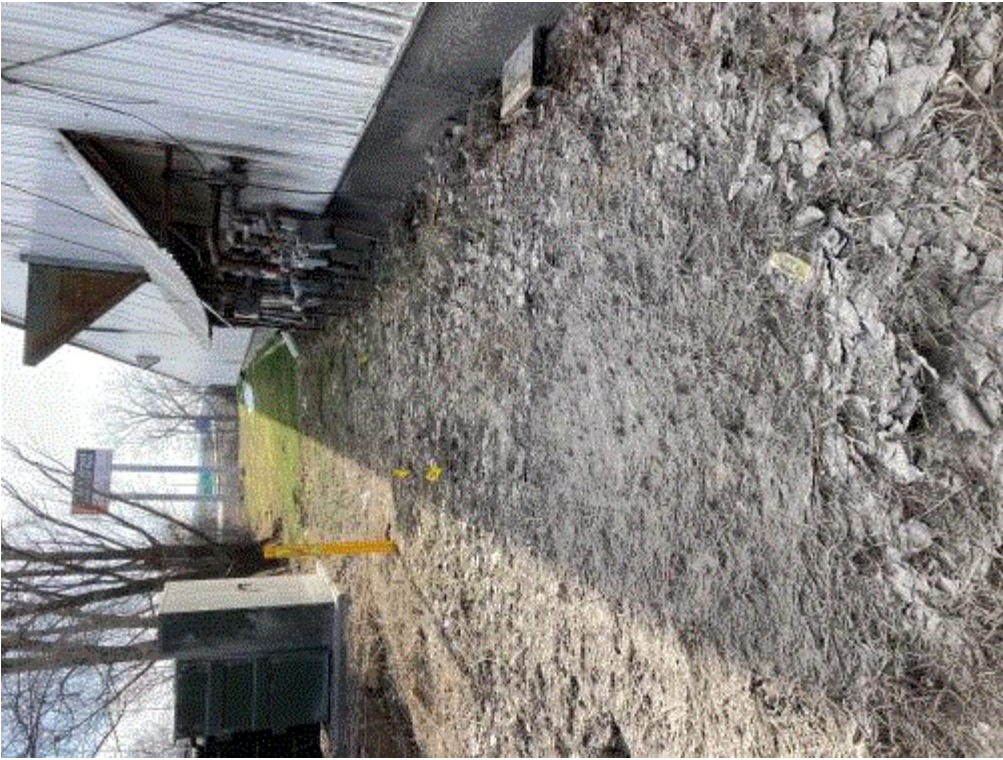
<b>Line 2:</b>	<b>Pressure drop reading</b>
<b>Unit 200</b>	<b>1.6" w.c (emitting particulate into ambient air and to the ground)</b>
<b>Unit 300</b>	<b>2.0" w.c</b>

We requested access to the exterior of the building on the eastern side that is adjacent to highway U.S. 131. We observed that Line 2 baghouse 200 was emitting paper dust outside, which was evident by the particles in the exhaust air and the accumulation of paper dust on the ground below the stack. (see photos below) This is a violation of Rule 910 and Rule 370 for failure to properly operate a control device and for failure to collect and properly dispose of an air contaminant. A Violation Notice will be issued. We also observed an unnamed stormwater collection ditch that was impacted by the paper particles and had what appeared to be accumulation of material in it.

**Image 1(Line 2 emissions)** : Paper particulate emissions from a line 2 baghouse. View image one turn clockwise.

Additionally, since there have been operational failures of the baghouses observed during both the 2019 and 2024 inspections, the AQD will request a formal Malfunction Abatement and Preventative Maintenance Plan for the lines and associated baghouses.

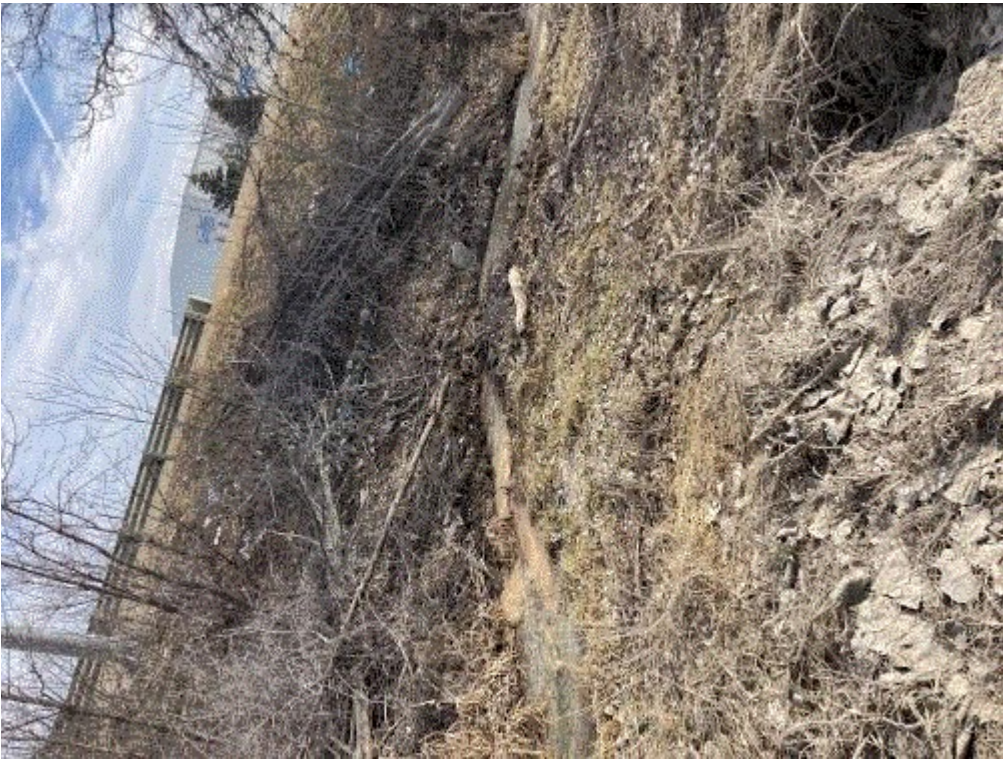
**Image 2(Line 2 emissions)** : Paper particulate emissions migrating down into water. View image one turn clockwise.

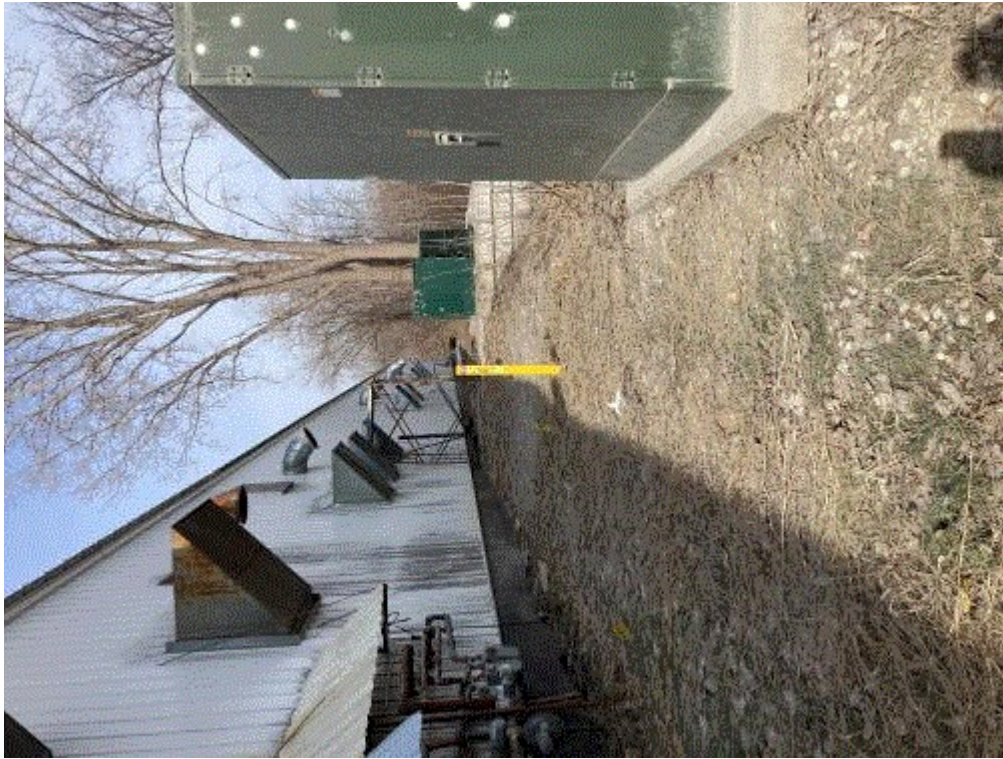
Each line operates in a roughly west to east orientation, and the baghouses are located on the east wall of the facility, and they exhaust outward horizontally or downward with a goosenecked stack along the length of the processing area.

**Image 3(Baghouse exhausts)** : Baghouse exhausts and air intakes for paper processing and pelletizing lines.
