DEPARTMENT OF ENVIRONMENTAL QUALITY
AIR QUALITY DIVISION
ACTIVITY REPORT: On-site Inspection

Facility: Bacco Construction Company (SRN: P1118)

Inspection

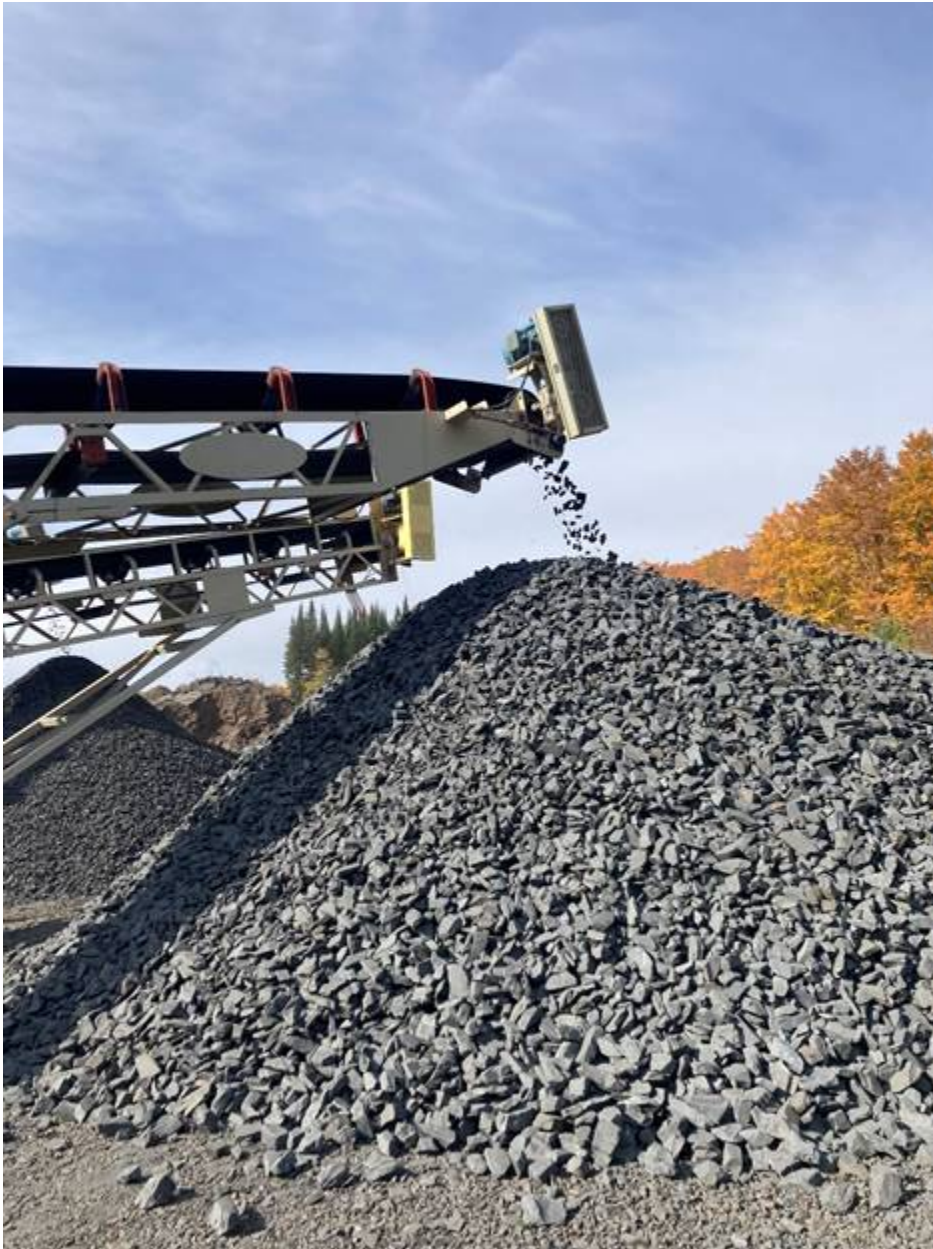
The plant was operating at the time of arrival. Rip rap was being produced. The drop heights from conveyors to transfer points were kept low to minimize dust. No visible emissions were observed from the storage piles. The plant roadways appeared well saturated and watering took place during the inspection. No exceedances of visible emissions were observed from any equipment. Additional equipment on-site included a diesel engine for power generation, water tanker, and loaders.

Image 1: Material coming off conveyor

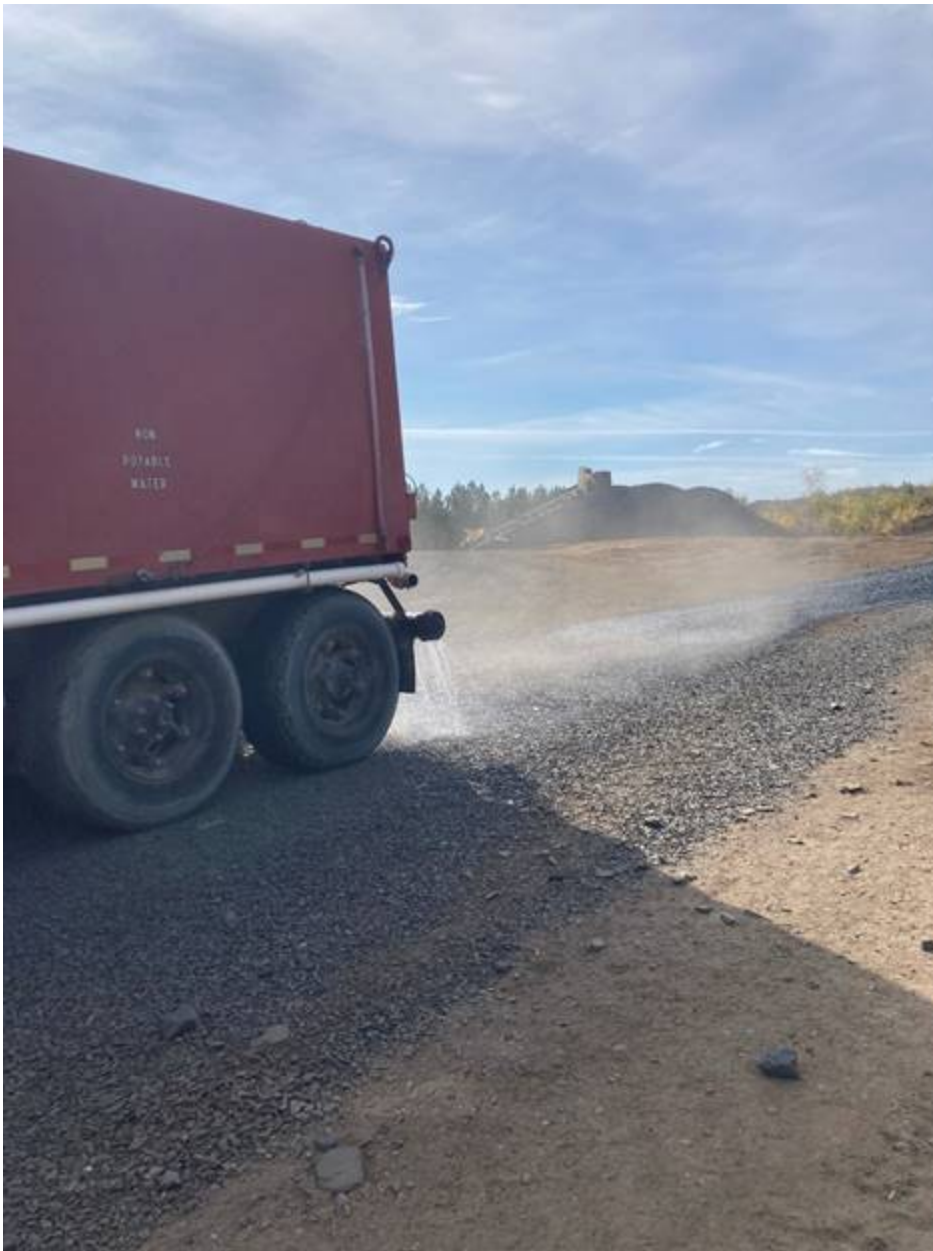
Process equipment was inspected for labels and water sprays where required. Water sprays were observed on required equipment. The table below lists the equipment that was observed on-site and labeled. Visible emission test records were provided via email following the inspection for each piece of crushing equipment on-site. All equipment passed the tests for their opacity limits.

Image 2: Water being applied
