GERDAU MACSTEEL, INC

MONROE, MICHIGAN

MONROE MILL: TESTING REPORT - CO & SO2 RATA

December 21, 2023

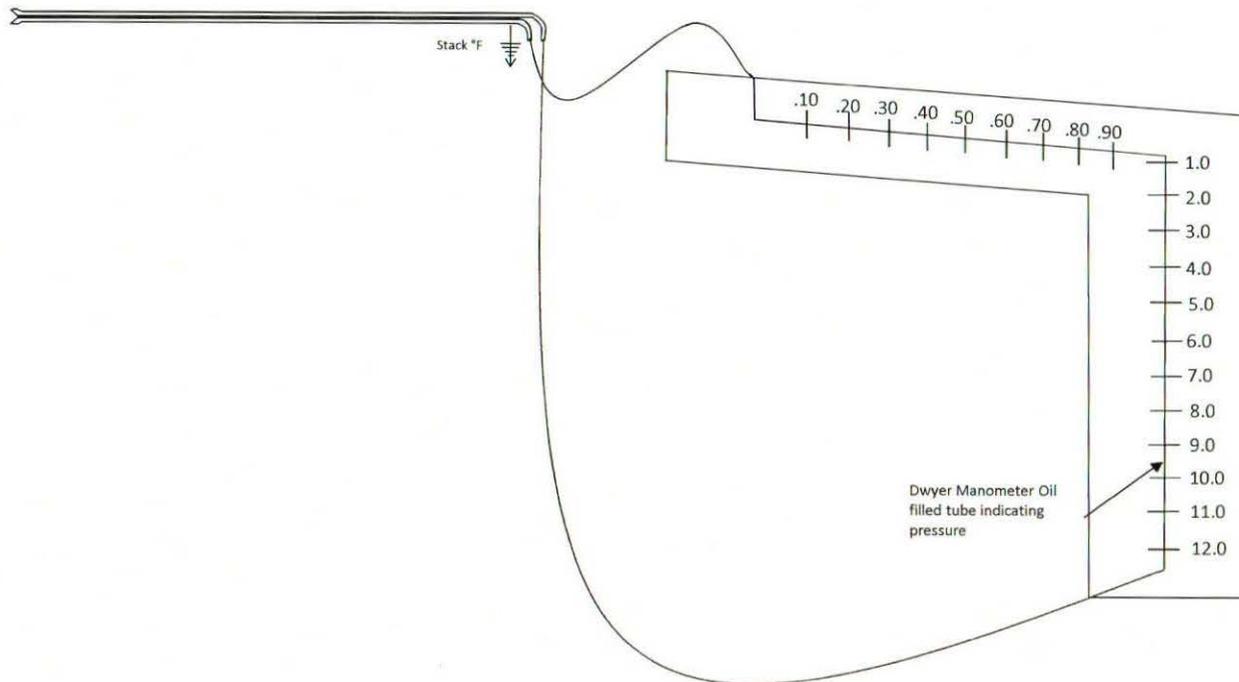
Figure 1: Schematic of US EPA Method 2

USEPA Method 2

The exhaust velocities and flow rates were determined following U.S. EPA Method 2, "Determination of Stack Gas Velocity and Volumetric Flow Rate (Type S Pitot Tube)". Velocity measurements were taken with a pre-calibrated S-Type pitot tube and incline manometer or digital manometer. Volumetric flow rates were determined following the equal area method as outlined in U.S. EPA Method 2. Temperature measurements were made simultaneously with the velocity measurements and were conducted using a chromel-alumel type "k" thermocouple in conjunction with a calibrated digital temperature indicator.

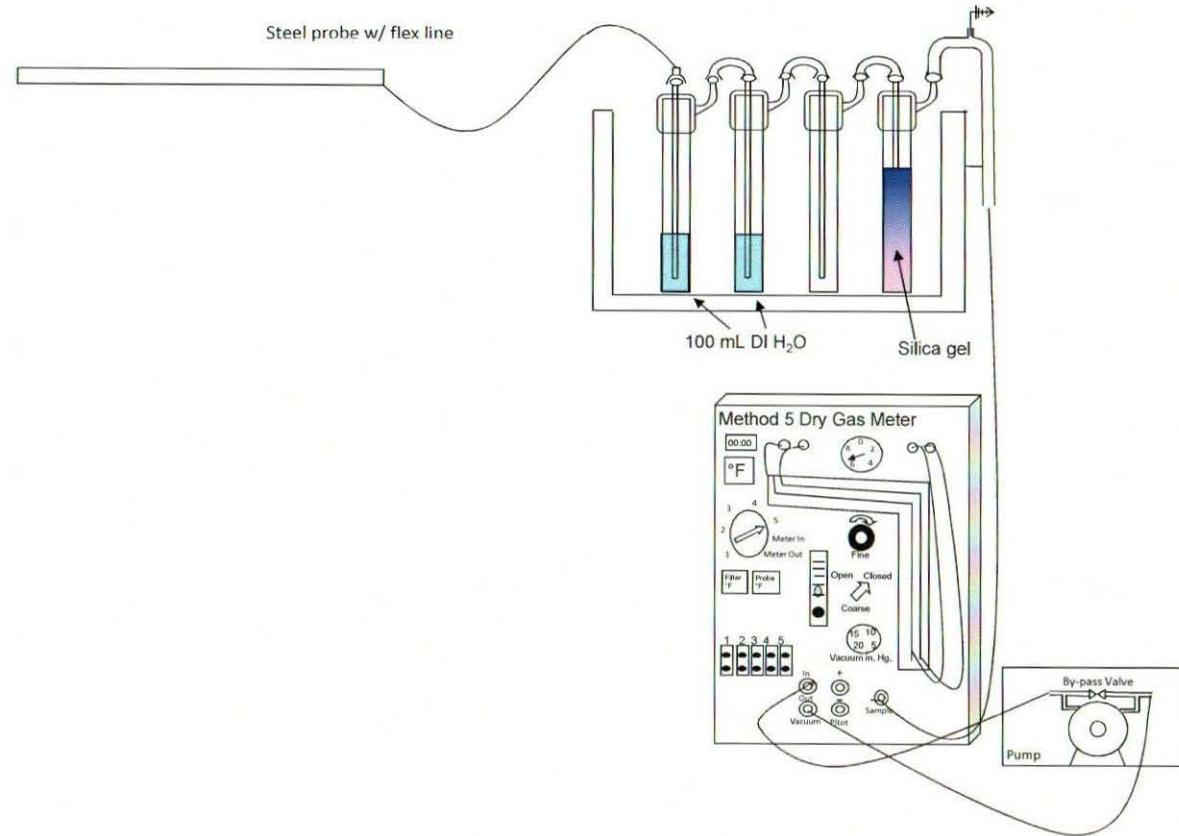
Figure No. 2: Schematic of US EPA Method 4

USEPA Method 4

Stack moisture content was determined through direct condensation and according to U.S. EPA Method 4, "Determination of Moisture Content of Stack Gases". A schematic of the Method 1 to 4 sampling train is provided in the **Figure Tab**. A single (1) 30-minute moisture test was conducted for every three (3) RATA tests.

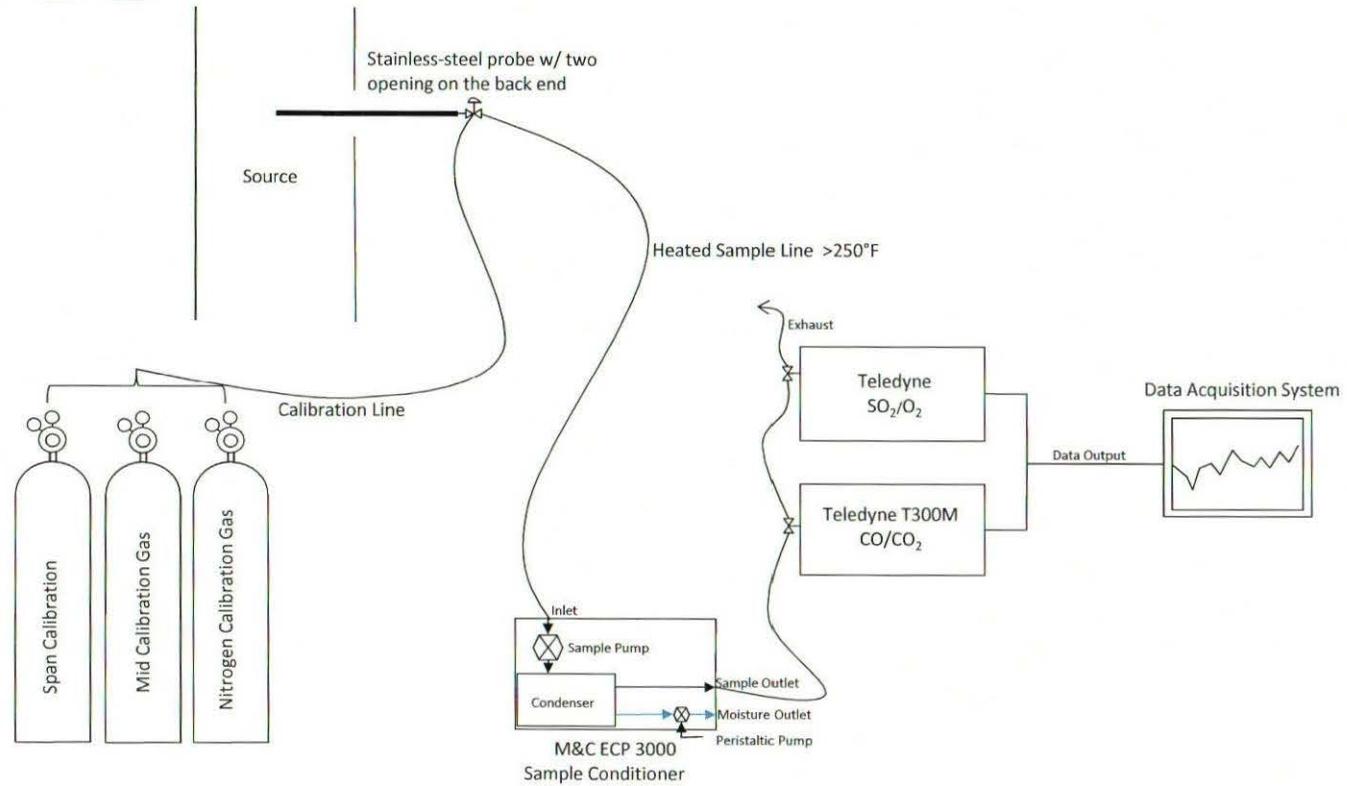
Figure No.3

USEPA Method 3A,6C,10

SO₂, CO₂, O₂, and CO concentrations were determined utilizing RWDI's continuous emissions monitoring (CEM) system. Prior to testing, a 3-point analyzer calibration error check was conducted using USEPA protocol gases. The calibration error check was performed by introducing zero, mid and high-level calibration gases directly into the analyzer. The calibration error check was performed to confirm that the analyzer response is within $\pm 2\%$ of the certified calibration gas introduced. Prior to each test run, a system-bias test was performed where known concentrations of calibration gases were introduced at the probe tip to measure if the analyzers response was within $\pm 5\%$ of the introduced calibration gas concentrations. At the conclusion of each test run a system-bias check was performed to evaluate the percent drift from pre and post-test system bias checks. The system bias checks were used to confirm that the analyzer did not drift greater than $\pm 3\%$ throughout a test run.

A gas sample was continuously extracted from the stack and delivered to a series of gas analyzers, which measure the pollutant or diluent concentrations in the gas. The analyzers were calibrated on-site using EPA Protocol No. 1 certified calibration mixtures. The probe tip was equipped with a sintered stainless-steel filter for particulate removal. The end of the probe was connected to a heated Teflon sample line, which delivered the sample gases from the stack to the CEM system. The heated sample line was designed to maintain the gas temperature above 250°F to prevent condensation of stack gas moisture within the line.

Before entering the analyzers, the gas sample passed directly into a refrigerated condenser, which cools the gas to approximately 35°F to remove the stack gas moisture. After passing through the condenser, the dry gas entered a Teflon-head diaphragm pump and a flow control panel, which delivered the gas in series to the analyzers. Each of these analyzers measured the respective gas concentrations on a dry volumetric basis.

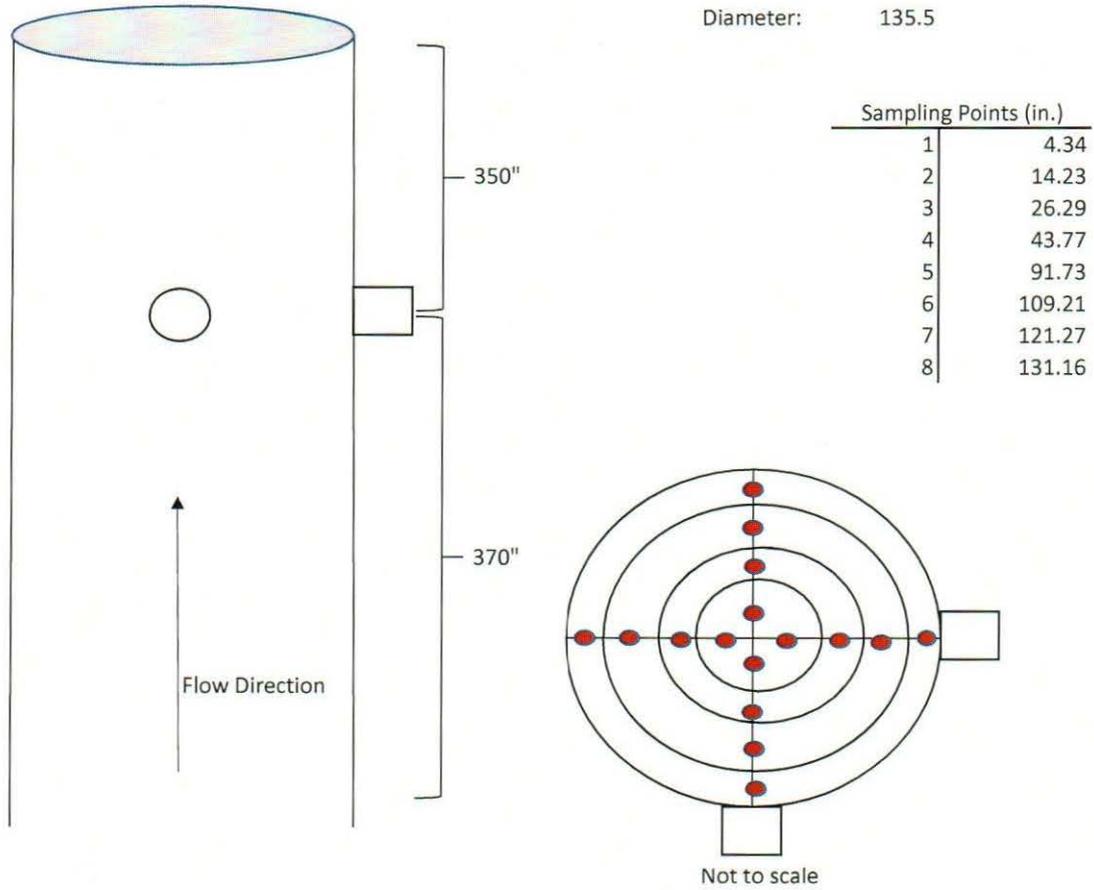
Figure No. #4

EUEAF East
Gerdau
Monroe Mill
Monroe, Michigan

Stack figures can be found in the **Figures Tab**. The EUEAF stacks met USEPA Method 1 requirements.

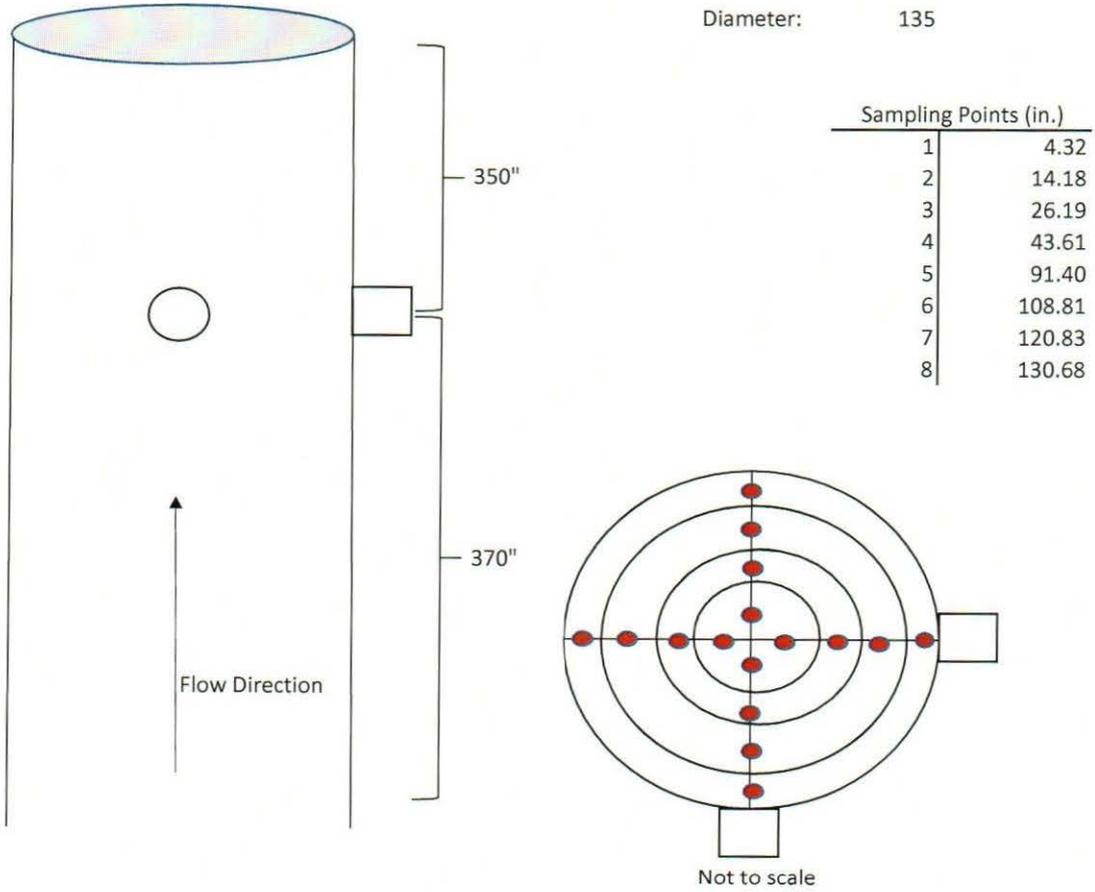
Figure No. #5

EUEAF West
Gerdau
Monroe Mill
Monroe, Michigan
