DEPARTMENT OF ENVIRONMENTAL QUALITY
AIR QUALITY DIVISION
ACTIVITY REPORT: On-site Inspection

FACILITY: Crop Production Services - Woodbury		SRN / ID: B7364
LOCATION: 211 REESE ST, WOODBURY		DISTRICT: Lansing
CITY: WOODBURY		COUNTY: EATON
CONTACT: Clay Martz , Facility Manager		ACTIVITY DATE: 10/26/2021
STAFF: Michelle Luplow	COMPLIANCE STATUS: Compliance	SOURCE CLASS: MINOR
SUBJECT: Onsite, unannounced inspection to determine compliance with PTI 7-15 for anhydrous ammonia tanks.		
RESOLVED COMPLAINTS:

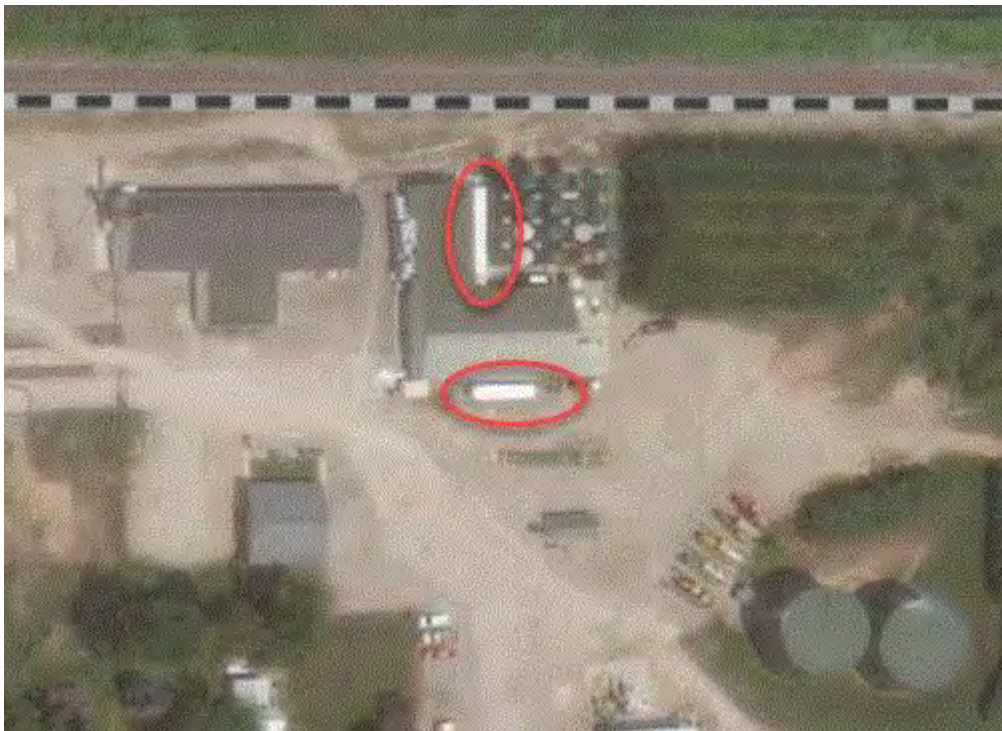
Image 1(NH3 tanks installed) : Aerial Bing maps photo of the site prior to removal of the 2 tanks.

C. Martz stated that both the 18,000-gallon and 30,000-gallon anhydrous ammonia tanks have been removed from the facility. He took me to the 2 locations where the tanks were stored. The 18,000-gallon tank was installed south of the liquid storage building, oriented east to west. The 30,000-gallon tank was installed on the north side of the liquid storage building, oriented north to south. I verified both tanks had been completely removed. Photos were

discouraged while onsite. Attached are aerial maps (Bing maps for tanks installed, Google maps for tanks uninstalled) to show where the tanks were and that they have been removed.

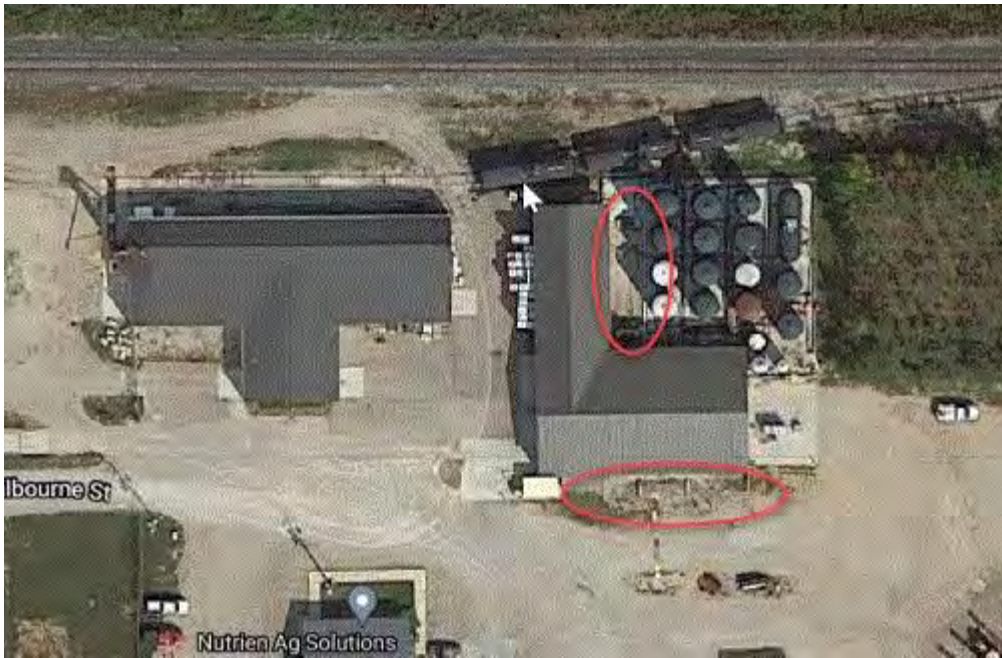
Image 2(Tanks removed) : Note the tanks have been removed according to Google maps aerial photo.

I will submit a request to void PTI 7-15 and have a copy sent to C. Martz.
