**DEPARTMENT OF ENVIRONMENTAL QUALITY
AIR QUALITY DIVISION
ACTIVITY REPORT: On-site Inspection**

N782274757

FACILITY: TRENDWELL ANTRIM INC- Section 4 Wells		SRN / ID: N7822
LOCATION: SECT 4 WELLS SW SW NW SEC 4 T29N R2E, ALBERT TWP		DISTRICT: Gaylord
CITY: ALBERT TWP		COUNTY: MONTMORENCY
CONTACT:		ACTIVITY DATE: 10/29/2024
STAFF: Tammie Puite	COMPLIANCE STATUS: Compliance	SOURCE CLASS: SM OPT OUT
SUBJECT: 2025 FCE Inspection		
RESOLVED COMPLAINTS:

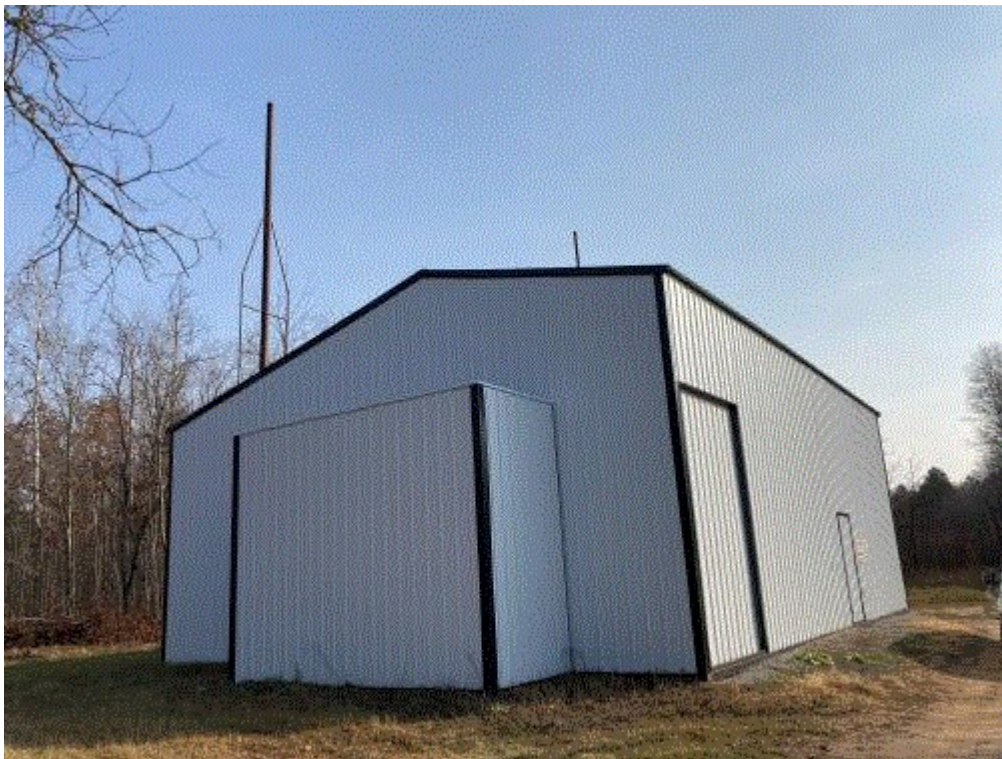
Image 1(N7822) : Exterior View of Building

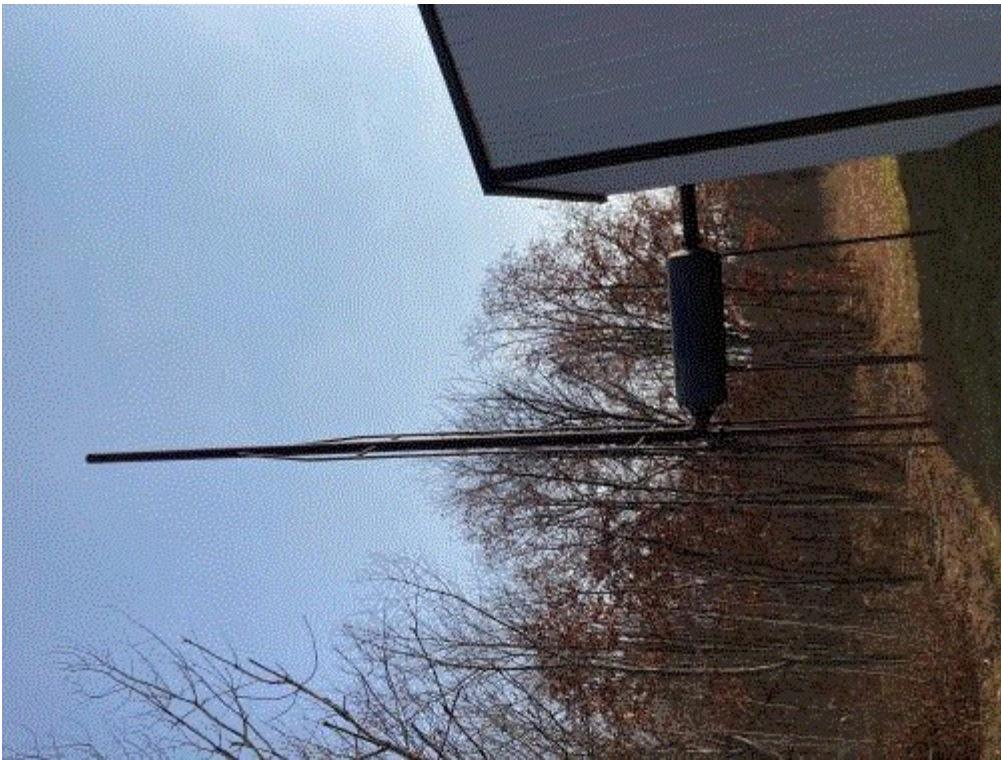
The exhaust stack for the engine is to have a maximum diameter of 8 inches and a minimum height above ground of at least 52 feet. The stack appears to meet these requirements. The stack is equipped with a muffler for noise control. It does not have any catalytic control device.

Image 2(Stack) : Stack with Muffler

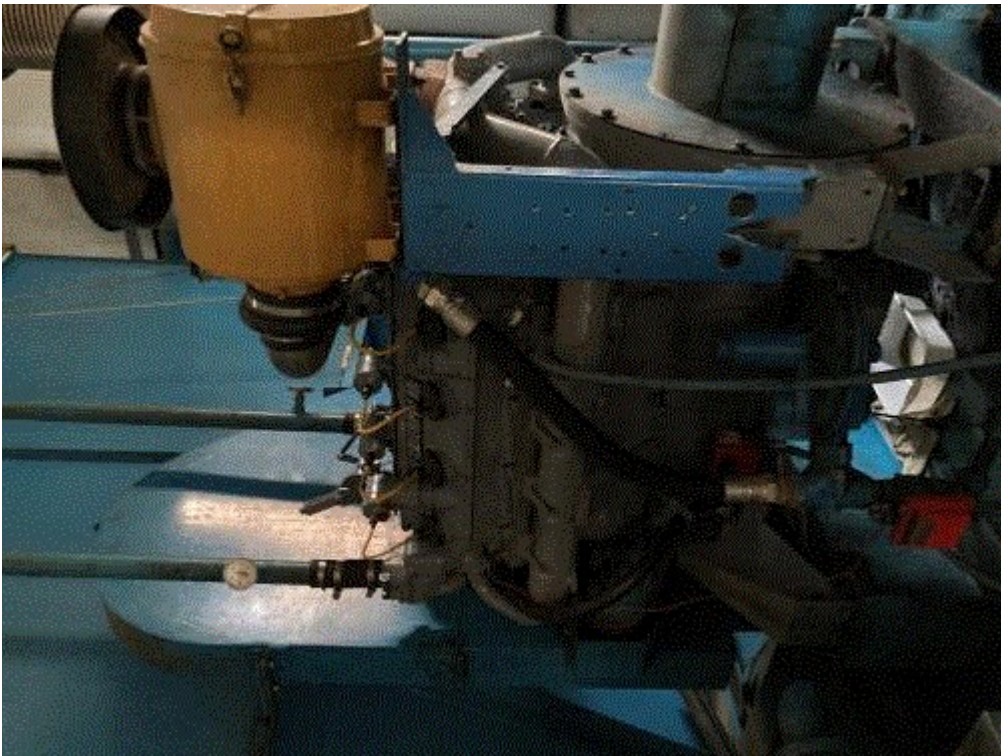
- Operating at 1103 RPM
- Oil Pressure – 59 psi

Image 3(EUENGINE 1) : CAT G3408 NA, 8 cylinder, 255 HP, 190 KW, 1800 RPM, Engine Serial # GNB01889, Unit # 2025

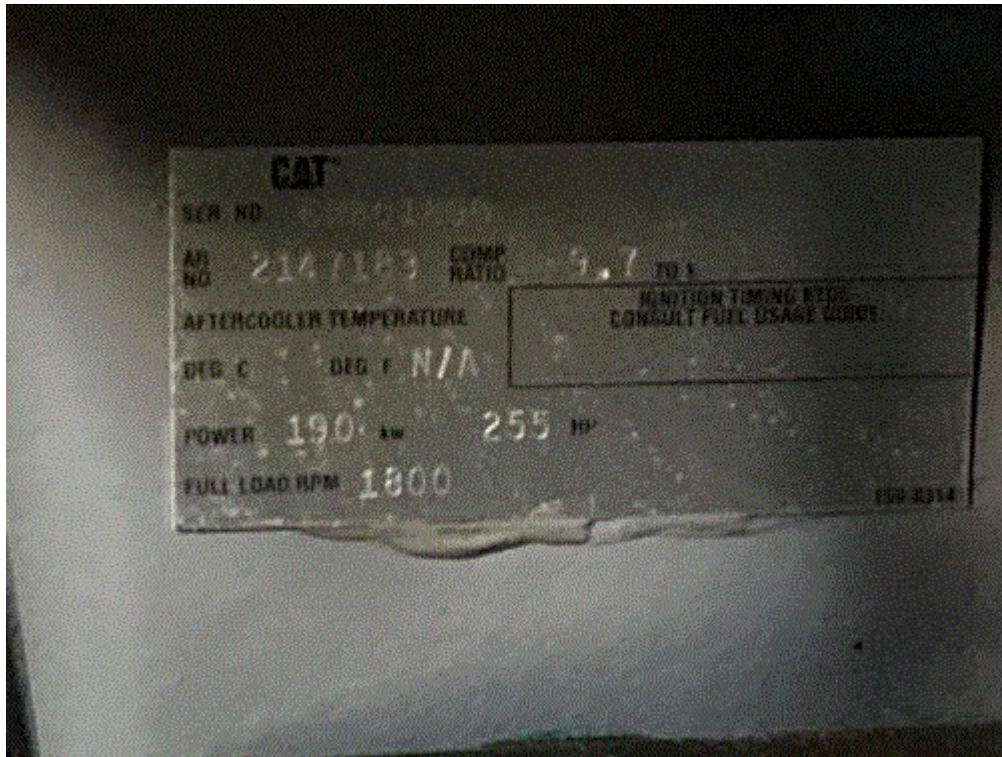
The permitted engine matches the engine onsite, but the engine that is reported in Emissions Reporting and Equipment Inventory is different. I will follow up with the company to correct this.

Image 4(Engine Tag) : CAT G3408 NA, 8 cylinder, 255 HP, 190 KW, 1800 RPM, Engine Serial # GNB01889, Unit # 2025

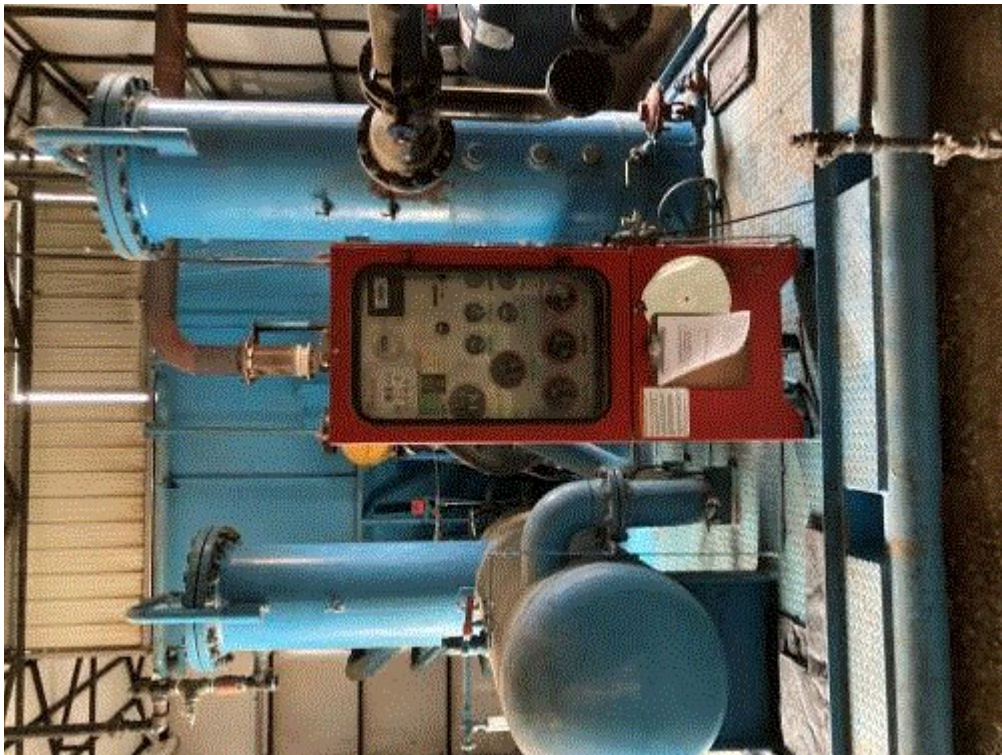
Image 5(Image of Engine) : Engine on Skid
