**DEPARTMENT OF ENVIRONMENTAL QUALITY
AIR QUALITY DIVISION
ACTIVITY REPORT: Self Initiated Inspection**

FACILITY: Elm Plating Co. - Hupp Street	SRN / ID: P0636
LOCATION: 533 Hupp Street, JACKSON	DISTRICT: Jackson
CITY: JACKSON	COUNTY: JACKSON
CONTACT: Brian Boyer , Director of Environmental Engineering	ACTIVITY DATE: 12/14/2018
STAFF: Stephanie Weems	COMPLIANCE STATUS: Compliance
	SOURCE CLASS: SM OPT OUT
SUBJECT: Self-Initiated Partial Compliance Inspection (PCE) of Elm Plating (Plant 3), a HAP Synthetic Minor / Opt-Out Source conducted in response to request for termination of CO 27-2016.	
RESOLVED COMPLAINTS:

Self-Initiated Partial Compliance Inspection (PCE) of Elm Plating (Plant 3), a HAP Synthetic Minor / Opt-Out Source.

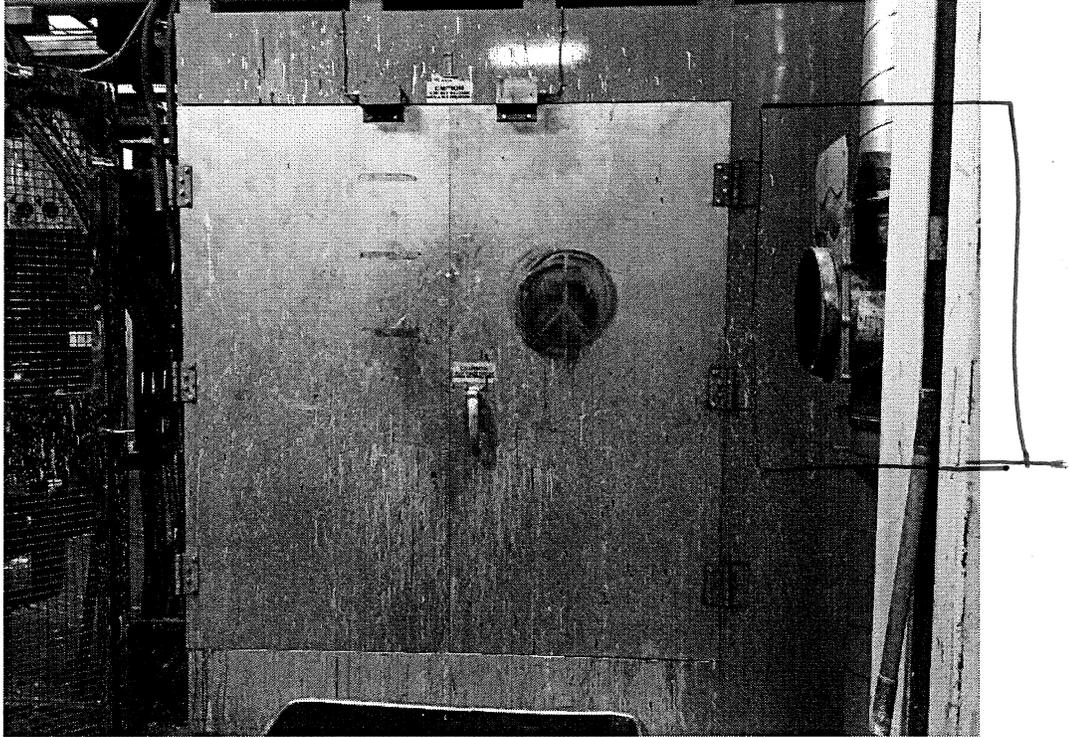
Image 3: EU-DIPSPIN1

There were little to no VOC odors prevalent throughout the facility. There was an open duct on the wall, seen in Image 3, near Line 1 that Sam explained helped to pull building air in and duct it to the RTO. This helps to limit the amount of VOCs in the in-plant air.

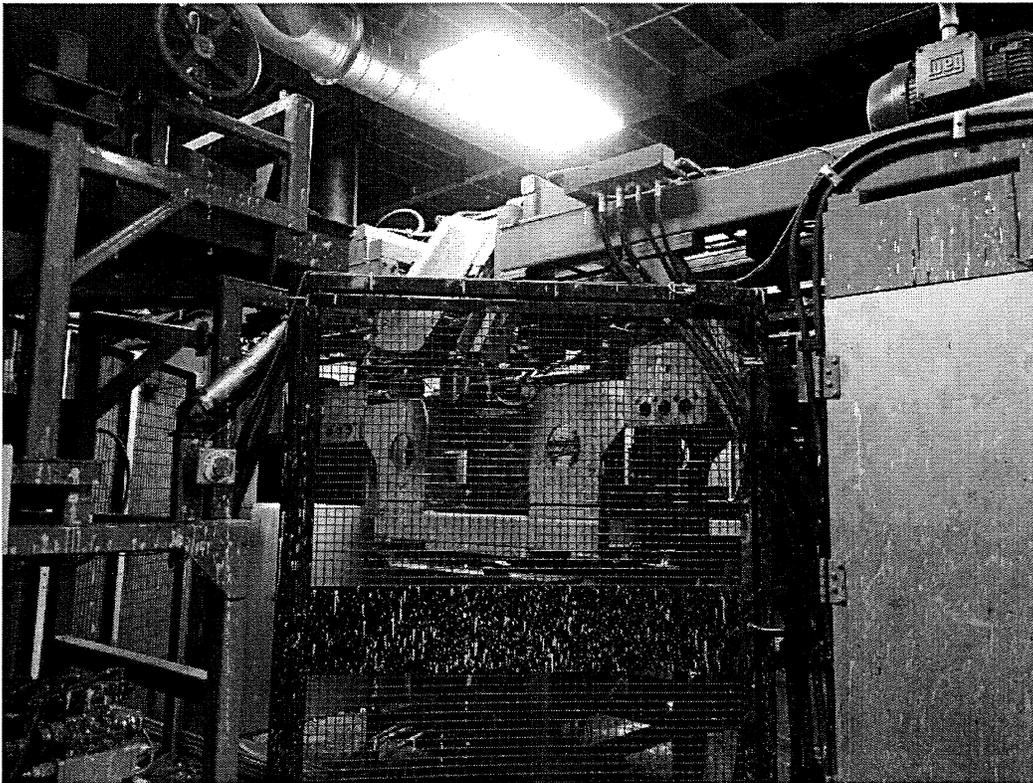
Image 4: EU-DIPSPIN1

Coating Line No. 1 (EU-DIPSPIN1) consists of two (2) dip-spin coating reservoirs followed by a natural gas fired conveyorized curing oven with two zones. The first oven zone (preheat) is heated with a 1.5 MMBtu/hr burner. The second oven burner (curing) is heated with a 2.5 MMBtu/hr burner.

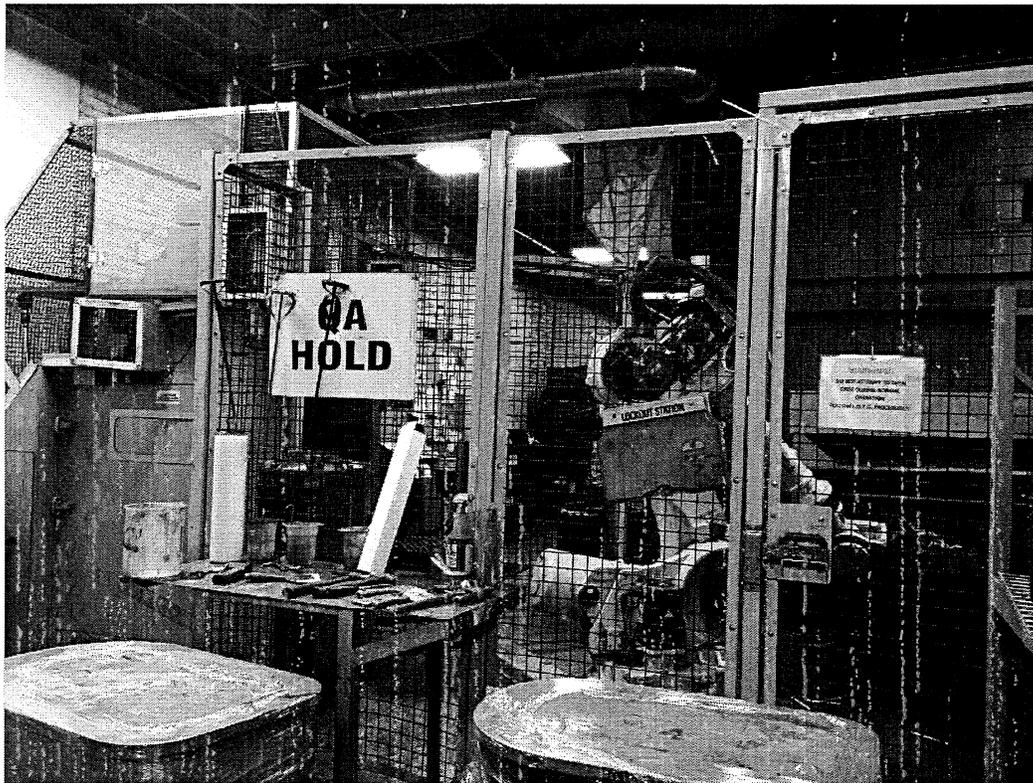
Image 2: EU-DIPSPIN2

Coating Line No. 2 (EU-DIPSPIN2) consists of one (1) dip-spin coating reservoir and a separate natural gas fired conveyorized curing oven with one zone. Parts are transferred approximately 25 feet from the dip-spin coating reservoir to the curing oven by robotic arm. The curing oven is heated with a 3.0 MMBtu/hour burner.

Sam and Brian gave us a tour of the facility, showing us both of the original dip-spin lines (EU-DIPSPIN1 and EU-DIPSPIN2). Both lines were operating. Line 2 was located near the entrance to the facility. This line was operated by a robotic arm that inserted the steel baskets into the coating reservoir, and at the end of the process, dumped the coated products onto the oven conveyor. See Image 2 attached. Line 1 was located further within the facility. This consisted of two larger coating reservoirs. See Images 3 and 4 attached. Sam stated that, once the third line becomes operational and completes their production tests, these dip-spin lines will be removed.

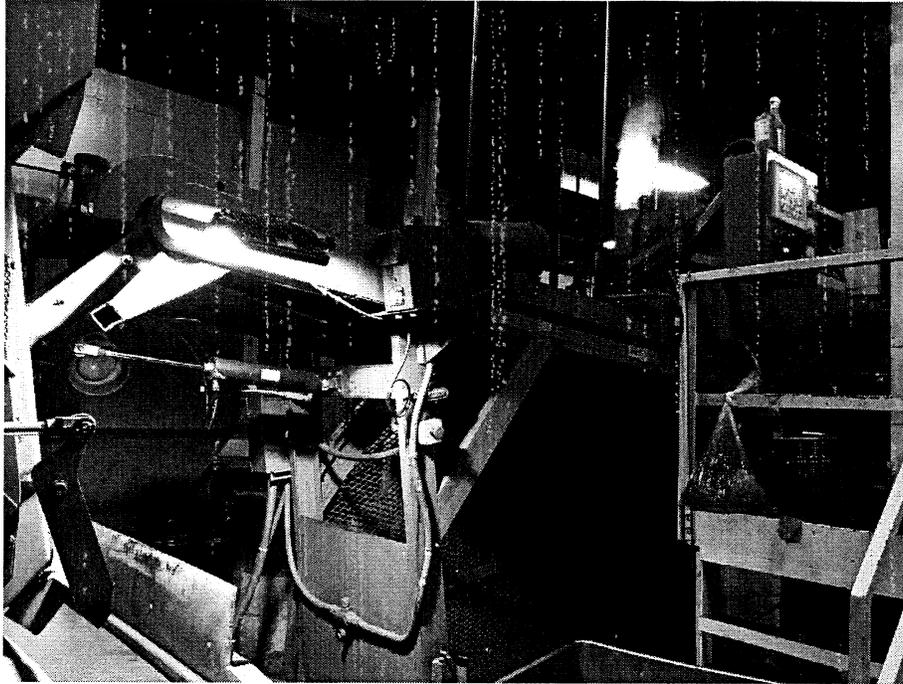
Image 5: Water-cooled shot blaster

The water-cooled shot blaster (see Image 5) was in operation while the table blaster was not. These processes use a separate dust collector. The shot blaster is exhausted internally, while the table blaster is exhausted externally. Sam explained that once the third line becomes operational, the shot blaster and table blaster will no longer be used either.

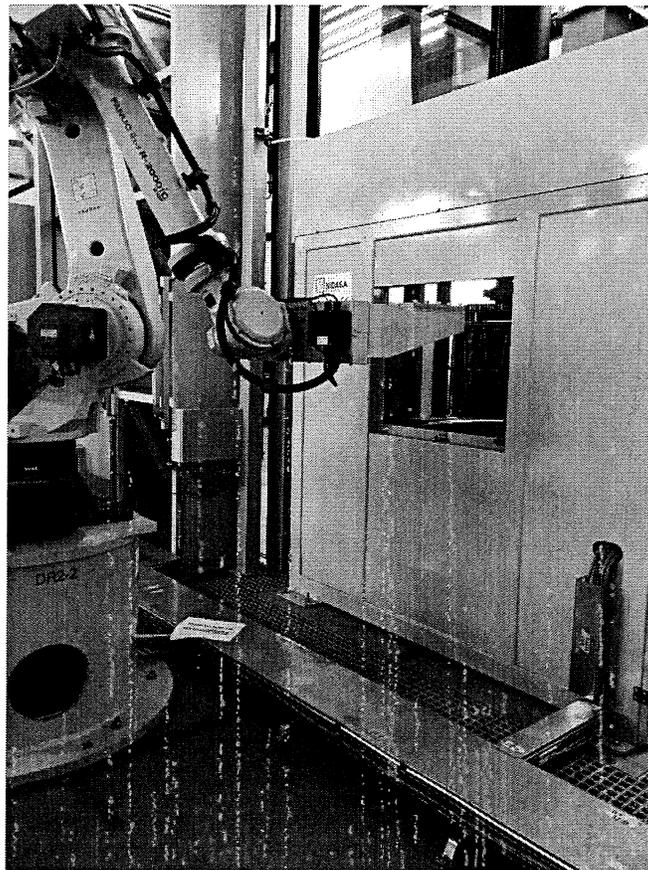
Image 6: EU-DIPSPIN3 reservoir

We were then directed into the newly building's new addition. This is where the third dip-spin line is being installed. Sam explained to us how the robotic arms lift and move the steel mesh baskets between the coating reservoirs and the ovens. There are three coating reservoirs that can spin up to three mesh baskets at a time. Each of these three reservoirs are housed within their own dip-spin booth, and the entire coating and heating process is housed within a booth. The exhaust from the dip-spin booths and the enclosed process is routed to the RTO. See Images 6 and 7. Sam explained how all three coatings of the product will occur back-to-back within the enclosed process, instead of their current way of moving coated parts from line to line to complete all three coatings. He also stated that the new oven will have three levels so that each step of the coating process will be able to be heated in the oven simultaneously.

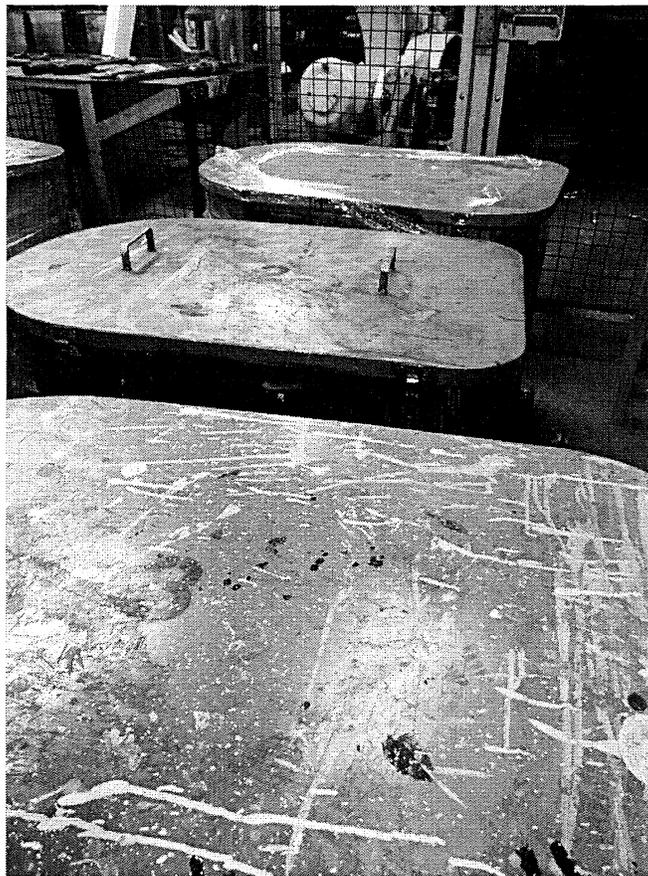
Image 8: Storage of paint/solvents

Storage of paint/solvents appeared to be done properly with closed lids on everything and generally good housekeeping throughout. See Image 8.

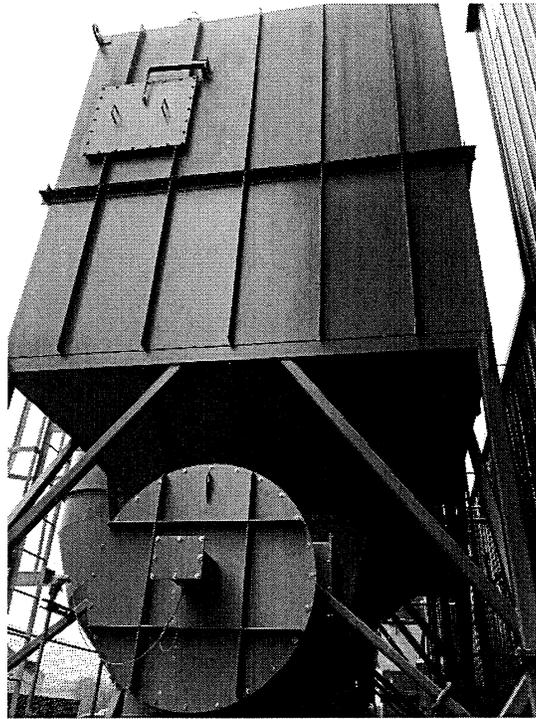
Image 9: RTO

Next, Sam and Brian showed us the RTO. Images 9 and 10 show one angle of the RTO. When shown into the control room, I was able to see that the combustion zone reading was 1504 degrees F, meeting the requirements of their permit. According to Brian, the RTO runs continuously when the lines are operating, and production cannot start on the lines unless the RTO is operational.
