Aquatic Study

# *Aquatic Assessment*

Kennecott Minerals Company  
Eagle Project  
Marquette County, Michigan

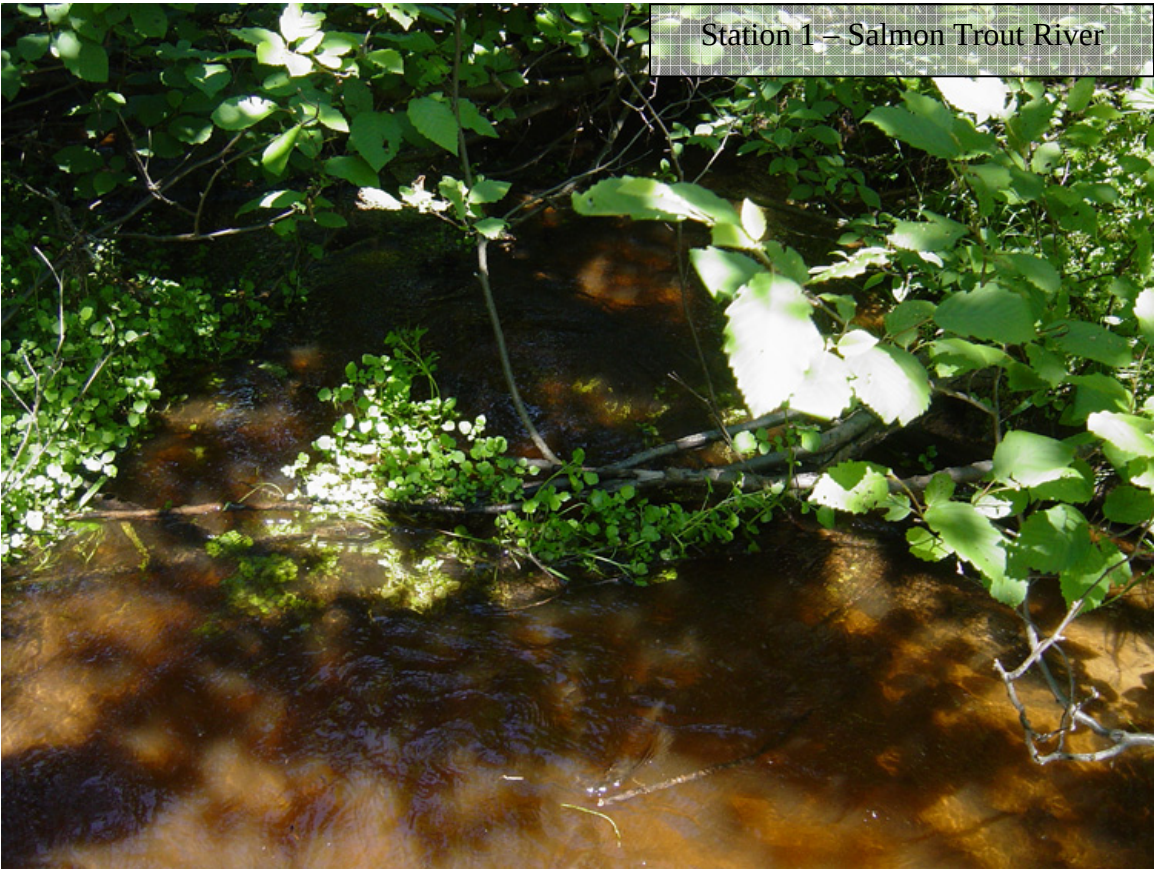
Station 1 – Salmon Trout River

Station 1 is located at the downstream end of the study area within a remote part of the river valley. The river averages approximately 6 ft (1.8 m) in width and 3.5 inches (9 cm) in depth. On the date of sampling, Station 1 had an estimated surface velocity of 2.6 ft/second (0.8 m/sec) and a water temperature of 52°F (11°C). The sampling station is 125 ft (38 m) in length and covers approximately 755 ft<sup>2</sup> (70 m<sup>2</sup>).

The habitat evaluation for Station 1 also resulted in an excellent rating (**Table 3, Appendix B**). The station was considered to be a riffle/run stream and received a total score of 179 out of a possible score of 200. The reach is high gradient with substrates dominated by gravel, sand, and a wide variety of cover and habitat types are present. Eel grass (*Vallisneria*

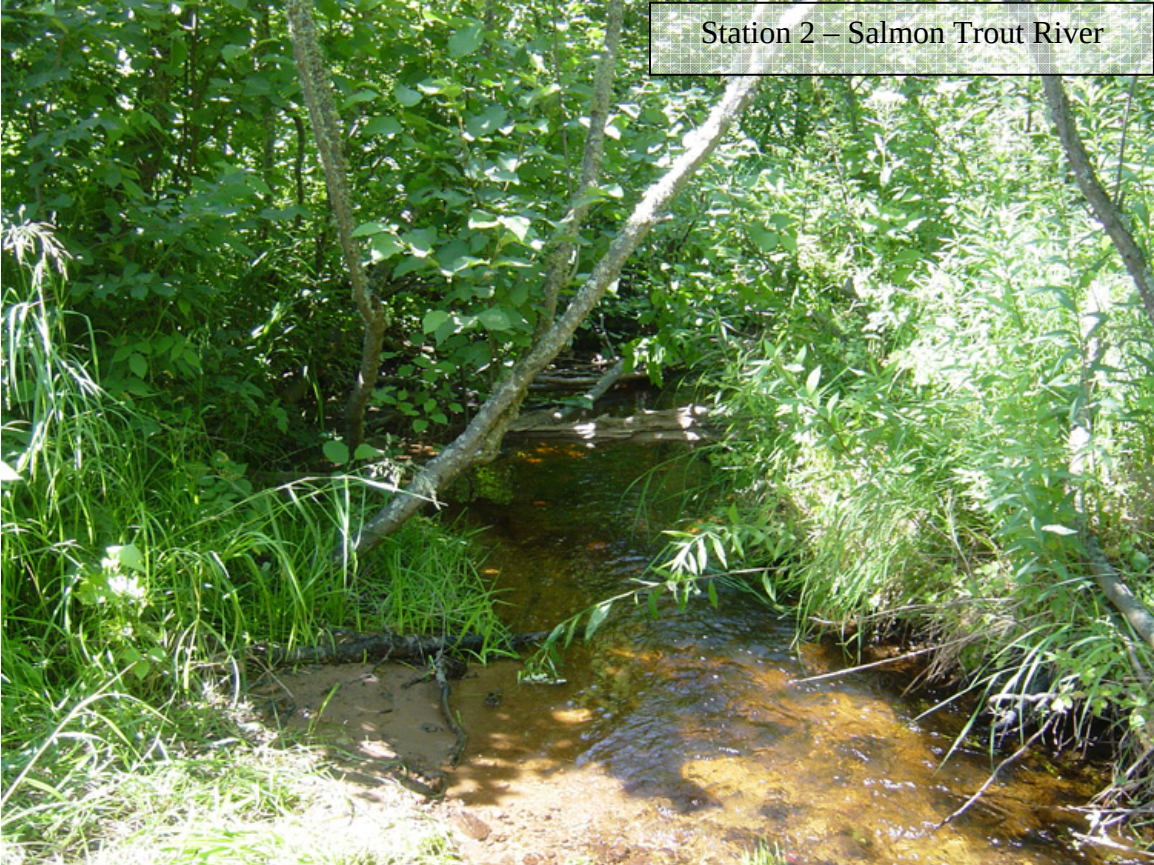
Station 2 – Salmon Trout River

The habitat score was 161 on the glide/pool rating system, giving Station 2 an excellent rating (**Table 3, Appendix B**). The station is lower gradient than Station 1 and substrate is dominated by sand and other fine materials. Eel grass, watercress and attached algae were observed growing within the stream, and the banks are covered by sedge meadow and scrub-shrub vegetation. Sedge meadow is dominated by bluejoint grass, while the scrub-shrub is dominated by tag alder.

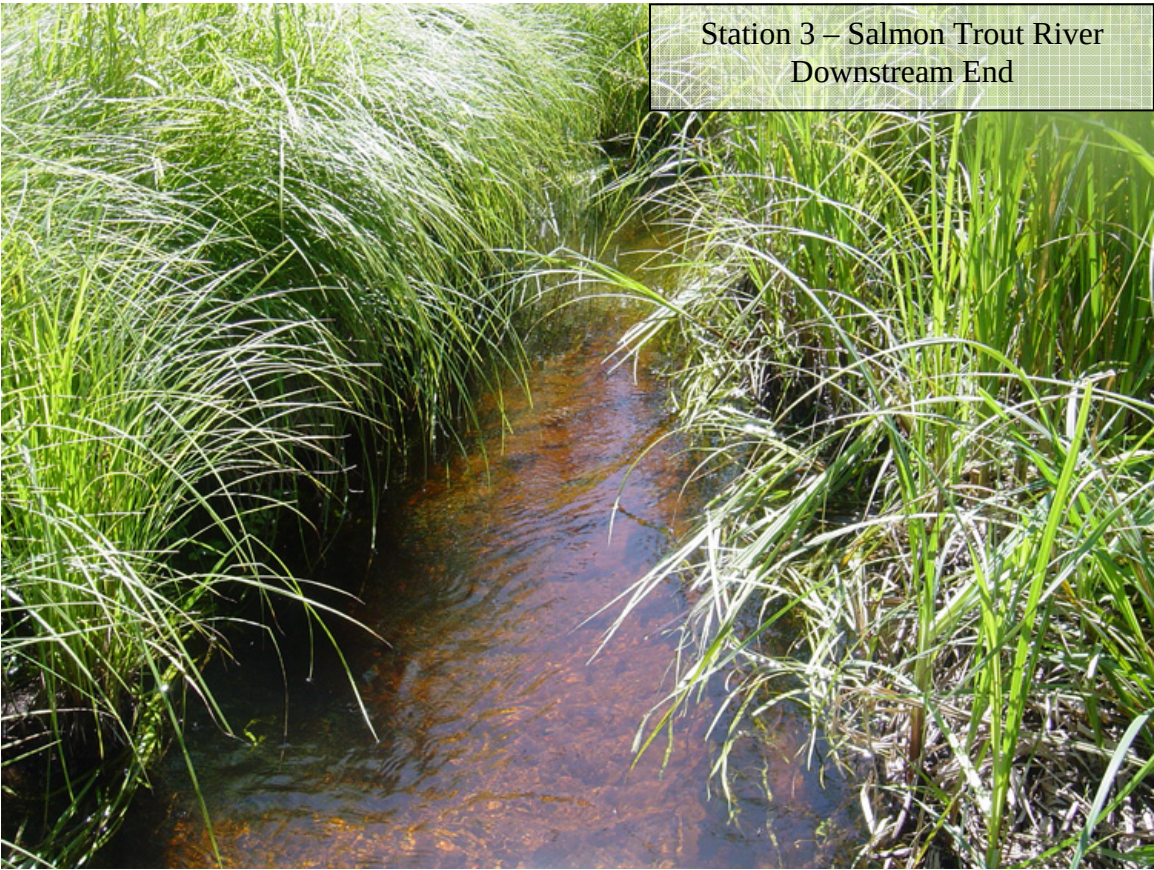
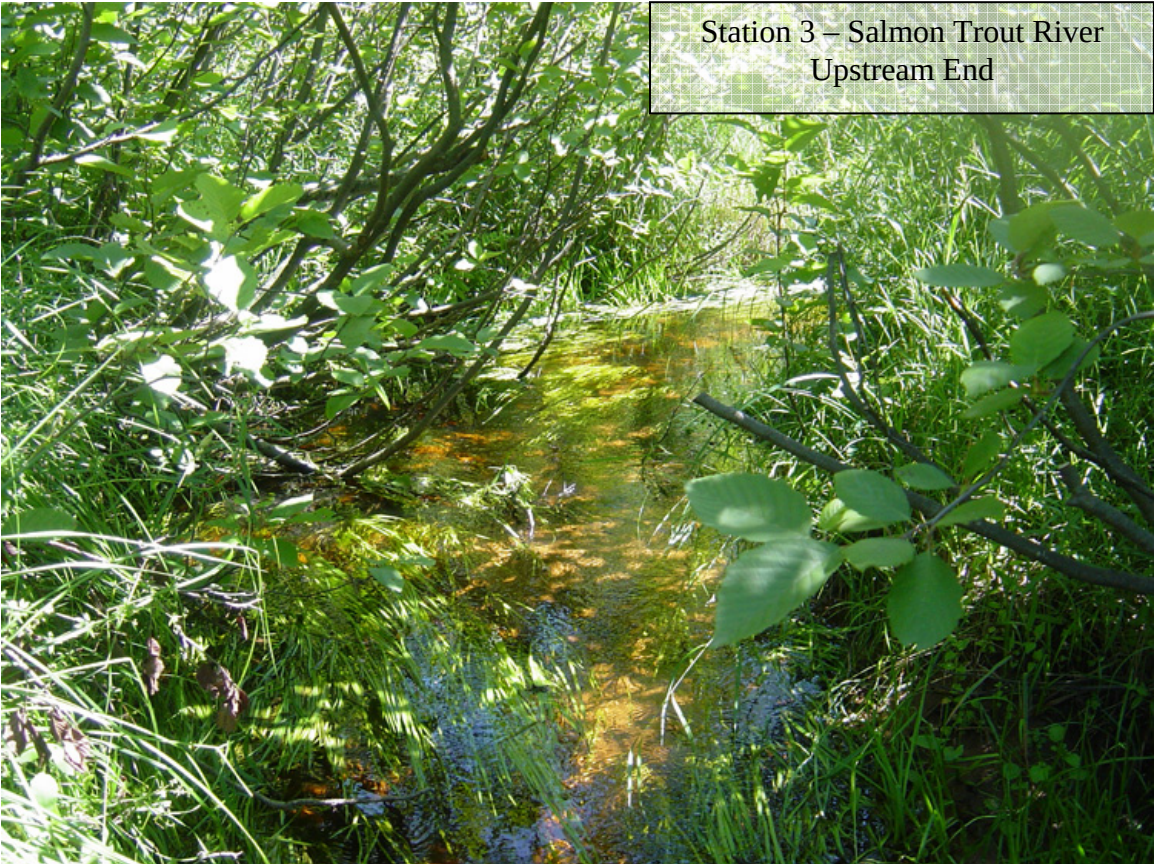
Habitat was also rated as excellent at Station 3, scoring 165 (**Table 3, Appendix B**). The station is characterized as a riffle/run system and has moderate gradient with sand and coarse substrate. Similar to the previous two stations, eel grass, watercress and attached algae were found growing with the channel. Riparian vegetation is dominated by tag alder, providing a very dense cover and root masses within the stream.

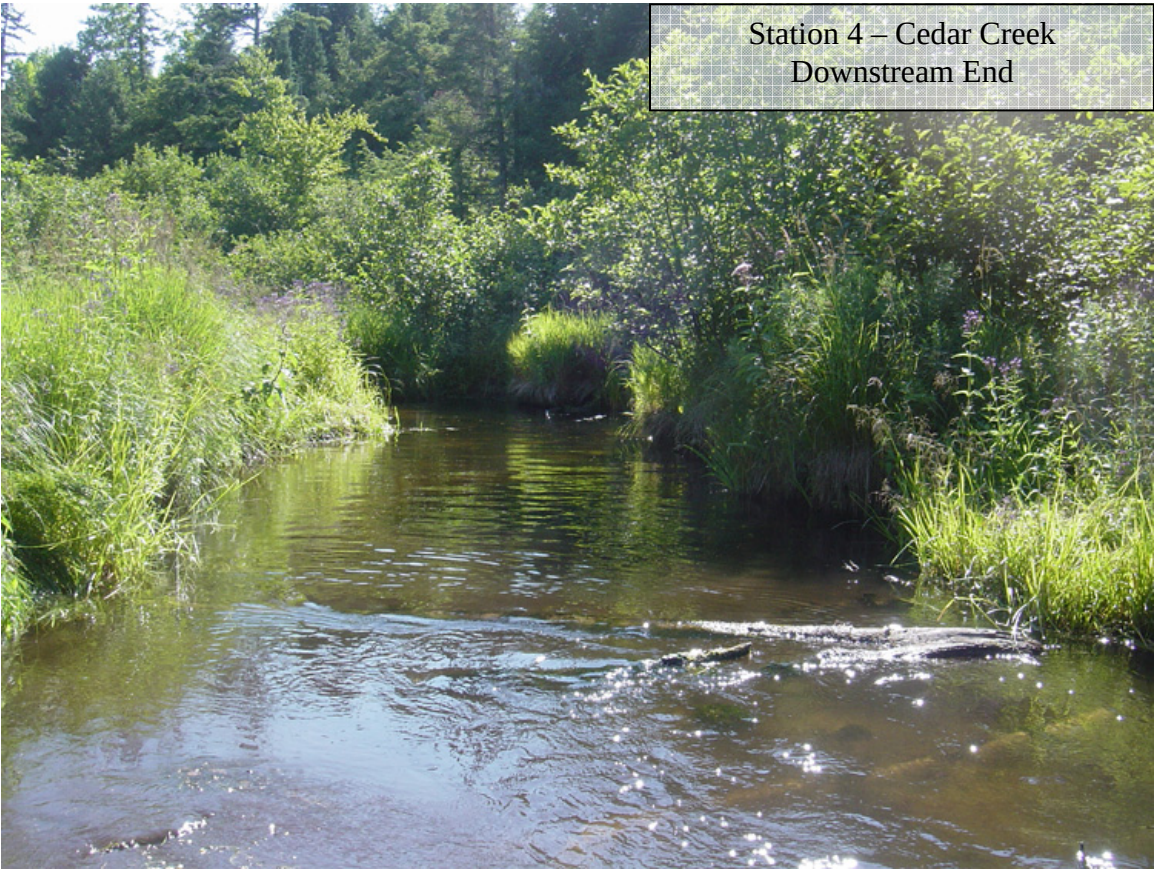
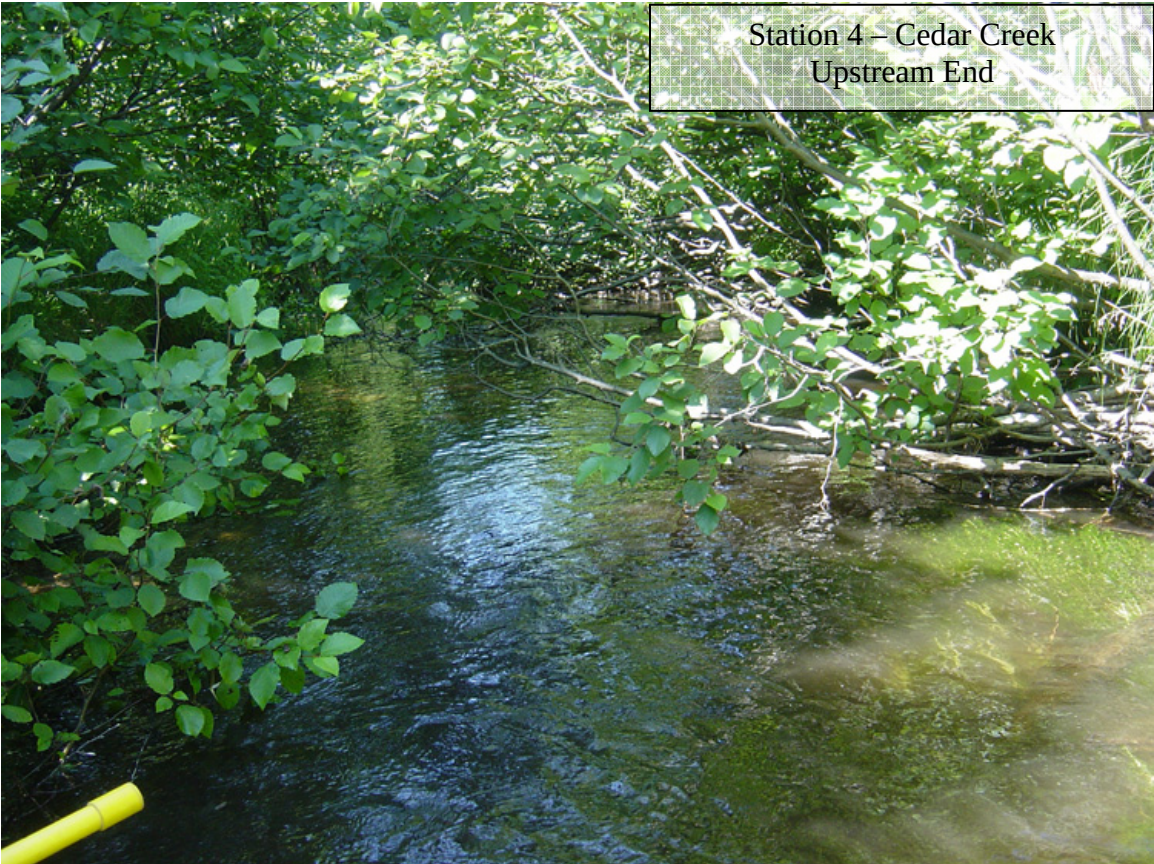
Station 4 exhibits characteristics of both a riffle/run and glide/pool type of stream. Several hundred meters of stream were visually surveyed upstream, but it was still unclear as to which type was more dominant. Therefore, as recommended in Procedure 51, the station was scored using both forms. The riffle/run segment had a total score of 148 (good). The glide/pool segment had a total score of 163 (excellent). Since the results were similar, they were averaged to give the station a total score of 155 and a borderline excellent rating (**Table 3, Appendix B**).

Sediment deposition is present within this reach and appears to be the most significant cause of impairment, as evidenced by the low scores for embeddedness and sediment deposition. The stream has a moderate gradient; however, fine sand and silt substrates are dominant. Eel grass, star duckweed (*Lemna trisulca*), slender naiad (*najas flexicalis*) and filamentous algae were observed in the sampling station. Riparian cover is dense and dominated by tag alder.
