DEPARTMENT OF ENVIRONMENTAL QUALITY  
 AIR QUALITY DIVISION  
 ACTIVITY REPORT: Self Initiated Inspection

FACILITY: Advanced Disposal Services Arbor Hills Landfill Inc		SRN / ID: N2688
LOCATION: 10690 W. SIX MILE RD, NORTHVILLE		DISTRICT: Jackson
CITY: NORTHVILLE		COUNTY: WASHTENAW
CONTACT:		ACTIVITY DATE: 04/25/2019
STAFF: Mike Kovalchick	COMPLIANCE STATUS: Non Compliance	SOURCE CLASS: MAJOR
SUBJECT: Site visit of Fortistar to investigate an issue with Turbine 4 and discrepancy in power rating. Also site visit at the landfill to continue on-going investigation/observation of ETLF event.		
RESOLVED COMPLAINTS:

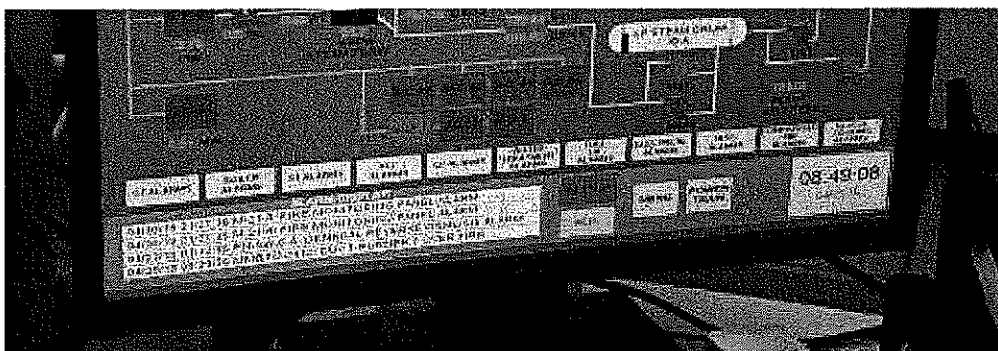
Carlos indicated that the turbine is swooped out every 40,000 hours. (They are used about 8500 hours per year.) He said that the 3rd version of turbine 4 was installed on December 1, 2014.) He said that the generator itself should be the original one. I asked him to search his records to see if he can locate specific spec for the previous turbines. He said he would get back to me by the end of the day if he was able to find anything.

**Image 1(Turbine 4) : Turbine 4**
