DEPARTMENT OF ENVIRONMENTAL QUALITY
AIR QUALITY DIVISION
ACTIVITY REPORT: Self Initiated Inspection

FACILITY: Advanced Disposal Services Arbor Hills Landfill Inc		SRN / ID: N2688
LOCATION: 10690 W. SIX MILE RD, NORTHVILLE		DISTRICT: Jackson
CITY: NORTHVILLE		COUNTY: WASHTENAW
CONTACT:		ACTIVITY DATE: 06/07/2019
STAFF: Mike Kovalchick	COMPLIANCE STATUS: Non Compliance	
SUBJECT: Landfill visit observations.		SOURCE CLASS: MAJOR
RESOLVED COMPLAINTS:

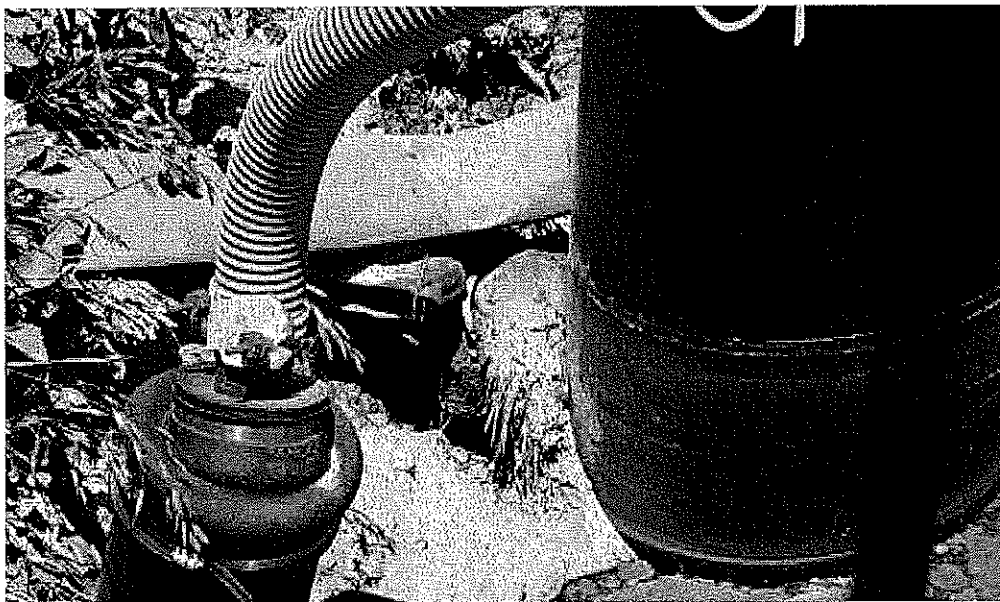
TS-01 pump seemed to be functioning this time with little over spill liquid into the adjacent retention ponds. No gas was coming out of the ground at the adjacent valve shutoff pole like the last time but instead had moved back directly next to TS-01 itself. (Methane meter showed only a few ppm lingering at the shutoff pole.) This time, 2 ground hog size holes had opened up creating intense odors downwind (this time towards the SW). (See attached pics of both holes that likely are a single hole that Y's out at the surface.) They had the characteristic black sulfide staining and were by far the largest gas holes that I've seen. (These holes may have been present before but would have been flooded with liquid so would have not been able to see them.) I attempted to sample it using the Jerome meter approaching the hole from upwind direction. However, disconcertingly the likely very high levels of gas saturated the sensor so I was unable to obtain a H2S reading. Methane was in excess of the methane sensor maximum of 10,000 ppm. Construction to re-engineer TS-01 has yet to commence. They are putting out to bid shortly for the installation of new force main that will run from a new lift station that will be associated with TS-01 to the leachate tank farm. Anthony would not hazard a guess on when this project would be completed.

Image 1(TS-01 Gas hole) : TS-01. Note gas hole at base.
