**DEPARTMENT OF ENVIRONMENTAL QUALITY
AIR QUALITY DIVISION
ACTIVITY REPORT: On-site Inspection**

FACILITY: Great Lakes Cremation Service, Inc.		SRN / ID: N8339
LOCATION: 29547 Costello Dr, NEW HUDSON		DISTRICT: Warren
CITY: NEW HUDSON		COUNTY: OAKLAND
CONTACT: Gil Pietrandrea , Facility Manager		ACTIVITY DATE: 02/10/2021
STAFF: Robert Elmouchi	COMPLIANCE STATUS: Non Compliance	SOURCE CLASS: MINOR
SUBJECT: Complaint investigation and targeted inspection.		
RESOLVED COMPLAINTS: C-20-04233, C-20-04253, C-20-04264, C-20-04382, C-20-04390, C-21-00223, C-21-00383

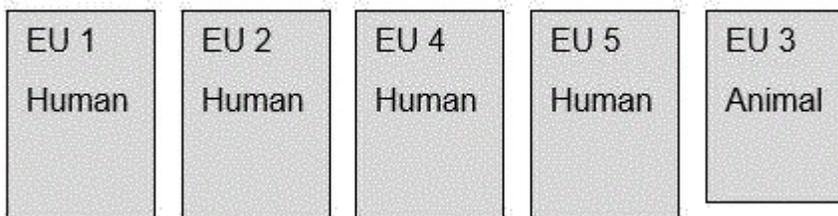
Figure 1.

Image 4(FIGURE 1) : Graphic of the physical arrangement of the permitted emission units with emission unit (EU) permit name abbreviations.

Pietrandrea a follow-up email on February 12, 2021, in which I attached a Word document, which stated, "Below is a list that correlates each AQD assigned Emission Unit ID with the corresponding Great Lakes Cremation cremation unit name. Permit to Install numbers 232-09B and 61-15 require records shall be kept in a satisfactory manner. To comply with the permits, the AQD requests that all permit required records clearly identify the AQD Emission Unit ID. Great Lakes Cremation may use the abbreviation of EU to indicate Emission Unit as in figure 1 below."
