DEPARTMENT OF ENVIRONMENTAL QUALITY AIR QUALITY DIVISION ACTIVITY REPORT: On-site Inspection

A133768059				
FACILITY: Central Concrete		SRN / ID: A1337		
LOCATION: 1277 N. Bridge Street, ALMA		DISTRICT: Lansing		
CITY: ALMA		COUNTY: GRATIOT		
CONTACT: Steve Findsen , Alma Plant Manager		ACTIVITY DATE: 07/10/2023		
STAFF: Michelle Luplow	COMPLIANCE STATUS: Compliance	SOURCE CLASS: MINOR		
SUBJECT: Onsite compliance inspection to determine compliance with PTI 695-83				
RESOLVED COMPLAINTS:

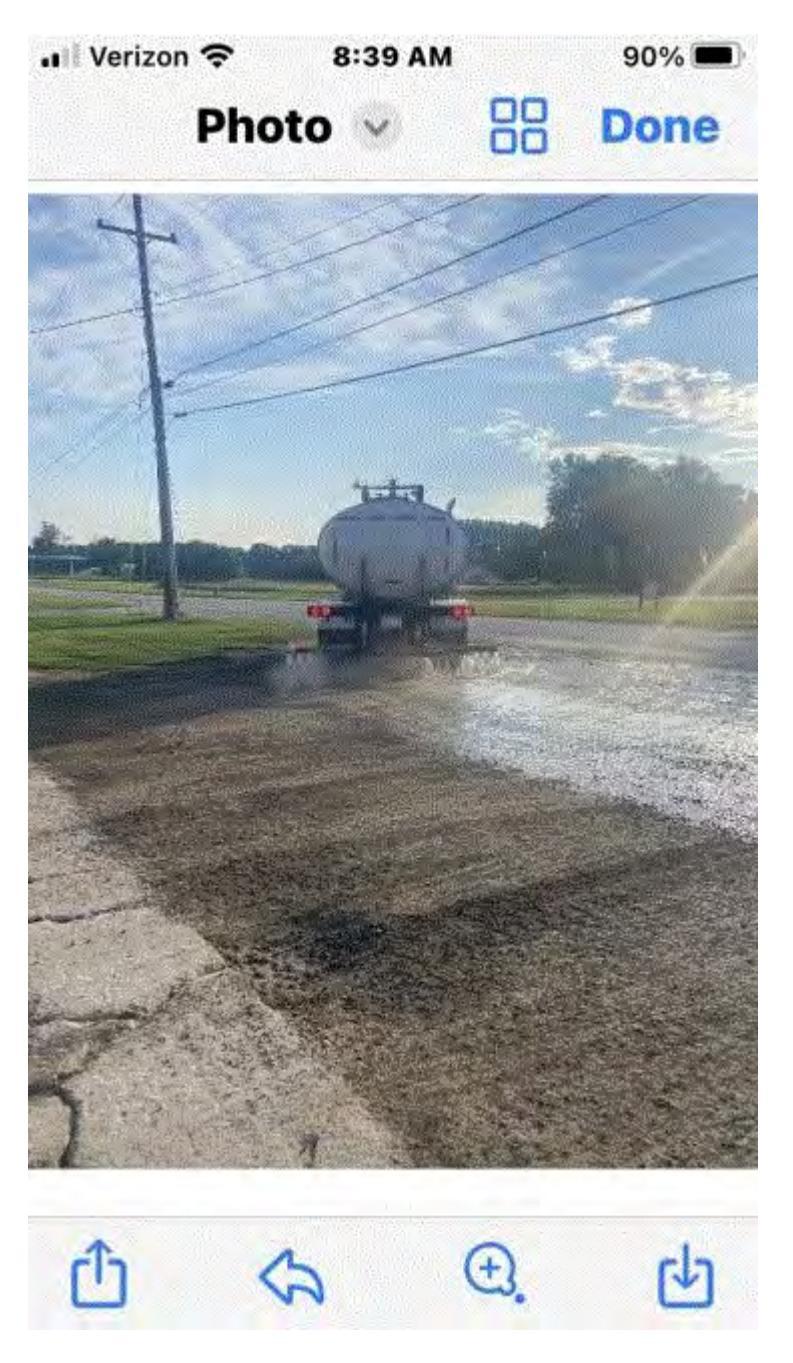
Image 1(CaCl2 (1)) : Photos of calcium chloride being applied to unpaved road/plant yard on 7/11/23. Photo Credit: Central Concrete.

On July 12, 2023, I was informed that Central Concrete ordered a calcium chloride truck, which applied chloride to all unpaved areas of the facility on July 11, 2023, (one day after being put on notice that fugitive dust was an issue). See attached photos. Calcium chloride application will control dust from the unpaved yard and therefore there should be little to no track-out onto the public road after application of this product.

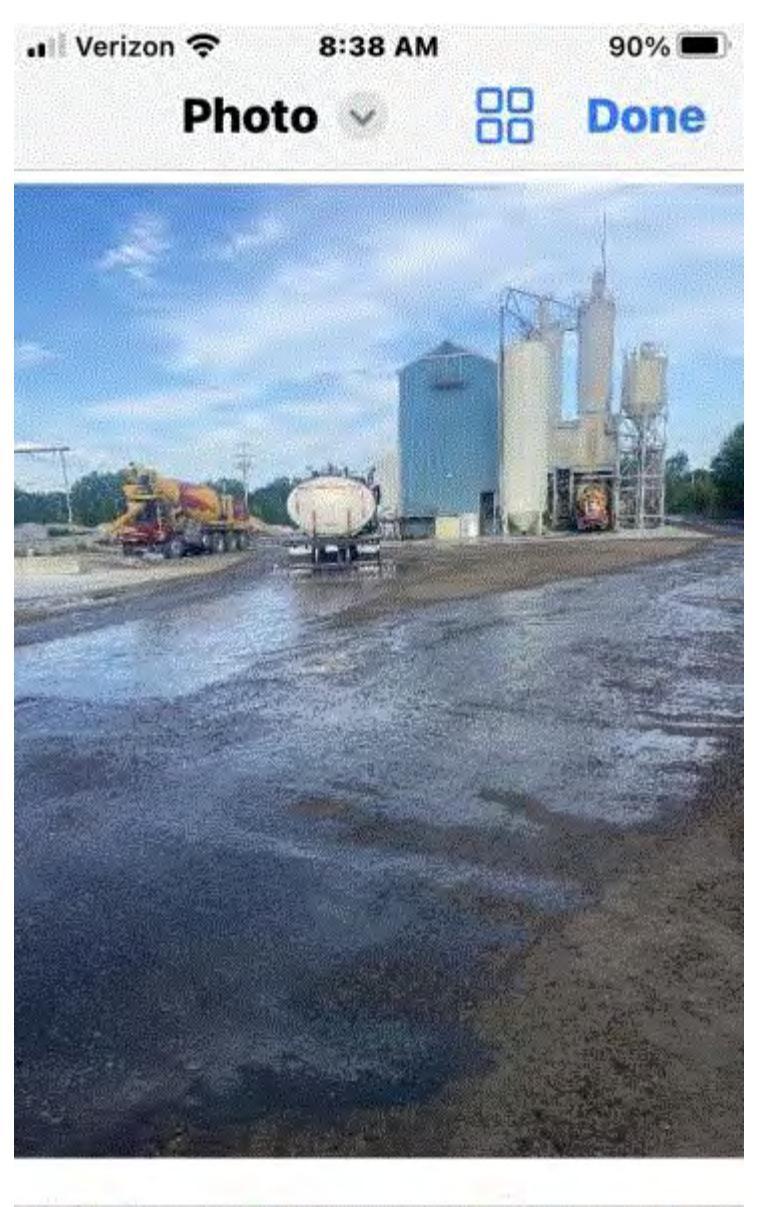
Image 2(CaCl2 (2)) : Photos of calcium chloride being applied to unpaved road/plant yard on 7/11/23. Photo Credit: Central Concrete.

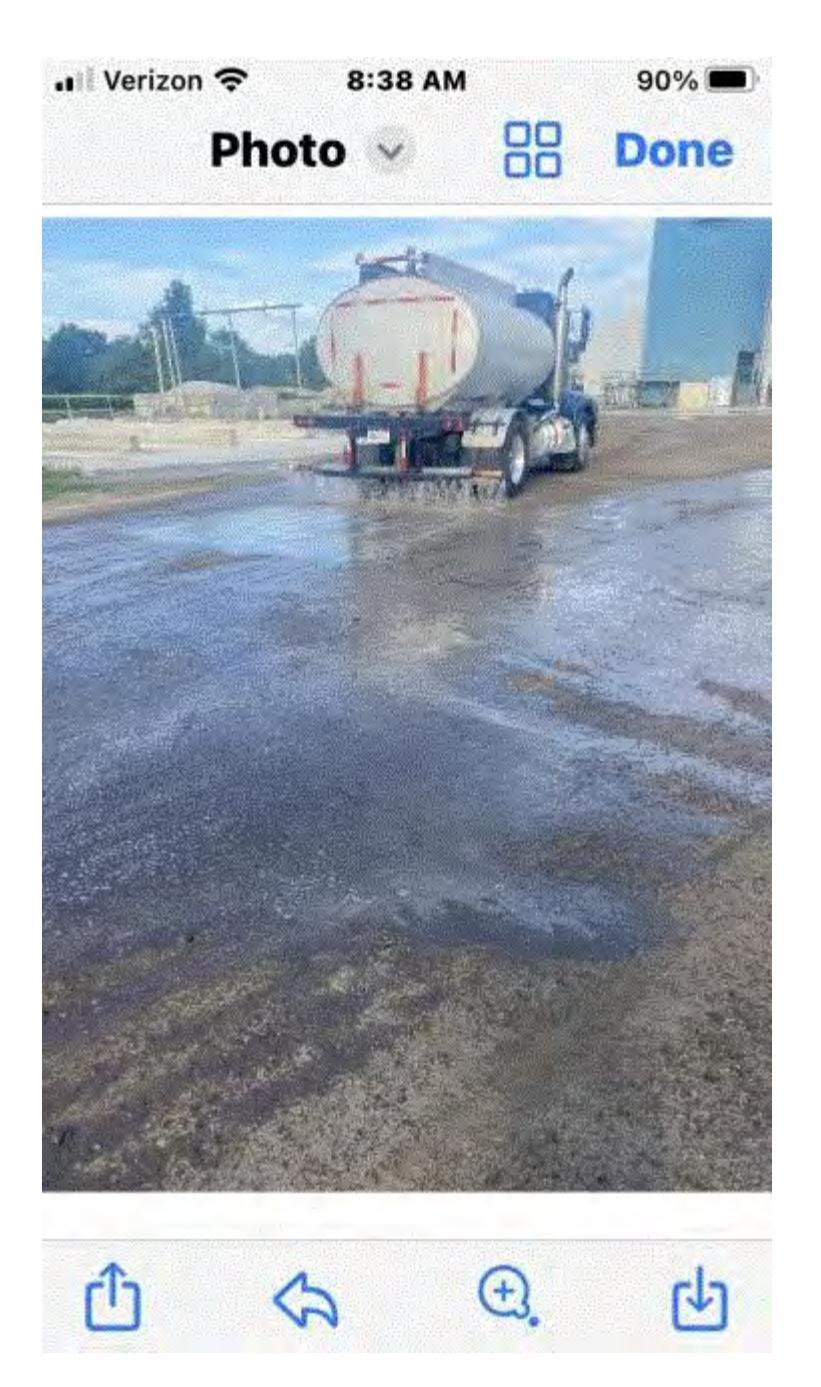
Image 3(CaCl2 (4)): Photos of calcium chloride being applied to unpaved road/plant yard on 7/11/23. Photo Credit: Central Concrete.

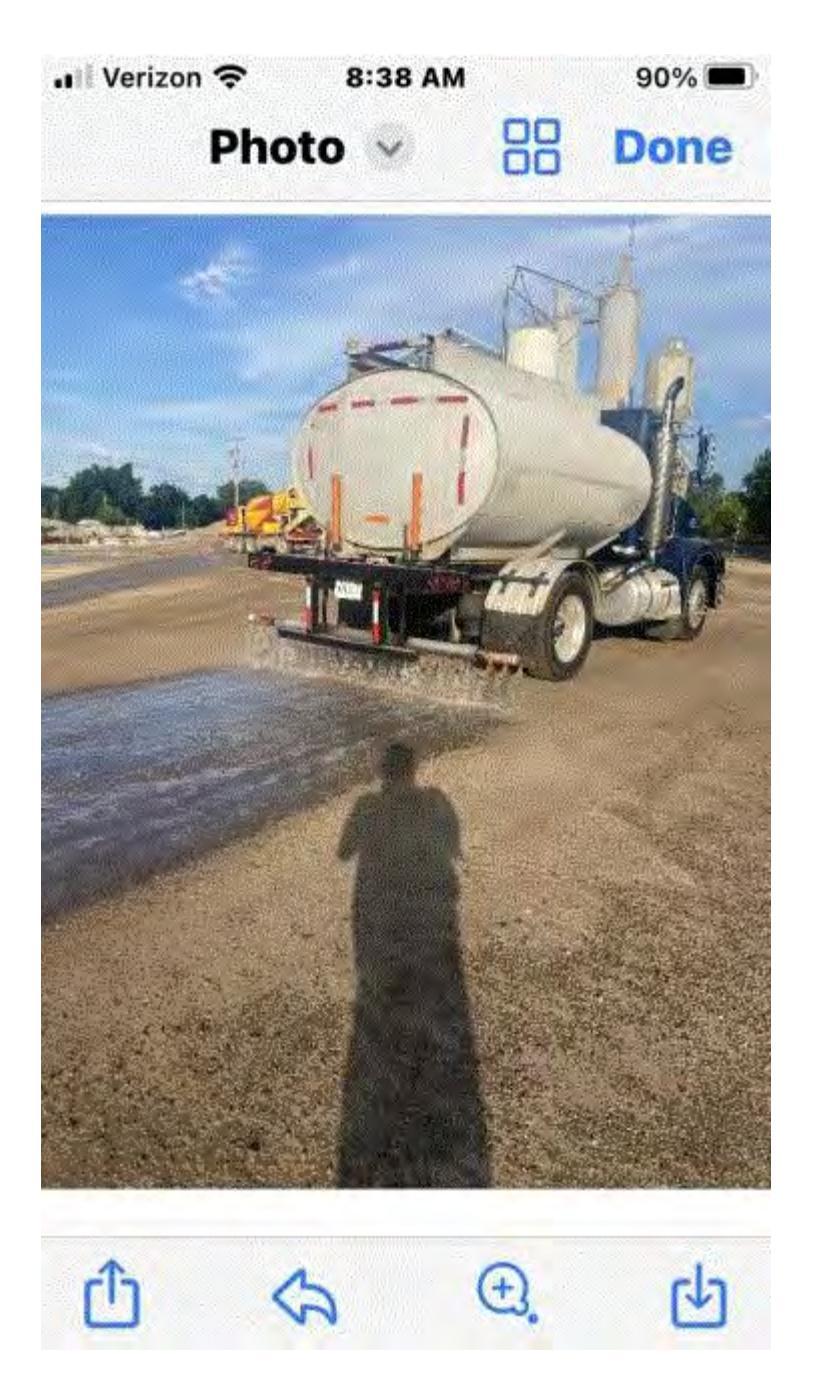
Image 4(CaCl2 (5)) : Photos of calcium chloride being applied to unpaved road/plant yard on 7/11/23. Photo Credit: Central Concrete.

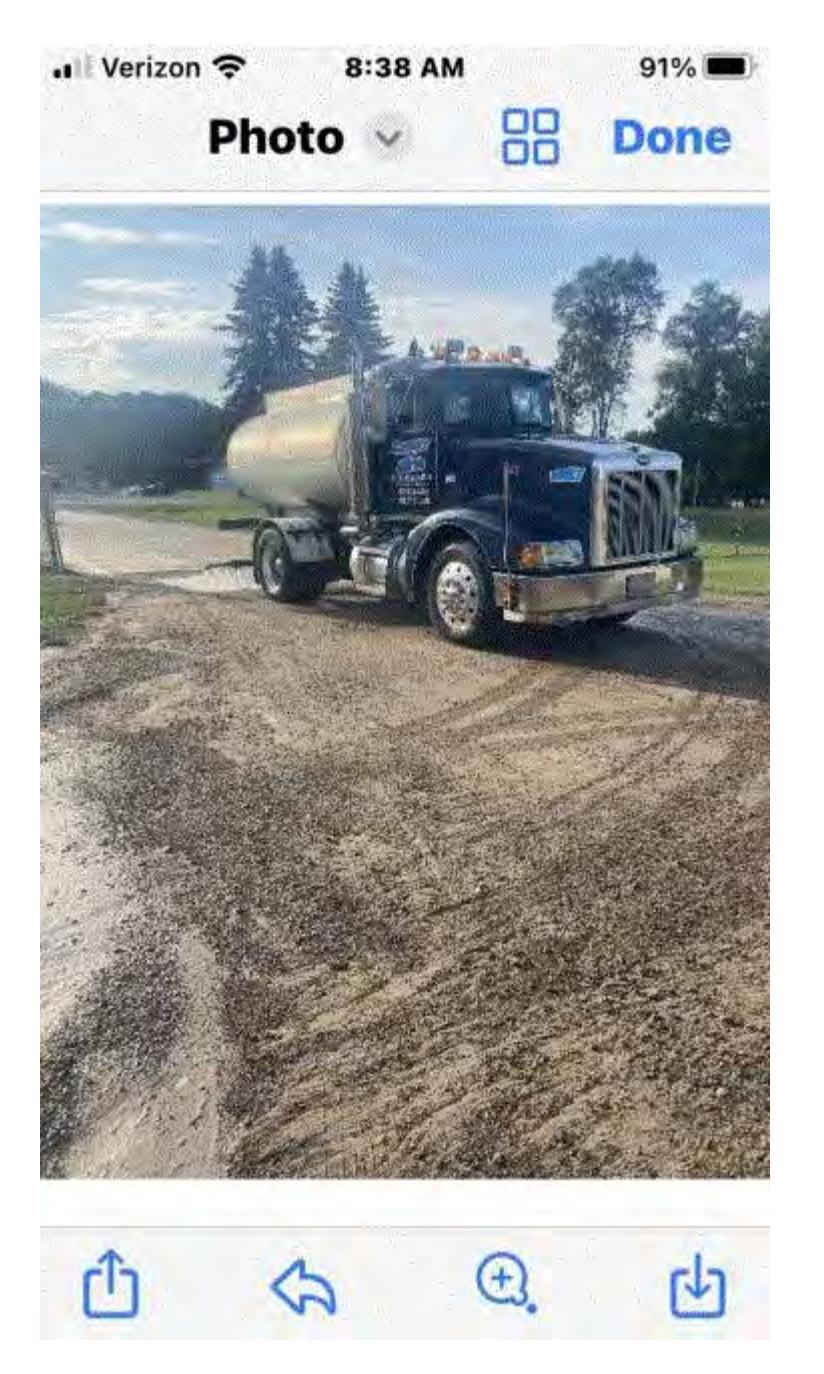
Image 5(CaCl2 (6)) : Photos of calcium chloride being applied to unpaved road/plant yard on 7/11/23. Photo Credit: Central Concrete.
