#### DEPARTMENT OF ENVIRONMENTAL QUALITY AIR QUALITY DIVISION ACTIVITY REPORT: On-site Inspection

B365859785			
FACILITY: Martinrea Bishop Circle		SRN / ID: B3658	
LOCATION: 10501 M-52, MANCHESTER		DISTRICT: Jackson	
CITY: MANCHESTER		COUNTY: WASHTENAW	
CONTACT: Michael Zobel, EHS Manager		ACTIVITY DATE: 09/09/2021	
STAFF: Mike Kovalchick	COMPLIANCE STATUS: Non Compliance	SOURCE CLASS: SM OPT OUT	
SUBJECT: Company remains out of compliance with Rule 201 violations, no MAERS report and stack issues.			
RESOLVED COMPLAINTS:

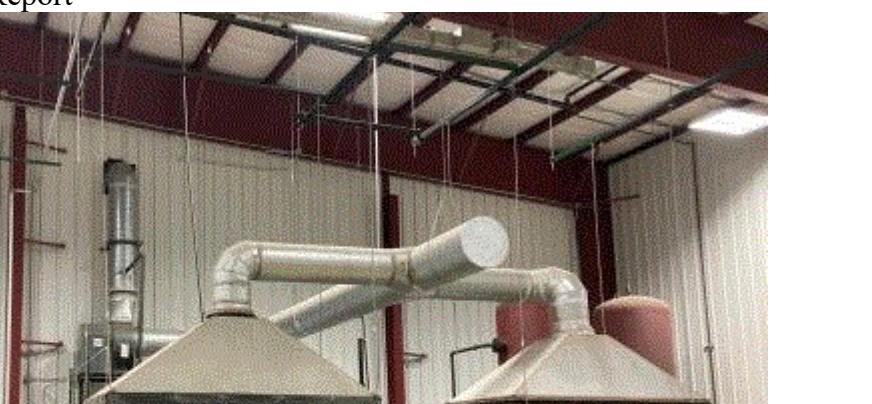
The 2 older electric powered autoclaves were not in operation during the inspection but were still warm. I was given the impression that they will be using the newer steam autoclave as much as possible instead. These autoclaves have a hood above each entrance door which exhausted outside. (See attached photo.)

**Image 1(Electric Autoclaves)** : 2 old autoclaves with a hoods that go to a combined stack with raincape.

Process Description	Condition Violated	Comments
PTI 61-14 emission unit EURUBBEREX (Autoclaves)	PTI 61-14 Special Condition VIII. STACK/VENT RESTRICTION(S)- 1. SVAUTOCLAVE1 2. SVAUTOCLAVE2	Combined autoclave stack does not vent unobstructed vertically upward; has rain cap and otherwise is not consistent with Stack/vent parameters described in the permit.
PTI 61-14 emission unit EURUBBEREX (Oven)	PTI 61-14 Special Condition VIII. STACK/VENT RESTRICTION(S)- 3. SVOVEN	Stack does not vent unobstructed vertically upward; has rain cap. A second oven stack not previously identified as part of the original permit application also has a rain cap.
PTI 61-14 Flexible Group FGFACILITY	PTI 61-14 Special Condition VI. Monitoring/Recordkeeping 2.a, b, c, d, e.	Company failed to provide require records for calculated HAP emissions.

In addition to the VN, the Company is being required to modify or resubmit their PTI application that is currently under review to be consistent with stack configurations that were observed during the inspection. Furthermore, as part of the PTI application, the Company is being required to provide a demonstration that Rule 301 20% opacity standard can be met for their oven. This will consist of Method 9 readings taken during the oven cycle period for both oven stacks.

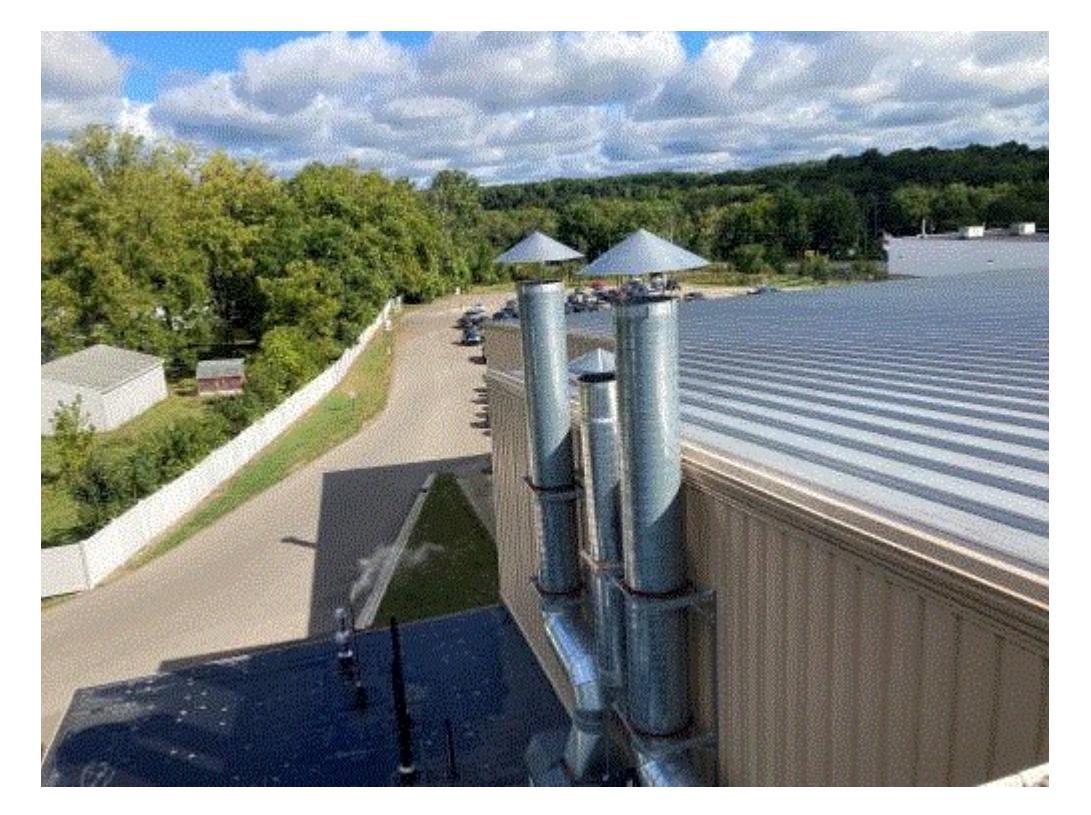
Next, we visited the roof which was accessed by a ladder inside the building. The roof was in good shape including all the ventilation equipment observed. See attached photos. However, rain caps were observed on the autoclave and oven stacks. These had not been described in either the previous permit or the more recent permit application. Furthermore, smoke was observed coming out a small oven stack also with a rain cap which was concerning. Opacity was estimated to be at 10 to 15%. It was not clear at what point in the oven cycle the smoke was occurring in. This suggests the possibility that higher opacity could be generated at a different time in the cycle such as when the rubber is first added to the oven. Emissions from the other oven stack were not observed as the oven doors were closed during the inspection.

Image 2(Autoclave Oven): 2 larger stacks from steam autoclaves. Smaller stack from hood above oven. Rain caps on all.

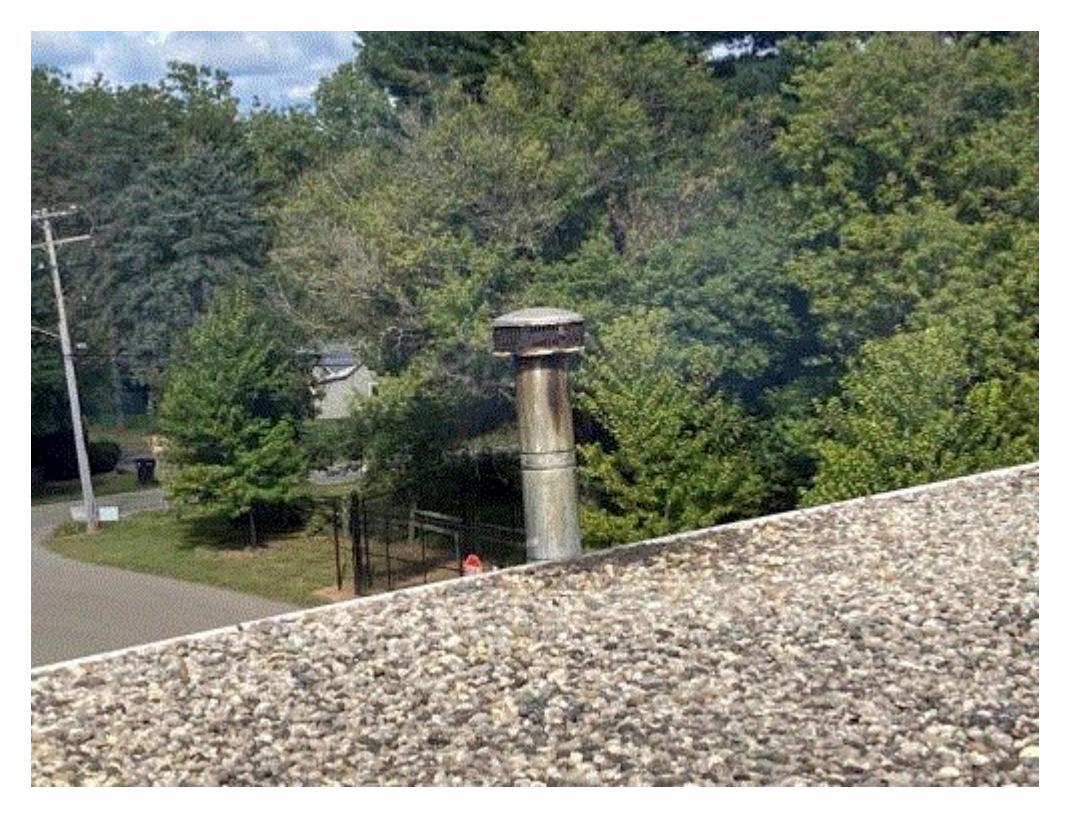
The conventional oven had a set point of 400 degrees F. It had 2 stacks associated with it. One from the hood located above where the doors open to the oven and smaller one to the oven itself. The smaller one had not been described in the recent permit application. A Company representative indicated that the oven operates on a 45-minute cycle. When the doors are open, a lot of smoke escapes out and is drawn into the hood for about a 15-minute period. This was not observed during the inspection. See attached photo of the front of the oven.

Image 3(Oven stack) : Oven stack showing 10% opacity smoke.

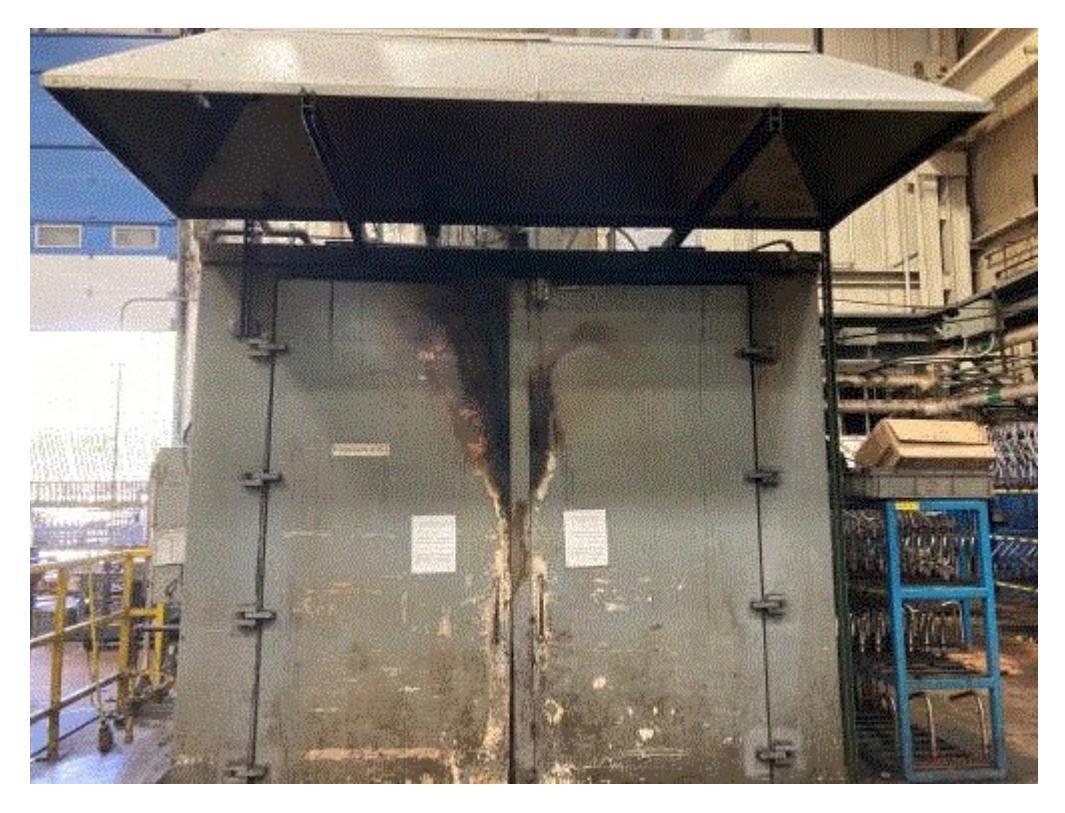
Image 4(Oven doors) : Oven doors with hood above it
