# FORD MOTOR COMPANY

#### FLAT ROCK ASSEMBLY PLANT (FRAP): **RCO OCM TEST REPORT**

RWDI #2300558 January 19, 2023

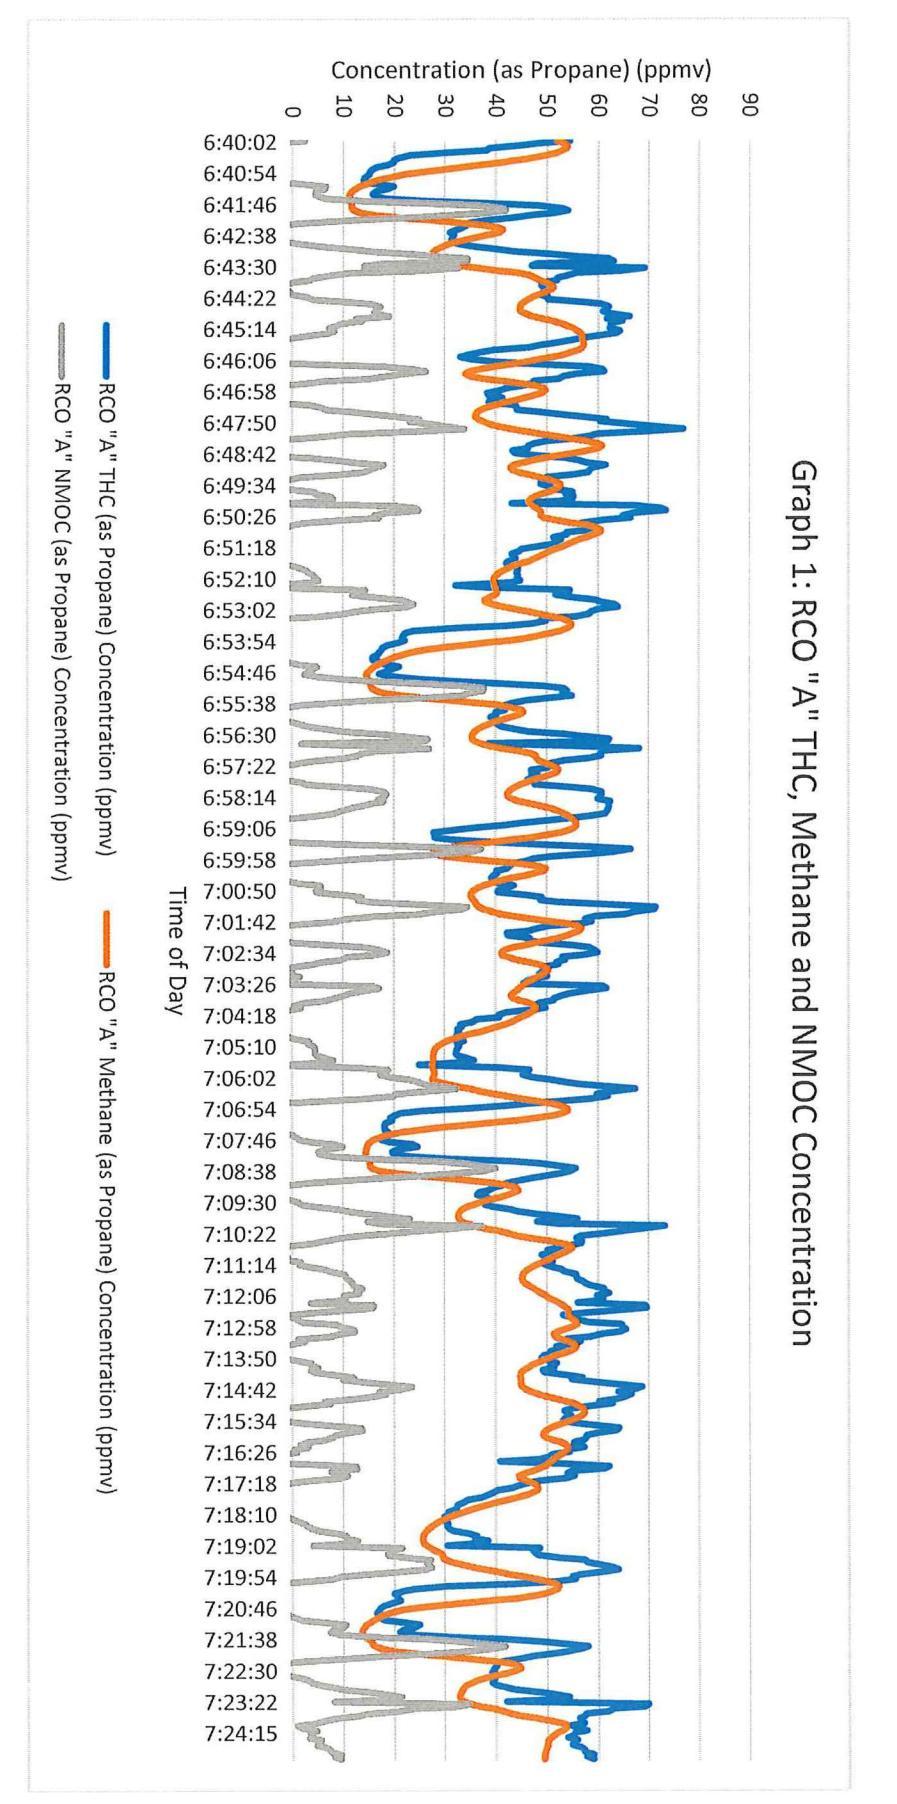
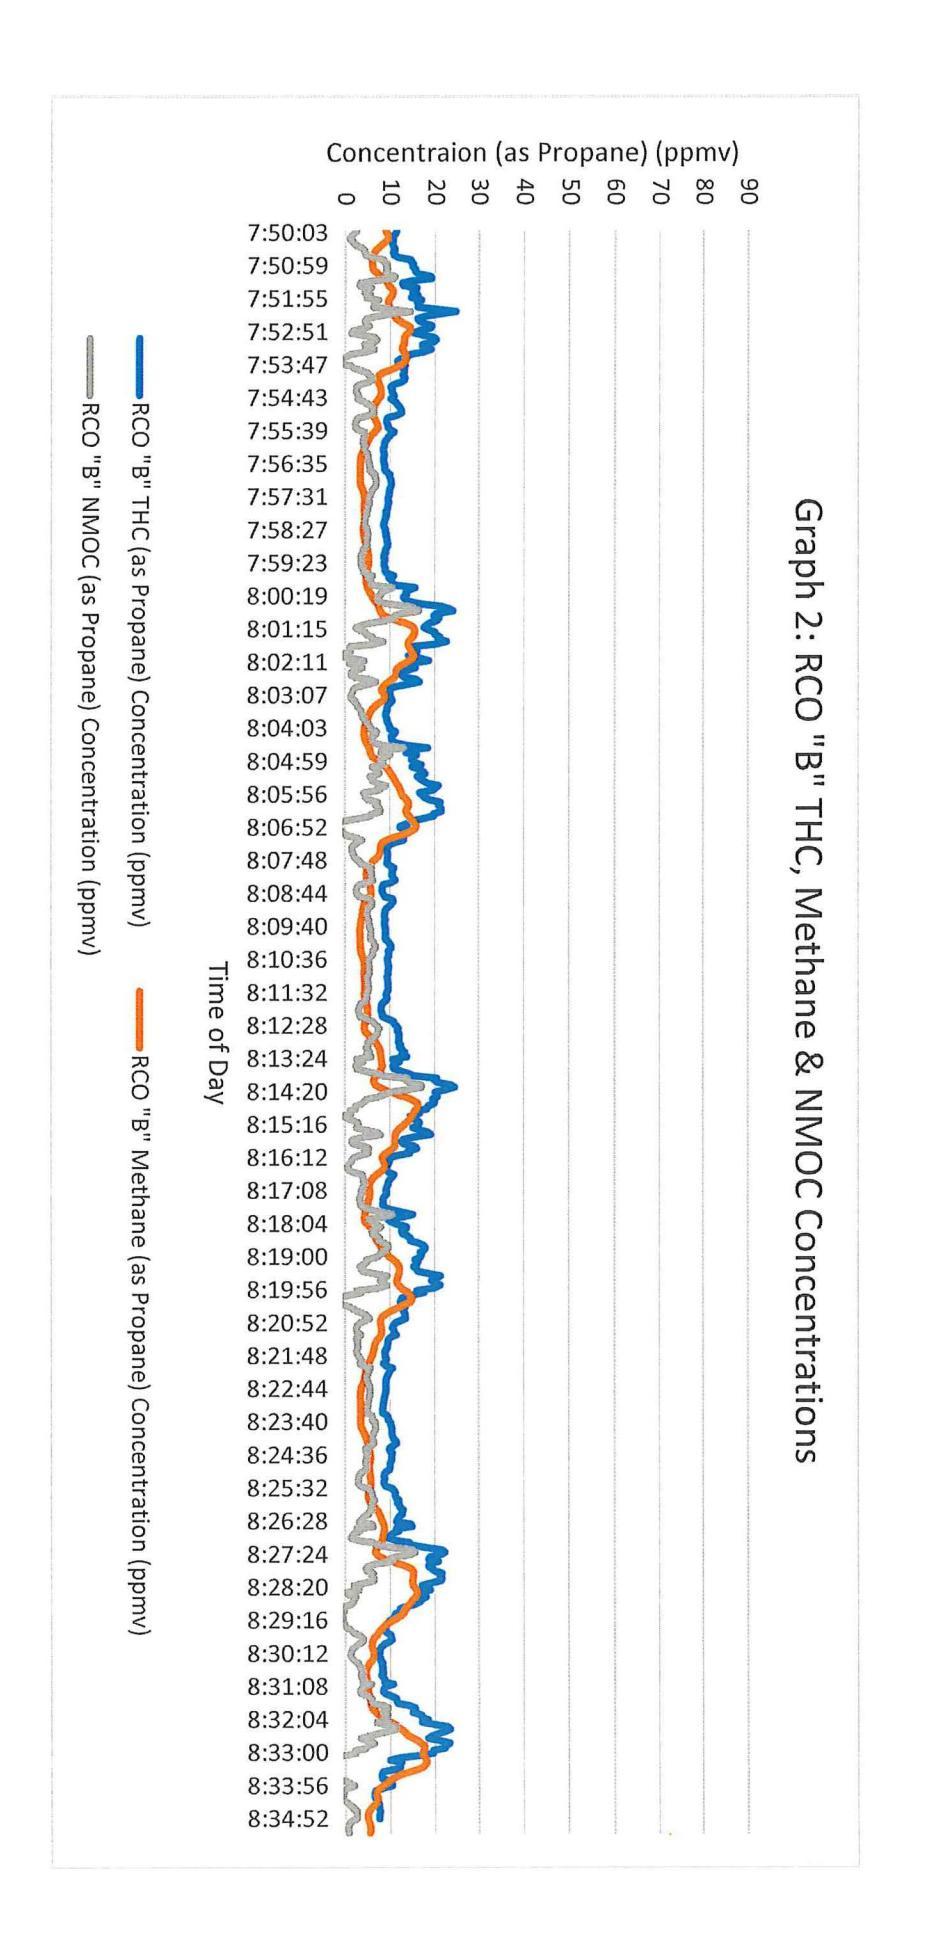
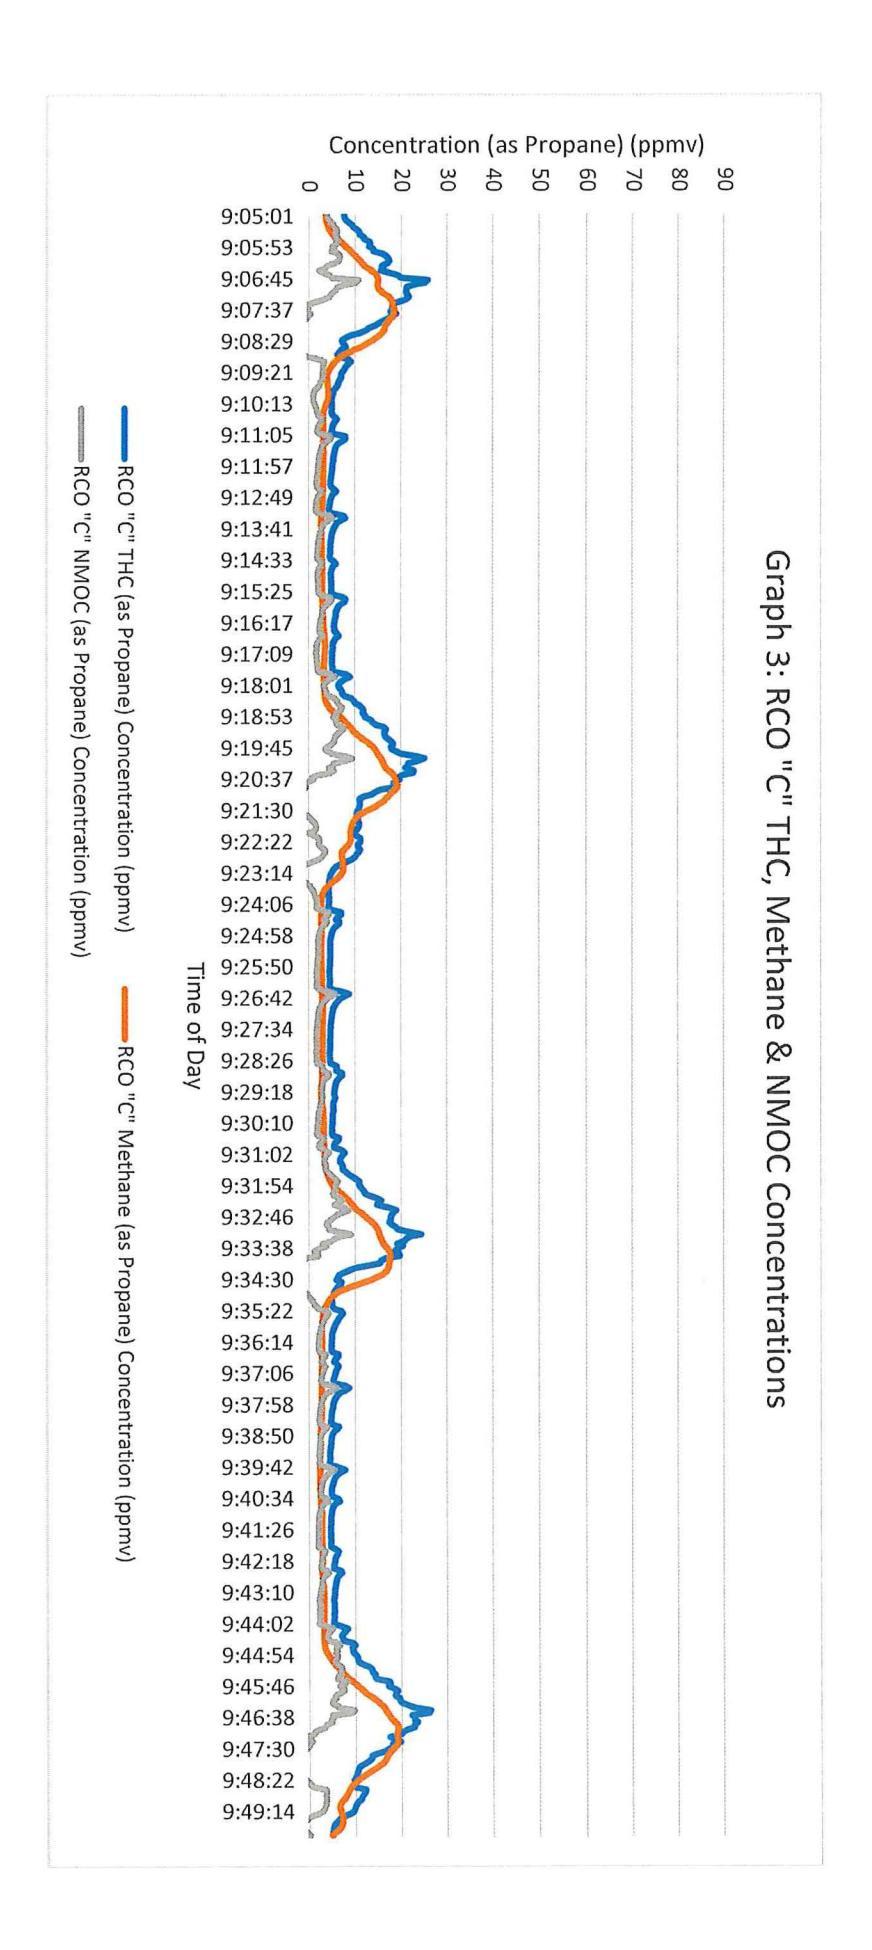
Graph 1:	RCO "A" THC, Methane & NMOC Concentrations
Graph 2:	RCO "B" THC, Methane & NMOC Concentrations
Graph 3:	RCO "C" THC, Methane & NMOC Concentrations

Detailed Results are provided in Appendices B and F and Graphs 1 to 3.
