DEPARTMENT OF ENVIRONMENTAL QUALITY  
AIR QUALITY DIVISION  
ACTIVITY REPORT: On-site Inspection

<b>FACILITY:</b> NORTHERN MICHIGAN VENEERS INC		<b>SRN / ID:</b> B6259
<b>LOCATION:</b> 710 RAINS DR, GLADSTONE		<b>DISTRICT:</b> Marquette
<b>CITY:</b> GLADSTONE		<b>COUNTY:</b> DELTA
<b>CONTACT:</b> Troy LaCasse , Plant Manager		<b>ACTIVITY DATE:</b> 01/17/2023
<b>STAFF:</b> Lauren Luce	<b>COMPLIANCE STATUS:</b> Compliance	<b>SOURCE CLASS:</b> MINOR
<b>SUBJECT:</b> Targeted Inspection FY23		
<b>RESOLVED COMPLAINTS:</b>

**Facility: Northern Michigan Veneers (SRN: B6259)**

**Location: 710 Rains Dr, Gladstone, MI 49837, Delta County**

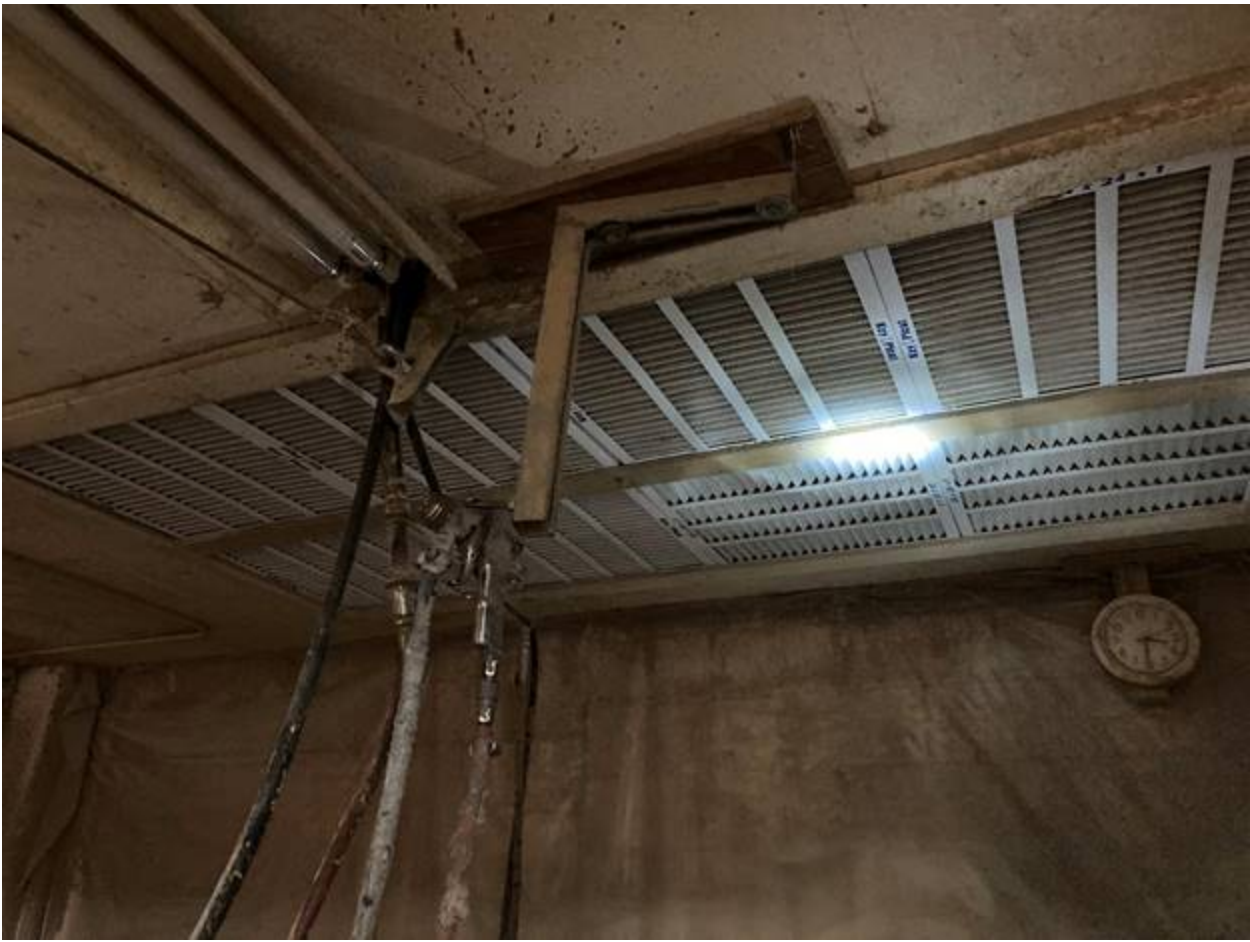
*Image 1: Glue booth filters*

PTI No. 234-92A is for the glue booth at the facility. AQD has not requested the facility to conduct performance testing on the booth (SC 1.1a, 1.1b). The facility provided required calculations for formaldehyde (SC 1.1c, 1.5, 1.7). The 12-month rolling average was 0.002 tons which is below the permitted limit of 0.61 tpy. The facility switched from a UF adhesive to a PVA CARB (California Air Resources Board) compliant adhesive around 2008. The adhesive currently used is ultra-low emitting. SDS sheets were provided for all materials used (SC 1.6). All adhesives are stored in closed containers and spent air filters are stored in closed boxes prior to being disposed of (SC 1.2, 1.3). Glue booth filters were last changed two weeks ago and new filters were available on site (SC 1.4). The glue booth stack appeared to be at least 20 feet from ground level (SC 1.8).

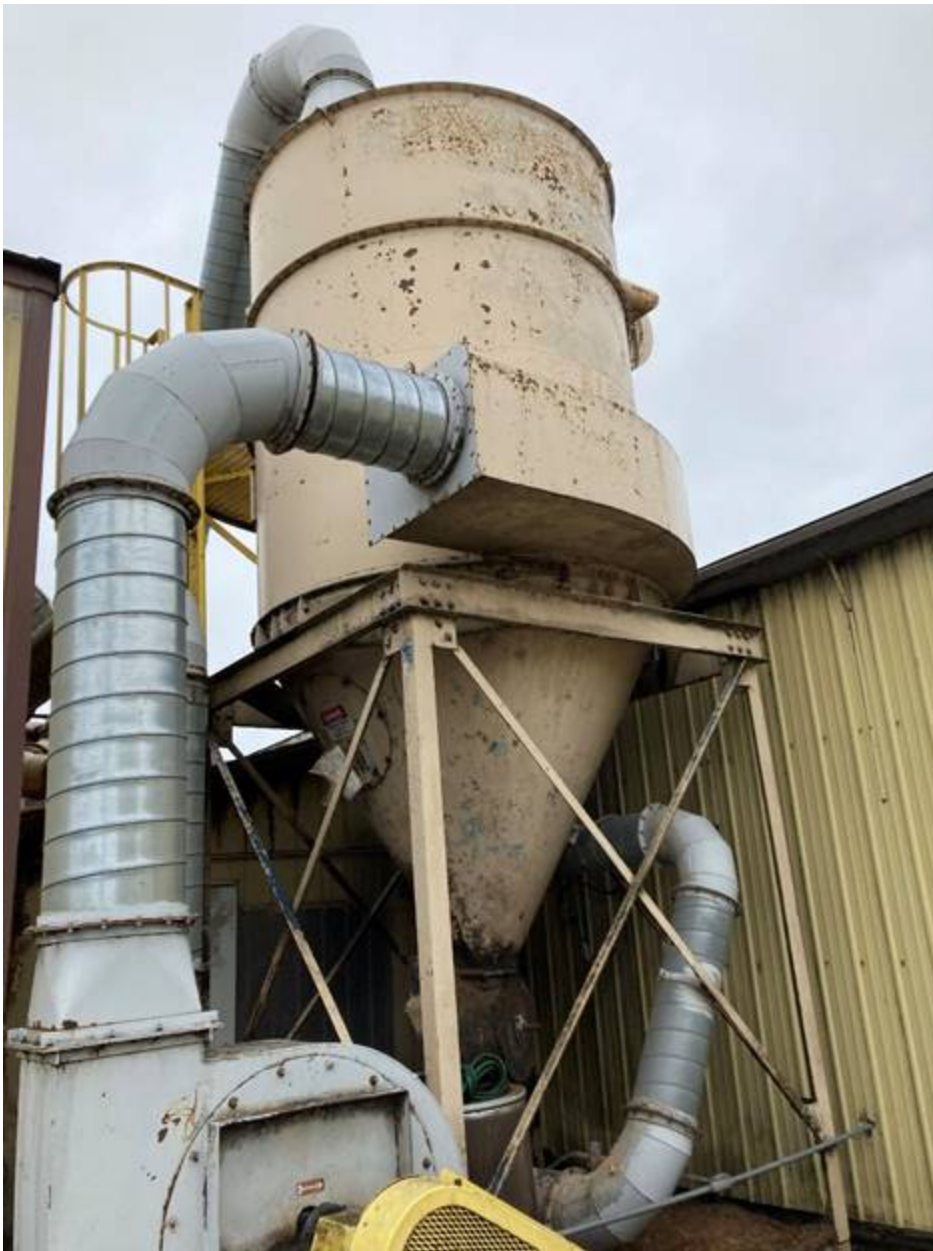
*Image 3: Veneer chipper cyclone*

PTI No. 764-77 is for a Jackson twin disc veneer chipper. The chipper utilizes a cyclone. Waste material is processed through the chipper and sold for fuel. AQD has not requested a performance test (SC 12, 15). The fugitive dust plan includes frequent sweeping and the chip collector (semi trailer) is within an enclosed building to prevent fugitive dust (SC 13). There were no visible emissions during the inspection (SC 14).
