RE: Response to October 4, 2021 Notice of Violation  
ADM Grain Company – Webberville, MI  
SRN: B8863, Ingham County

This letter is in response to the Violation Notice issued on October 4, 2021 to the ADM Grain Company (Company) facility located at 2700 N. Stockbridge Road, Webberville, MI (Facility). The Company appreciates the opportunity to respond to the Agency's concerns.

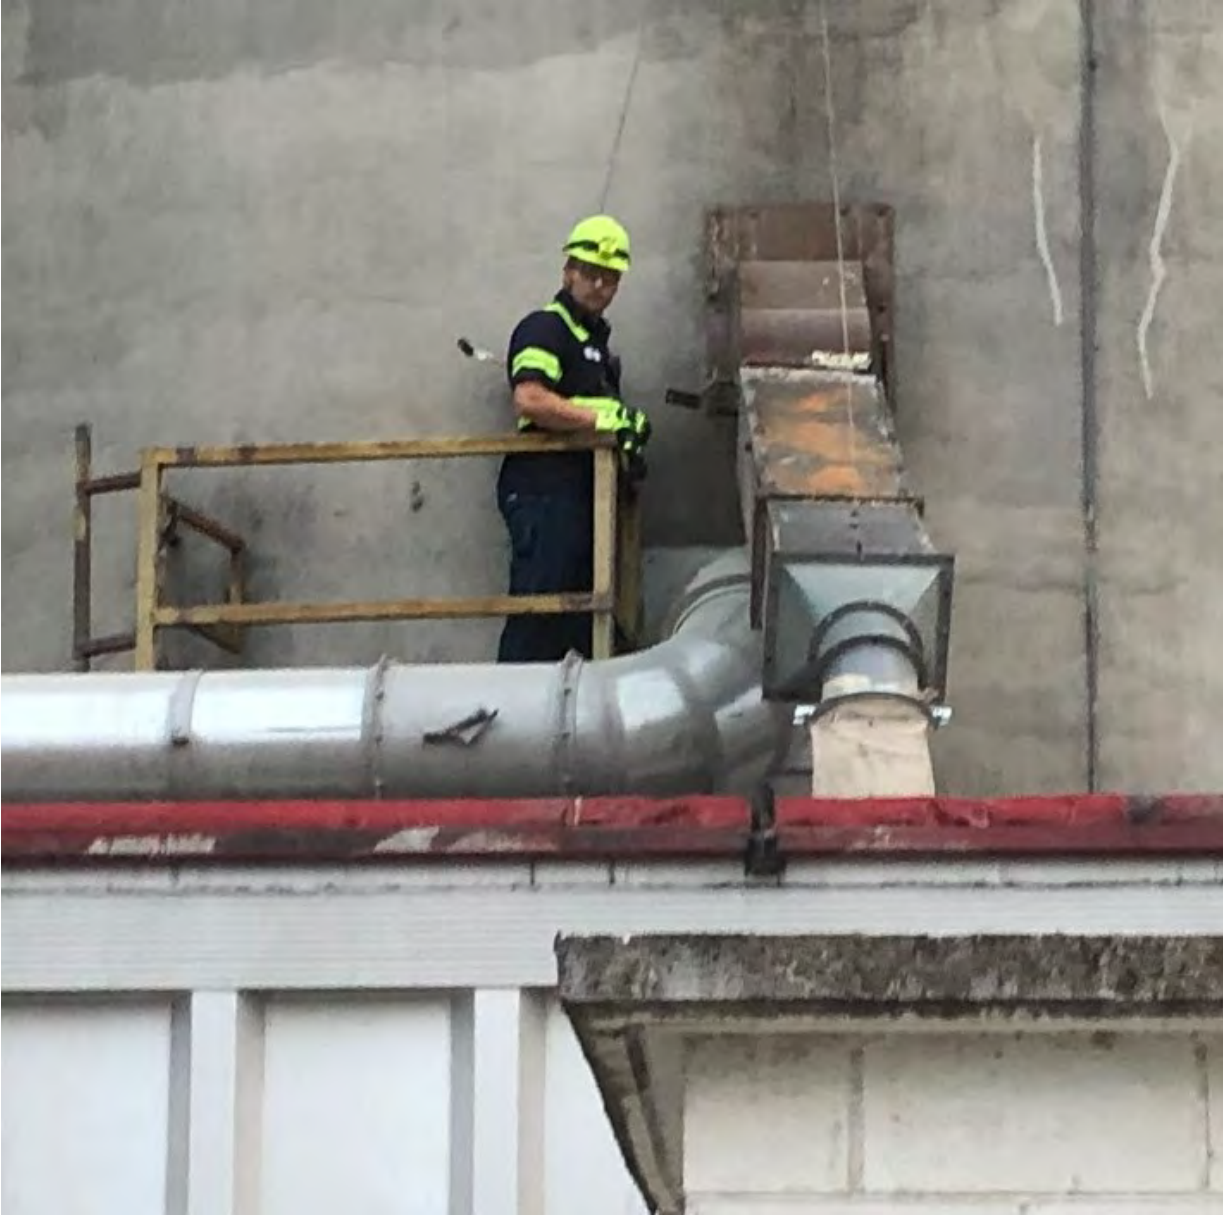
ATTACHMENT

After reviewing the inspection photos shared by the Agency, we acknowledge the need to further reduce emissions when loading trucks from the bin loadout spout highlighted by the Agency. Although the Agency did not provide results of a Method 9 test, the photographs shared by the Agency indicated opportunities for improvement on the infrequently used bin loadout spout depicted.

- Created a custom transition piece sized for the bin loadout spout
- Installed the custom transition piece, along with several elbow pieces, which slowed the velocity of the grain from the bin loadout spout when compared to the velocity from the bin loadout spout observed during the inspection
- Enclosed the top of the bin loadout spout
- Added a dust sock to the end of the bin loadout spout that will be inside the vessel during the truck loading process (See attached photo)
- Updated the relevant standard operating procedure to reflect the above-described changes
- Trained affected employees about the above-described changes to the equipment and SOP
