EXECUTIVE SUMMARY

RWDI USA Inc. (RWDI) was retained by FCA US LLC (FCA) to complete air emission testing program at their Detroit Assembly Complex – Mack (DACM) located at 4000 Saint Jean Street, Detroit, Michigan. DACM operates an automobile assembly plant that produces the all-new Jeep Grand Cherokee L. Under Permit to Install (PTI) 14-19A the emissions testing covers the required testing outlined in the FGAUTOASSEMBLY Flexible group (V(1)) for the following:

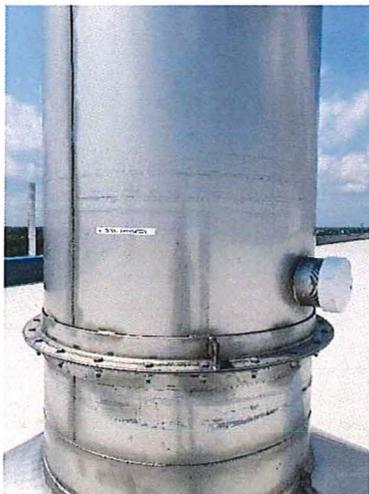
Figure 3.1.1.1 – Tutone Observation Zone Exhaust

Source	Parameter	Diameter	Approximate Duct Diameters from Flow Disturbance	Number of Ports	Points per Traverse	Total Points per Test	Anticipated Stack Temperature
SVPRMOBS (Tutone)	PM/PM ₁₀ /PM _{2.5}	44"	~7 downstream and >8 upstream	2	6	12 PM/Flow	82°F
SVC1BCOBS (Basecoat 1)	PM/PM ₁₀ /PM _{2.5}	36"	~9 downstream and >8 upstream	2	6	12 PM/Flow	87°F
SVC1CCOBS (Clearcoat 1)	PM/PM ₁₀ /PM _{2.5}	40"	~8 downstream and >8 upstream	2	6	12 PM/Flow	82°F
SVRPRCS (Rapid Repair)	PM/PM ₁₀ /PM _{2.5}	77.5"	-8 downstream and >2 upstream	2	6	12 PM/Flow	75°F
