SUBJECT: SRN: N2688, Arbor Hills Landfill, Washtenaw County

On July 26, 2022, the Department of Environment, Great Lakes, and Energy (EGLE), Air Quality Division (AQD) conducted an announced inspection of the Arbor Hills Landfill, a landfill that is owned and operated by GFL Environmental Inc., (Company) located at 10599 W. Five Mile Road, Northville Michigan. The purpose of this inspection was to evaluate surface methane concentrations at this facility within the requirements of the federal Clean Air Act; Part 55, Air Pollution Control, of the Natural Resources and Environmental Protection Act, 1994 PA 451, as amended (Act 451); the conditions of Renewable Operating Permit (ROP) number MI-ROP-N2688-2011a; National Emission Standards for Hazardous Air Pollutants 40 CFR Part 63 Subpart AAAA (NESHAP); and the Federal Plan requirements for Municipal Solid Waste Landfills that Commenced Construction On or Before July 17, 2014, and have not been modified or reconstructed since July 17, 2014, 40 CFR Part 62 Subpart OOO (Subpart OOO).

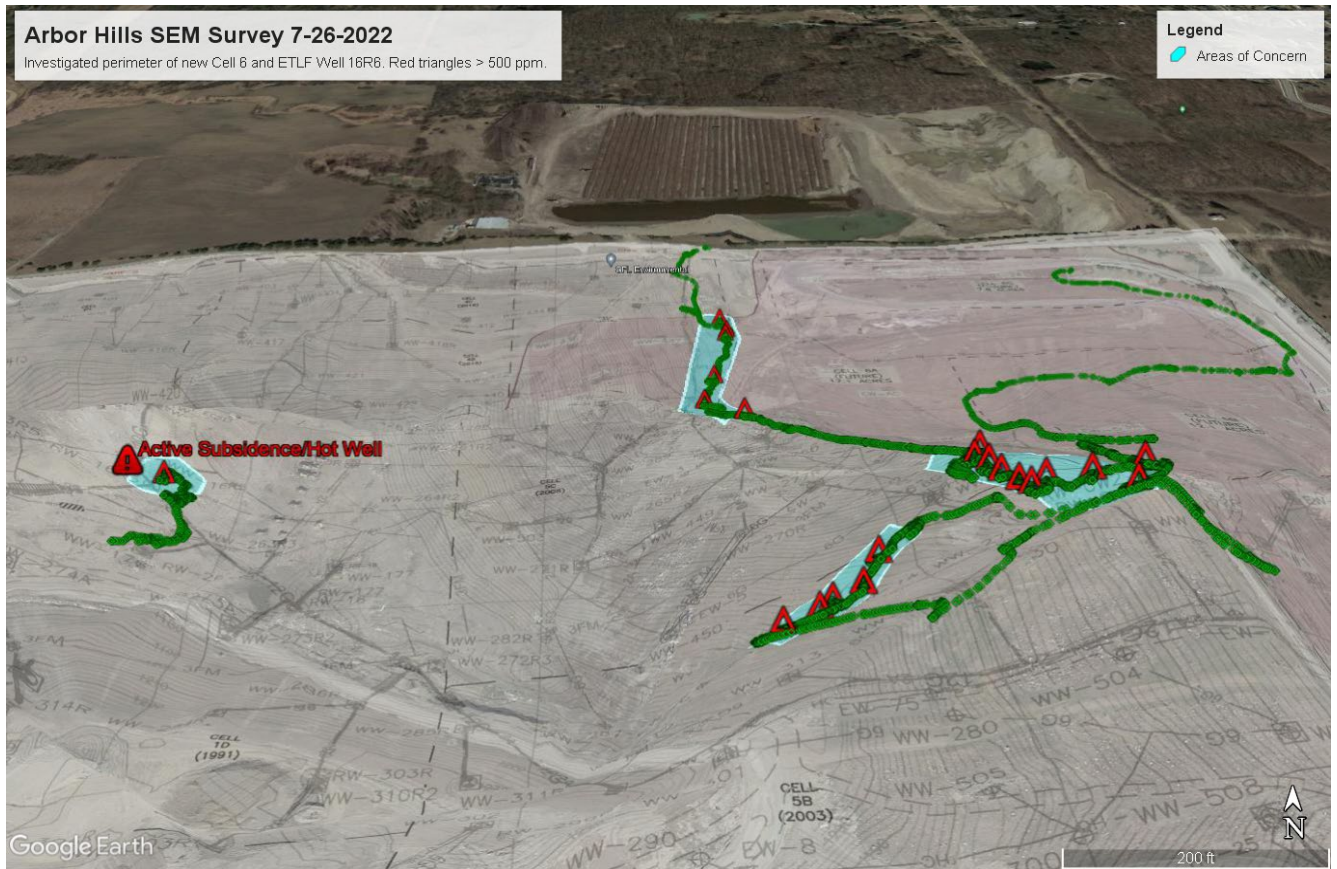
SEM survey path and locations of SEM exceedances:

During the inspection, AQD performed an abbreviated surface emission monitoring (SEM) inspection and found **22** areas with surface methane concentrations greater than 500 ppm above background.

- Methane emissions detected along a buried trench apparently containing a gas line running SW to NE just above and to the SW of Cell 6.
- Methane emissions detected along the edge of Cell 6 liner seam/overlap area along the north and west sides of Cell 6.
- A very active subsidence area surrounding well AHWW16R6 (185 degrees F with 7000+ ppm CO, 2 to 3% hydrogen) was identified. Surface cracks were observed in a conical shape that outlined a bowl like depression around the well. The bowl area was about 50 yards across. Very strong ash tray like smell was coming from this area. Methane and some H₂S were detected coming out of the cracks. The well itself was tilted on its side which purportedly happened just in the last few days.

As provided in a previous table, **22** locations were found to have exceeded the 500 ppm above background threshold during the inspection. The attached aerial image of the Arbor Hills Landfill shows the path followed during the survey and the locations of methane concentrations above 500 ppm.

- Address/fix all 22 SEM hits per federal requirements.
- Minimize landfill gas emissions/odors as much as possible along the perimeter of Cell 6 during the remaining excavation/construction phase of this cell.
- Conduct daily monitoring around the area of well AHWW16R6 until the situation stabilizes. This should include taking well head gas readings and conducting visual inspections to note any adverse changes and take further actions, as necessary.
- Conduct all required enhanced NESHAP monitoring now required for well AHWW16R6 and associated reporting requirements. Pursuant to the federal National Emission Standards for Hazardous Air Pollutants: Municipal Solid Waste Landfills 40 CFR Part 63 Subpart AAAA, §63.1981(h) a semi-annual report is required to be filed with AQD that includes results of the required quarterly SEM pursuant to the operational standards in §63.1958(d)(1).
