DEPARTMENT OF ENVIRONMENTAL QUALITY
AIR QUALITY DIVISION
ACTIVITY REPORT: Scheduled Inspection

FACILITY: APC-Jackson, LLC		SRN / ID: N3293
LOCATION: 2400 E HIGH ST, JACKSON		DISTRICT: Jackson
CITY: JACKSON		COUNTY: JACKSON
CONTACT: Debra S. Doyle , Human Resource Manager		ACTIVITY DATE: 03/25/2014
STAFF: Sersena White	COMPLIANCE STATUS: Compliance	SOURCE CLASS: SM 208A SYN MINOR CP
SUBJECT: Unannounced targeted inspection conducted. One permit for multiclone on cardboard box production lines. Water based inks used for coating/labeling. Follow-up regarding required recordkeeping required by permit and applicable exemptions. Follow up was received on April 17, 2014.		
RESOLVED COMPLAINTS:

Company Name: Action Packaging

Purpose of the Inspection is determine compliance with Federal and State Air Quality regulations, namely Permit to Install 1235-91B issued on September 22, 2006 to Advance Packaging Corporation

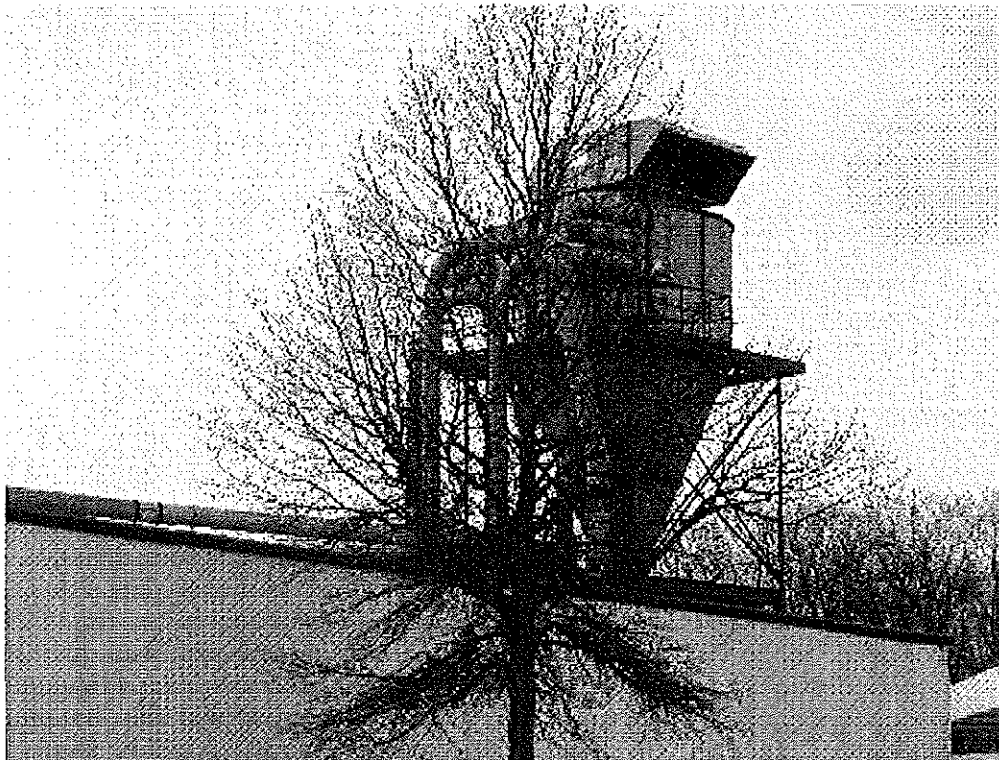
At approximately 2:18 p.m. Mark returns to his office and Debra and I return to the conference room to discuss the results of the inspection and determine follow up requirements. I left at approximately 2:25 p.m. I took a few photos of the cyclone while it was operating since the break was over by the time I left. They do not show any visible emissions.

Image 1(Cylone Exhaust 1) : Taken after leaving the plant.

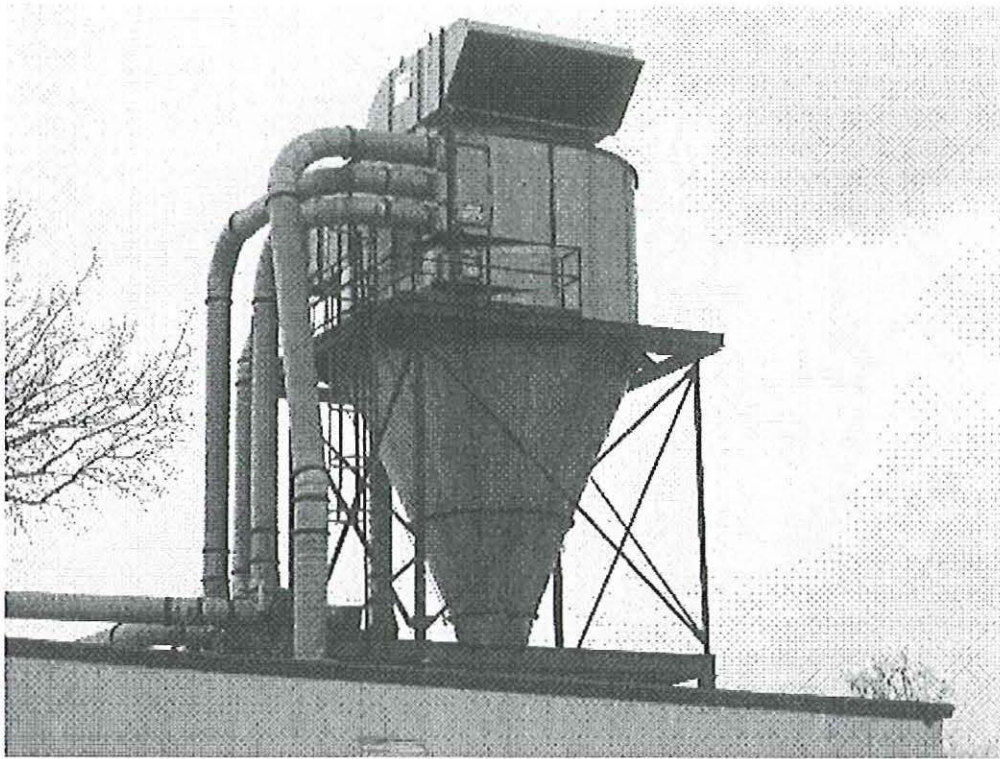
Attachments: E-mail correspondence and information about Action Packaging from the internet. The photos will be attached to the inspection report. The photos show four horizontal tubes that connect to a blower at the horizontal connection that forces the air from the lines into the cyclone. The blower motors and belts are inspected twice a year.

Image 2(Cyclone Photo 2) : This photo shows the ductwork feeding the cyclone. There is a screen covering the rectangle to prevent any large pieces from being exhausted.
