DEPARTMENT OF ENVIRONMENTAL QUALITY AIR QUALITY DIVISION

ACTIVITY REPORT: Complaint Investigation

FACILITY: Faithful Companion Mem	SRN / ID: N5753				
LOCATION: 4900 FERNLEE, ROYA	DISTRICT: Warren				
CITY: ROYAL OAK	COUNTY: OAKLAND				
CONTACT:	ACTIVITY DATE: 05/13/2022				
STAFF: Robert Elmouchi	COMPLIANCE STATUS: Compliance	SOURCE CLASS: MINOR			
SUBJECT: Unannounced visible emission observations in response to Complaint No. C-22-00780 (PEAS No. 24097).					
RESOLVED COMPLAINTS:

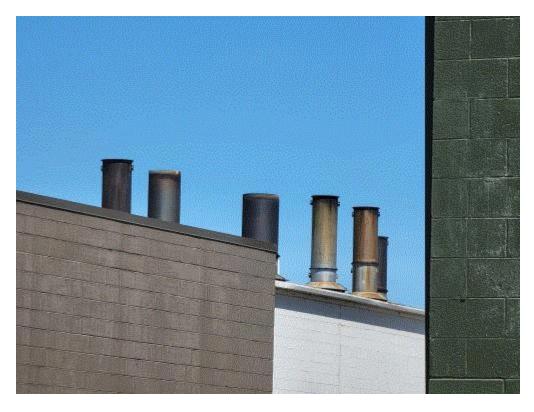
On May 13, 2022, I conducted visible emission observations from 11:45 a.m. to 12:45 p.m. I conducted observations from the parking lot at 4815 Delemere Avenue. At this address, I was able to observe all six exhaust stacks (photo attached) with the sun behind me as required per the Method 9 visible emissions test method. During this observation period, I detected visible emissions from the third stack from the north (center-right), and the southernmost stack (left stack). I observed zero percent visible emissions from the other four exhaust stacks.

At 12:07 p.m. I observed 70% opacity and zero percent opacity for the remainder of the six-minute observation period. Per Method 9 data reduction, the six-minute average opacity was 3%.

At 11:49 a.m., 12:18 p.m., and 12:26 p.m., I detected opacity from the southernmost stack (left stack). Per the Method 9 data reduction procedure, the six-minute average opacity beginning at 11:49 a.m. was 3%. The six-minute average opacity beginning at 12:18 p.m. was 3%. The six-minute average opacity beginning at 12:26 p.m. was 16%.

<u>Image 1(20220513_115248.jpg)</u>: View of exhaust stacks at 4900 Fernlee from 4815 Delemere Avenue. From left to right, the stacks are aligned from south to north. At this location, the view of the north most stack is partly obstructed by the adjacent stack.
