## **COMPLIANCE TEST REPORT**

# **CARBON MONOXIDE (CO) EMISSIONS TESTING**

## WHITE-SUPERIOR COMPRESSOR ENGINE

ALPENA COMPRESSOR STATION Harrison, Michigan

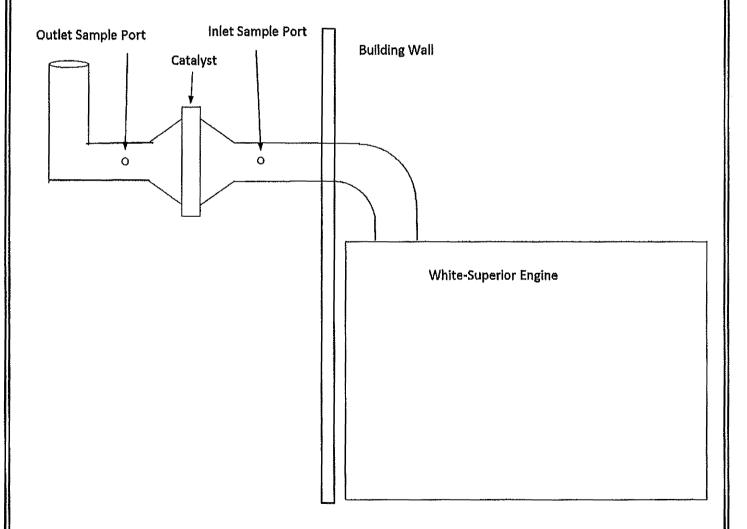
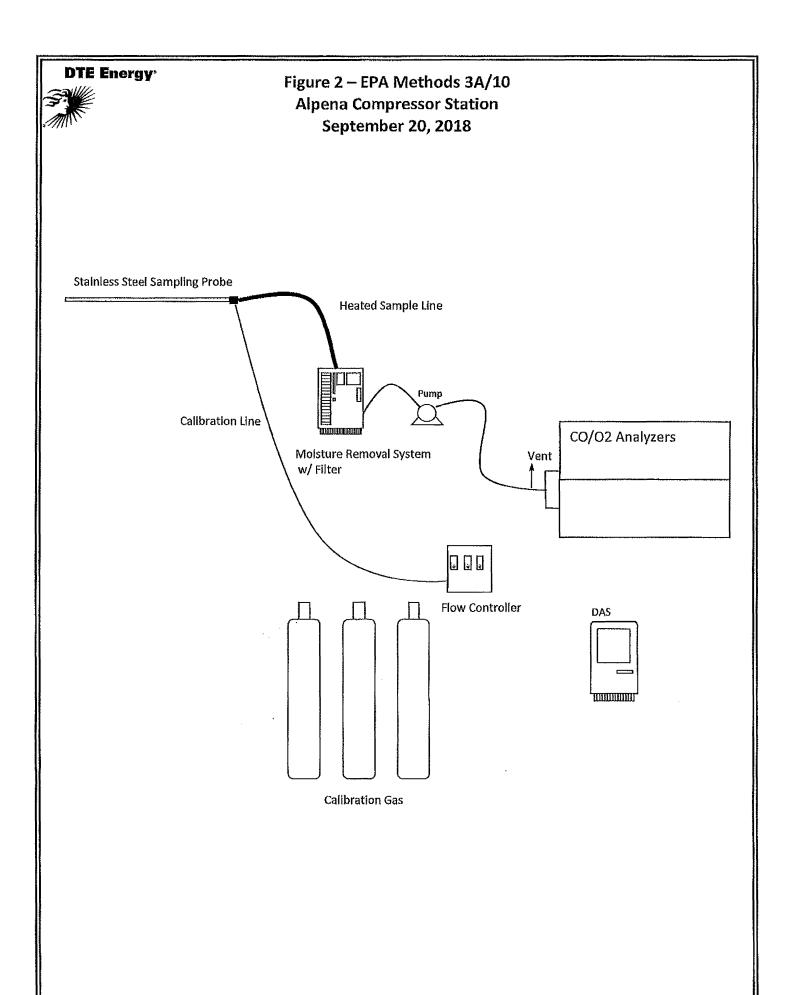
Figure 1 – Sampling Location Compressor Engine Alpena Compressor Station September 20, 2018

Schematic representations of the engine's exhaust and sampling locations are presented in Figure 1.

The EPA Methods 3A and 10 sampling system (Figure 1) consisted of the following components:

- (1) Stainless steel sampling probe.
- (2) Heated PTFE sampling line.
- (3) Sampling gas conditioner with particulate filter.
- (4) Flexible unheated PTFE sampling line.
- (5) Servomex 1400 O<sub>2</sub>/CO<sub>2</sub> gas analyzer and TECO 48i NDIR CO gas analyzer.
- (6) USEPA Protocol 1 calibration gases.
- (7) Data Acquisition System.

The emissions testing of the engine consisted of one 15-minute sample at the exhaust of the catalyst. Testing was conducted at three points across the diameter of the duct. Sampling was performed simultaneously for  $O_2$  and CO. Data was recorded at 10-second intervals.
