DEPARTMENT OF ENVIRONMENTAL QUALITY
AIR QUALITY DIVISION
ACTIVITY REPORT: On-site Inspection

FACILITY: Fritz Enterprises of Flint		SRN / ID: N6823
LOCATION: 5032 N Dort Hwy, FLINT		DISTRICT: Lansing
CITY: FLINT		COUNTY: GENESEE
CONTACT: U. Sam Amer , Corporate Environmental Manager		ACTIVITY DATE: 04/20/2022
STAFF: Daniel McGeen	COMPLIANCE STATUS: Non Compliance	SOURCE CLASS: MINOR
SUBJECT: Unannounced joint inspection by EPA Region 5 Air Enforcement and Compliance Assurance Branch and AQD.		
RESOLVED COMPLAINTS:

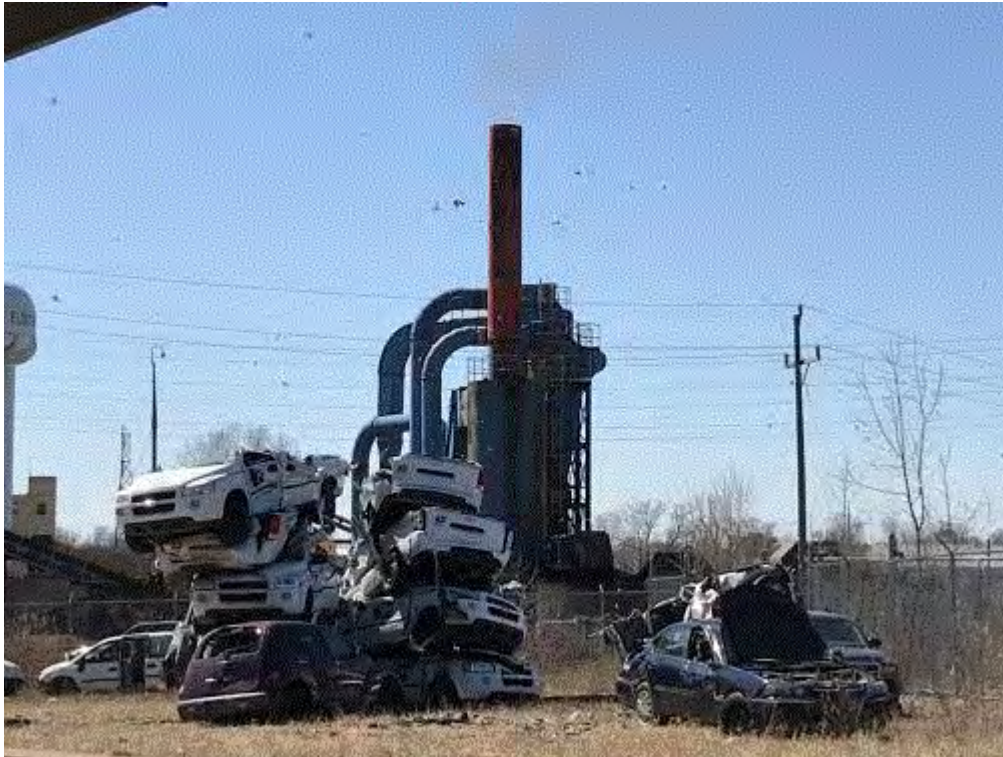
On 4/12/2022, EGLE Materials Management Division (MMD) inspectors Bryan Grochowski and Evin Maguire conducted an inspection of Fritz Enterprises. During their inspection, they observed numerous pieces of paper emitted by the wet scrubber which, along with a cyclone, is the air pollution control device for EU-ZBOX. E. Maguire noted that some of the papers appeared to leave the site. MMD staff also noted brownish opacity from the scrubber stack. A photo and video recording from MMD show a backlit plume of brownish opacity, as well as papers exiting the scrubber stack. Please refer to attached photo No. 1, taken by MMD on 4/12, of papers visible exiting the scrubber exhaust stack, with a faint, backlit plume of brown opacity.

1. The waste papers landing offsite were sufficient to constitute a violation of Rule 901(b) of the administrative rules promulgated under Act 451, which prohibits unreasonable interference with the comfortable enjoyment of life and property.

2. The large number of papers passing through the scrubber uncontrolled also indicate a violation of Rule 910 of the administrative rules promulgated under Act 451, which requires that an air-cleaning device shall be installed, maintained, and operated in a satisfactory manner and in accordance with the administrative rules and existing law.

3. The April 12, 2022, observation of waste papers leaving the wet scrubber also demonstrates that waste materials were not being contained and disposed of in an acceptable manner. This is a violation of PTI No. 92-00B, FG-SHREDDEROP, SC III.7, which requires in part that all waste materials generated by FG-SHREDDEROP shall be contained and disposed of or recycled in an acceptable manner in compliance with all applicable state and federal rules and regulations.

Image 1(1) : 4/12/2022 MMD photo of papers and backlit brown opacity from scrubber stack.

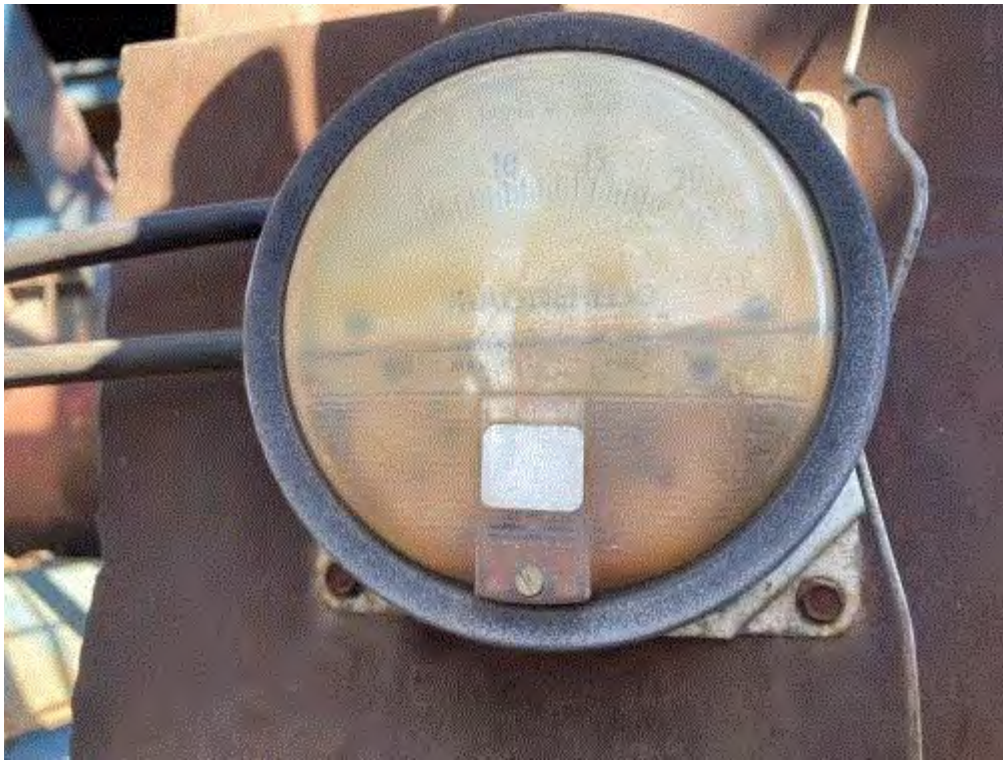
Per AQD's request, B. Fultz led us up onto the catwalk by the wet scrubber. AQD observed that the pressure drop gauge on the catwalk was missing its needle, and was therefore inoperable. Additionally, the clear glass face of the gauge was very difficult to see through, because of staining or fogging. Please refer to the attached photo No. 2, by AQD. This gauge was said to be for the cyclone, although it appears to have been referenced in B. Culham's 6/13/2013 inspection report as being for the wet scrubber.

The inoperable pressure drop gauge violated PTI 92-00B, EU-ZBOX Special Condition (SC) IV. 1, which requires that the scrubber be installed, maintained, and operated in satisfactory manner. In addition, it violated PTI 92-00B, EU-ZBOX SC VI. 1, which requires the permittee to install, maintain and operate a pressure drop gauge and a liquid flow indicator on the wet scrubber portion of EU-ZBOX. Lastly, it violated MAPC Rule 910, which requires that an air-cleaning device be installed, maintained, and operated in a satisfactory manner.

- SC 1 requires that the permittee shall not operate EU-ZBOX unless the cyclone and wet scrubber are installed, maintained, and operated in a satisfactory manner. *AQD observed that the pressure drop gauge on the catwalk was missing a needle and was inoperable, per the attached photo No. 2, by AQD. This pressure drop gauge was said to be for the cyclone, although it appears to have been referenced in B. Culham's 6/13/2013 inspection report as being for the wet scrubber. In addition, EPA noted that the liquid flow indicator for the wet scrubber which controls EU-ZBOX was damaged to the point of being inoperable Please see the attached photo No. 3, by AQD. Compliance status: Noncompliance.*

Image 2(2) : Inoperable pressure drop gauge for cyclone and/or wet scrubber.

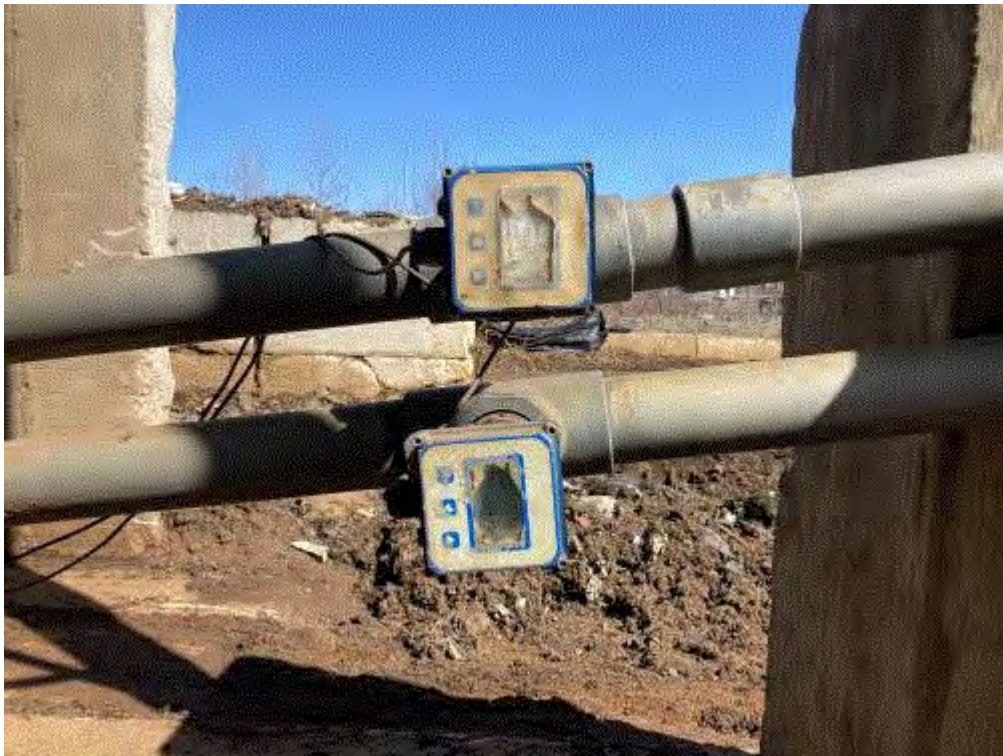
Back at ground level, B. Fultz showed EPA staff the liquid flow indicator for the wet scrubber which controls EU-ZBOX. As EPA's E. Leeds noted, it was damaged to the point of being inoperable, along with an adjacent gauge. Please see the attached photo 3, by AQD, of the two damaged gauges on water lines. The broken liquid flow indicator violated PTI 92-00B, EU-ZBOX SC IV. 1, and VI. 1, as well as MAPC Rule 910.

There was some confusion on the day of the inspection, as to the two broken gauges on the water lines leading to or from the wet scrubber. One of them, and it was uncertain which, was believed to be the water flow indicator mentioned in the permit. The purpose of the second one was unclear.

- SC 1 requires the permittee to install, calibrate, maintain and operate a pressure drop gauge and a liquid flow indicator on the wet scrubber portion of EU-ZBOX. *As discussed above, the pressure drop gauge and liquid flow indicator were damaged to the point of being inoperable. Please see the attached photos Nos. 2 and 3, by AQD. Compliance status: Noncompliance.*

5. During the April 20, 2022, joint inspection by EPA and AQD, it was observed that the pressure drop gauge and liquid flow indicator for the wet scrubber which controls EU-ZBOX were damaged to the point of being inoperable, per the attached photos. This is a violation of PTI No. 92-00B, EU-ZBOX SC IV.1, which requires that the wet scrubber be installed, maintained, and operated in a satisfactory manner, as well as a violation of EU-ZBOX SC VI.1, which requires the permittee to install, maintain and operate a pressure drop gauge and a liquid flow indicator on the wet scrubber portion of EU-ZBOX.

Image 3(3) : Broken water flow indicator and another broken gauge, the purpose of which was unknown.
