DEPARTMENT OF ENVIRONMENTAL QUALITY
AIR QUALITY DIVISION
ACTIVITY REPORT: On-site Inspection

FACILITY: Payne and Dolan Inc. Control 40 Asphalt Plant		SRN / ID: P1204
LOCATION: E 1/2 SE 1/4 S18 T47N R25W, SANDS TWP		DISTRICT: Marquette
CITY: SANDS TWP		COUNTY: MARQUETTE
CONTACT: Jim Mertes , Environmental Manager		ACTIVITY DATE: 09/05/2023
STAFF: Lauren Luce	COMPLIANCE STATUS: Non Compliance	SOURCE CLASS: SM OPT OUT
SUBJECT: On-site Inspection FY23		
RESOLVED COMPLAINTS:

Facility: Payne & Dolan Inc. C40 (SRN: P1204)

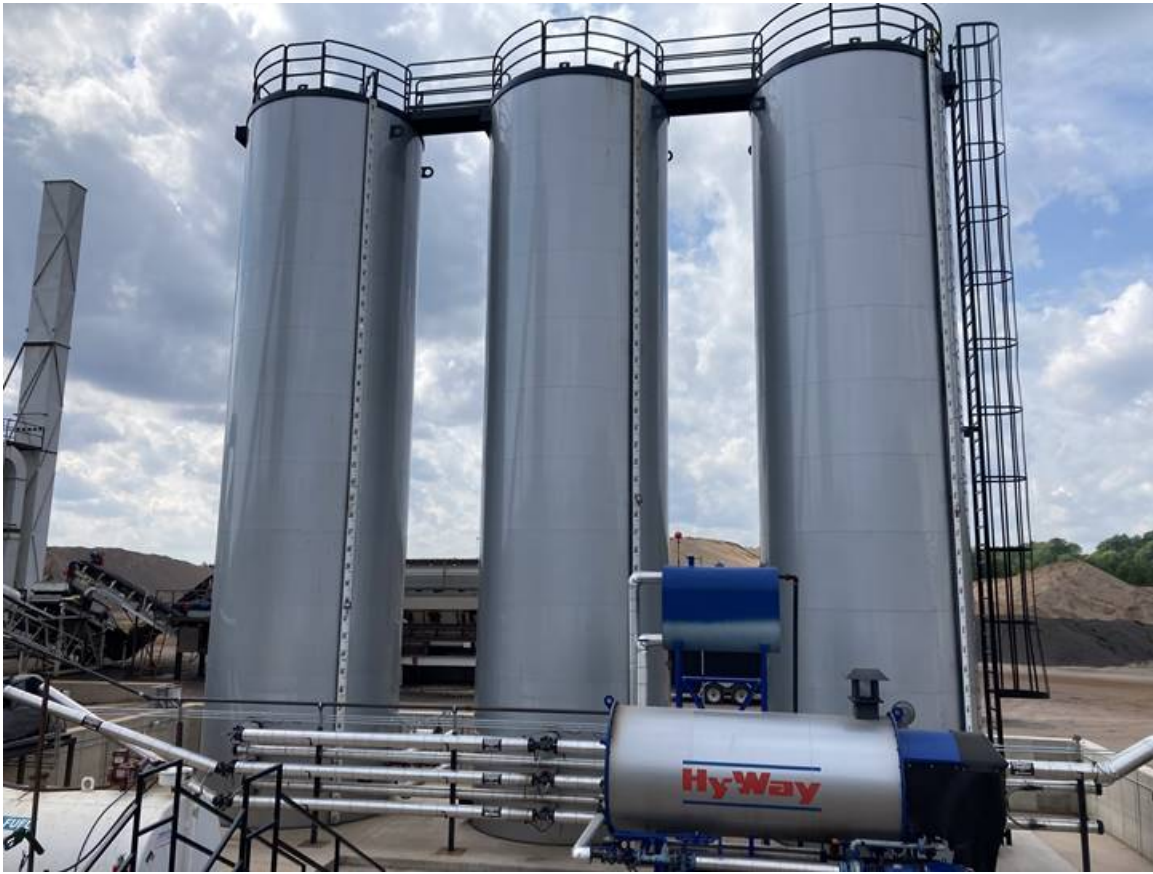
During the inspection, it was observed there that were three asphalt cements tanks on-site that are all approximately the same size. The company is aware of the discrepancy between what is permitted and what is on-site. A rule 201 violation will be issued for unpermitted equipment.

Image 1: Three AC tanks

Based on the site inspection and records reviewed, Payne & Dolan C40 does not appear to be in compliance with PTI No. 33-21 and a Rule 201 violation notice will be issued for having unpermitted equipment.

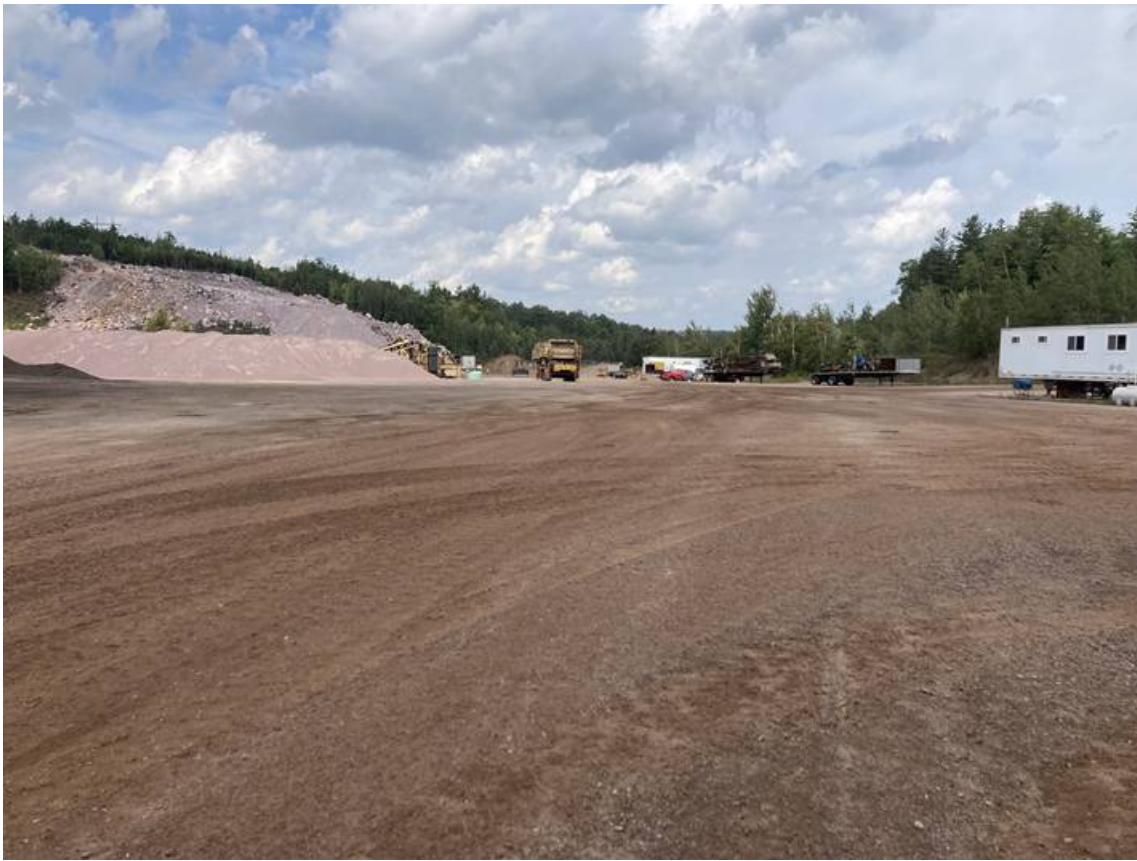
During the inspection, it was sunny with a moderate wind. The yard and roadways were well saturated. No visible emissions were present. Records of chloride application were provided. The yard and roadways had brined applied on 08/02/2023. The source did report fugitive dust from hauling in their 2022 MAERS reporting.

Image 2: Plant roadways

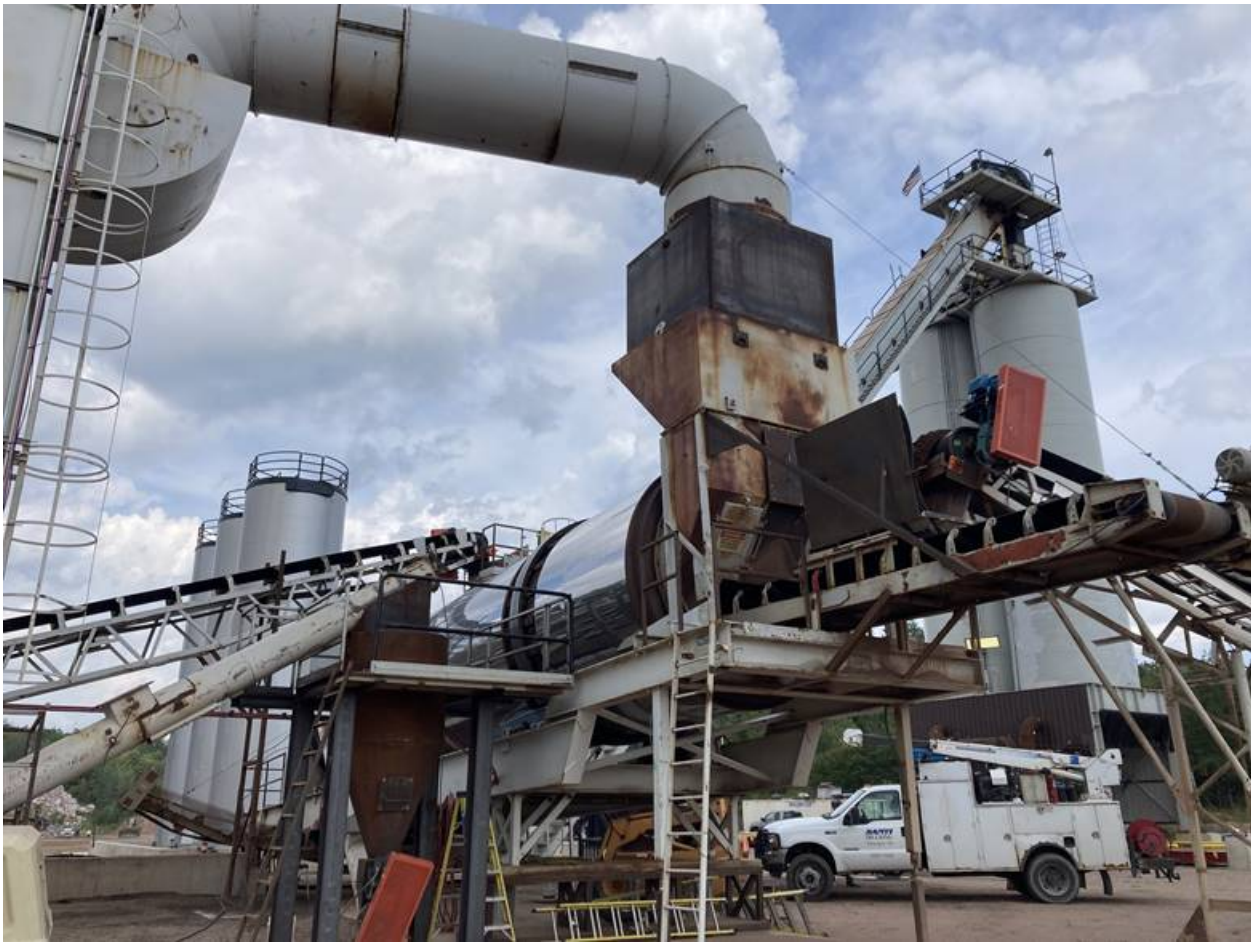
Image 3: Plant/Drum Dryer

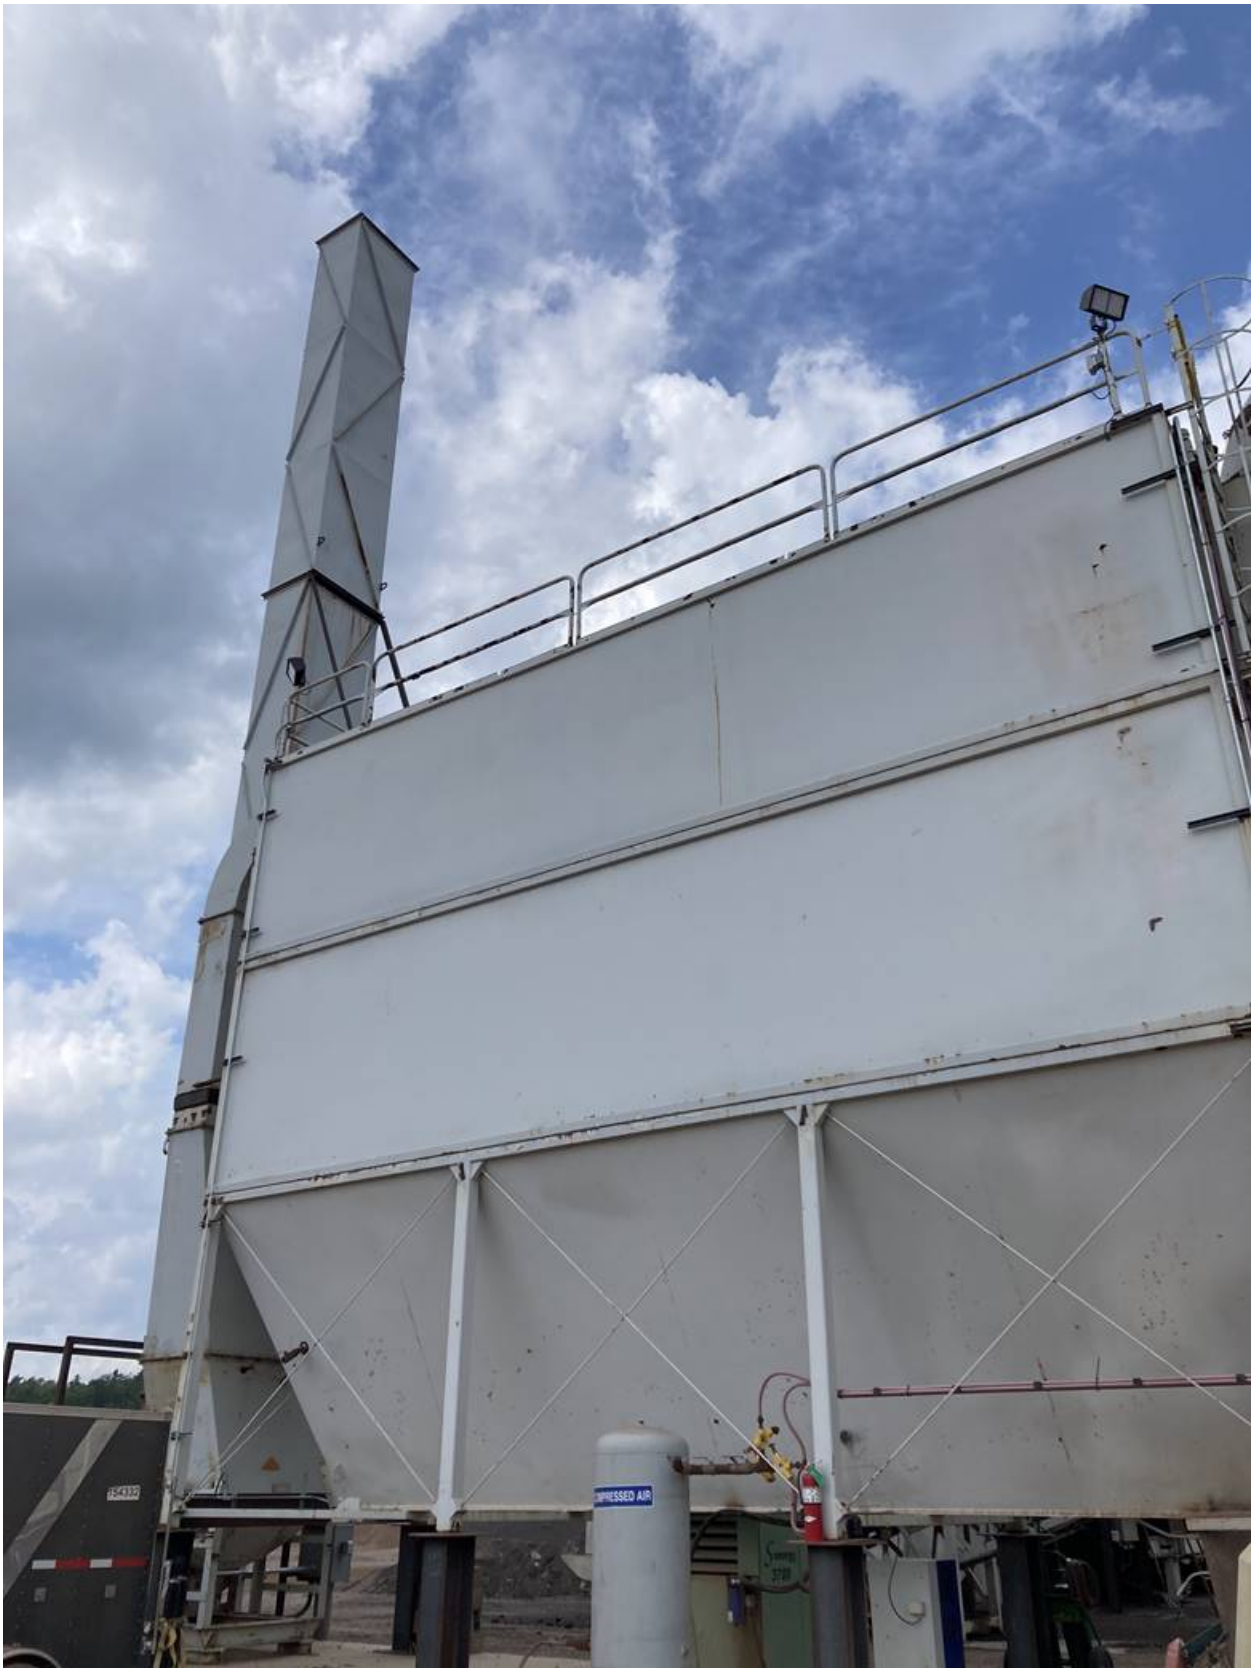
The baghouse is installed and operating properly. Additional bags are located on-site. At the date of inspection at 1:53PM, the pressure drop was 4.83 inches.

Image 4: Baghouse
