DEPARTMENT OF ENVIRONMENTAL QUALITY  
AIR QUALITY DIVISION  
**ACTIVITY REPORT: On-site Inspection**

<b>FACILITY:</b> Speedway SuperAmerica, LLC (SSA #7207)	<b>SRN / ID:</b> P0011
<b>LOCATION:</b> 3029 E. Kalamazoo St., LANSING	<b>DISTRICT:</b> Lansing
<b>CITY:</b> LANSING	<b>COUNTY:</b> INGHAM
<b>CONTACT:</b> Michael Cox , Project Manager	<b>ACTIVITY DATE:</b> 08/11/2021
<b>STAFF:</b> Michelle Luplow	<b>COMPLIANCE STATUS:</b> Compliance
<b>SUBJECT:</b> Announced, onsite, scheduled inspection to determine compliance with PTI 116-15	<b>SOURCE CLASS:</b> MINOR
<b>RESOLVED COMPLAINTS:</b>

## **FG-REMEDATION**

## **ANNUAL 2019 STATUS REPORT**

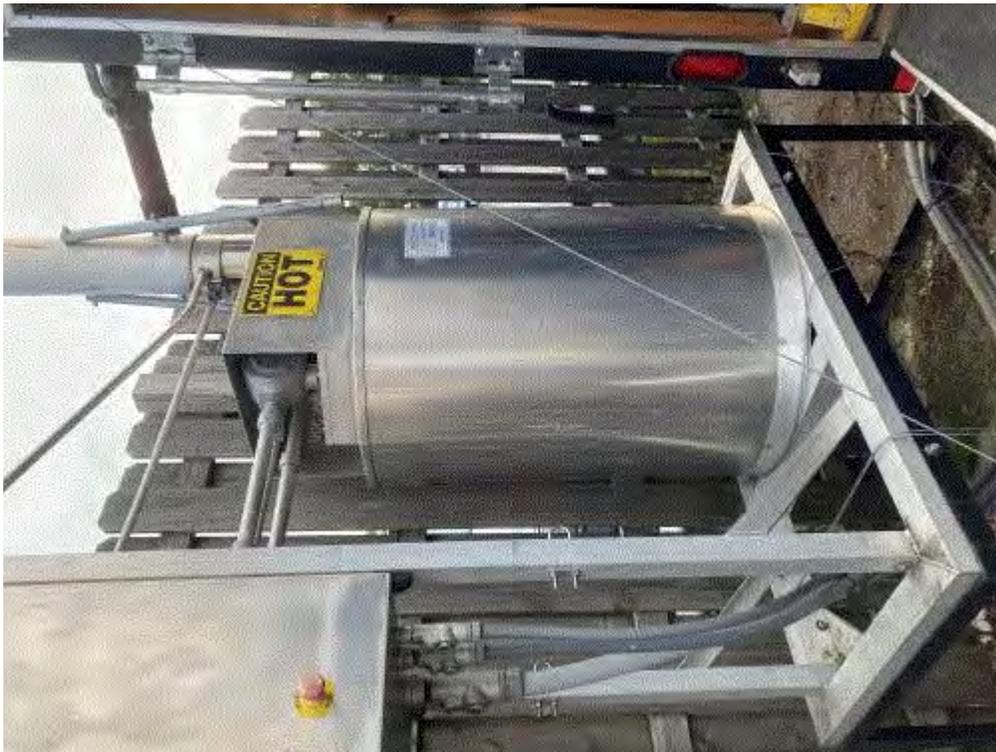
**Image 1(Catalytic Oxidizer)** : Control device for remediation.

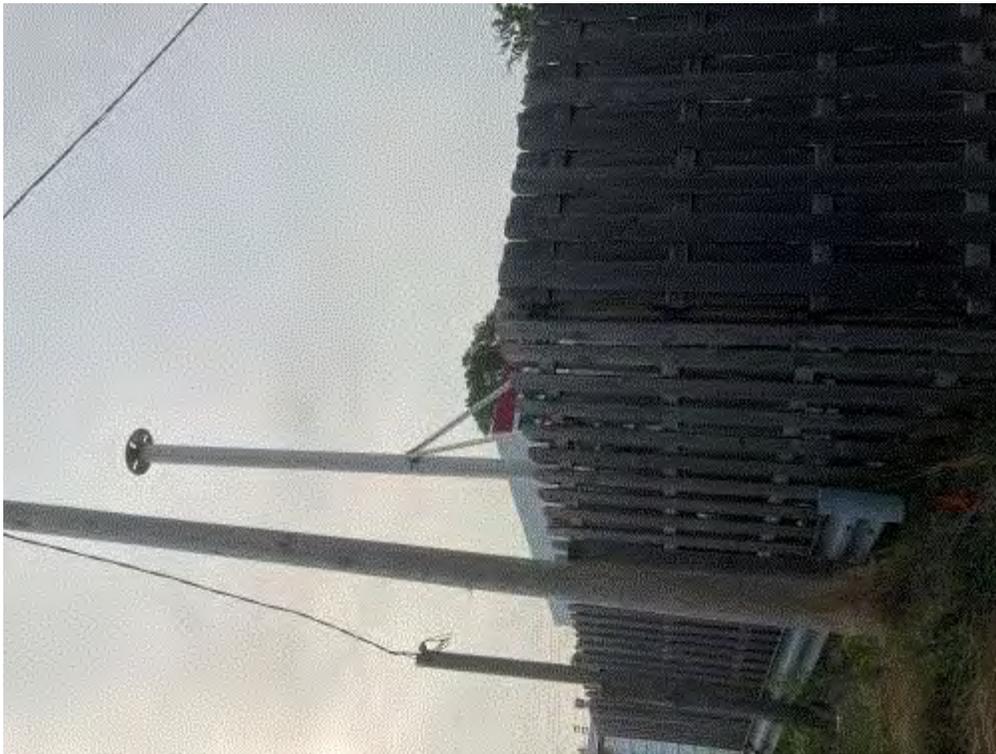
Exhaust gases are required to be discharged unobstructed vertically upwards to the ambient air at an exit point at least 1.5 times the building height, but not less than 20' above ground level. During the inspection I verified that the stack is greater than 20' from ground level, and appears to be 1.5 times the height of the remediation equipment trailer. I did note, however, that a raincap was on the stack. Mike Cox has been informed that the raincap must be removed if the remediation system is started up again to ensure compliance with the requirement that the stack discharge is unobstructed.

**Image 2(Exhaust Stack) :** Stack is appropriate height relative to the remediation trailer. Note that stack is obstructed with a raincap.

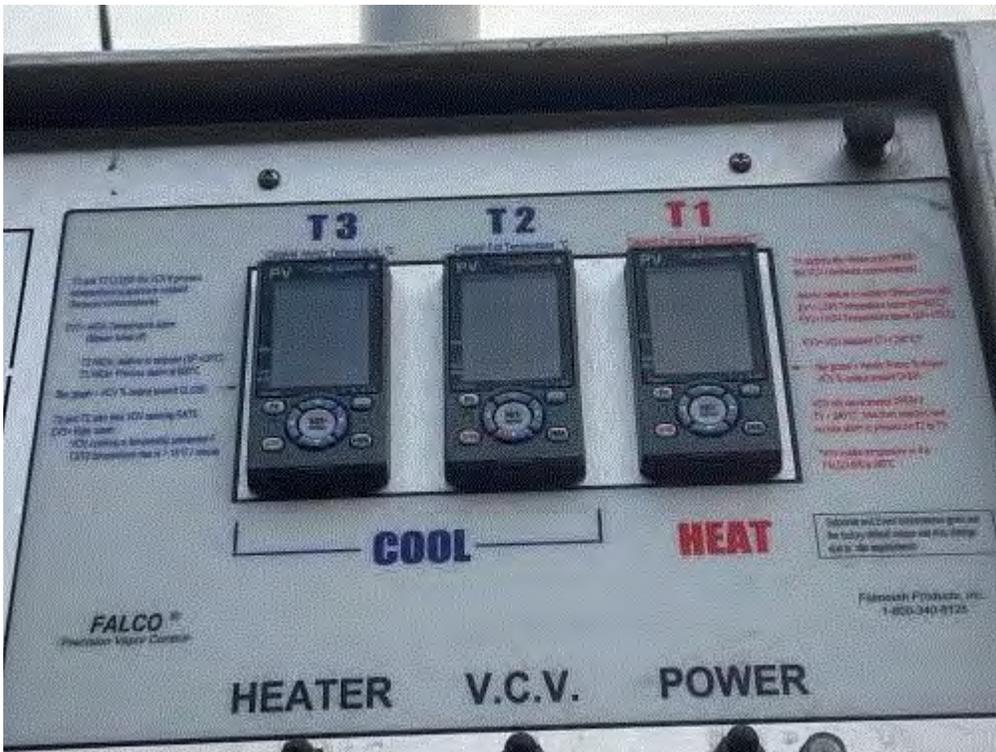
Although not operating, I verified that the catalytic oxidizer has a digital temperature monitoring device. "T1" is used to determine the inlet temperature into the catalytic bed. A snapshot review of the operation and maintenance records in 2019 indicate that the temperature of the inlet to the catalyst bed, T1, was greater than 600F (specifically 330C). M. Cox said that the catalyst did not need to be replaced during the years it operated, and that there were no malfunctions of the control device.

**Image 3(Temp Monitor) :** Note "T1" is monitor for inlet temperature to catalytic bed.

M. Cox has been informed that maintenance records should be made clearer in terms of following manufacturer's recommendations to maintain the catalytic bed, in the event that they determine the system will be operated in the future.
